VEHICLE DAMAGE INSPECTION REPORT

Handling Insurer:	China Taiping Insurance (Singapore) Pte. Ltd.	Policy No:	DMCVSN3023491600
Claimant Vehicle No :	SKJ3306R	Insured Vehicle No :	GZ3879S
Date of Loss:	22/06/2017	Nature of Claim:	TP
		Claim No:	SNM17D03716C02

Reg No:	SKJ3306R	Engine No:	F3871238B38B15A
Make & Model:	BMW 318CI, 2.0 (A)	Chassis No:	WBA8E360X0NT39183
Reg. Date:	04/02/2016 (Man. Year: 2015)	Odometer:	12526 km
Colour:	White		
Engine Capacity:	1499 cc		
Market Value/New Car Price:	N/A		
Sum Insured (S\$):	Market Value/New Car Price

Date of Assignment:	23/06/2017	
Date Inspected:	03/07/2017	Inspected At: Performance Motors Limited (Alexandra) 303 Alexandra Road, Sime Darby Performance Centre Singapore 159941
Estimated Period of Repair:	8.0 days

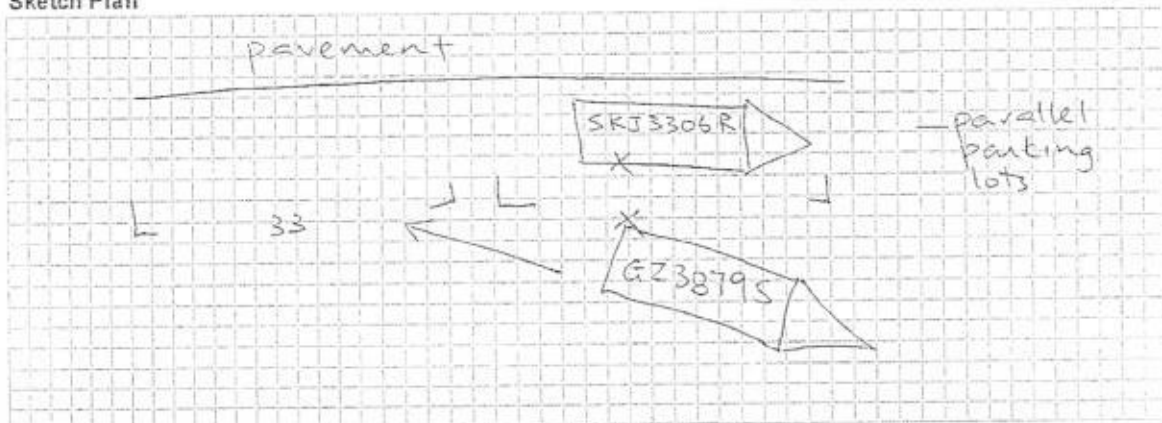
Sketch Plan

My car was parked at 17 Muhammed Sultan Rd, Parallel parking, on 22 June 2017, when I came to collect the car at around 10.30-10.40am, 2 persons were there and told me they hit my car while reversing into the parking lot behind my car. Their vehicle, left back, hit the right side of my car, around the back tyre/fuel tank area. We exchanged particulars and I also took photos of the damage of my car, and the position his vehicle that impact my car.
