**INITIAL INSPECTION REPORT OF VEHICLE NO. SHC 2453C**

Please be informed that we had conducted the inspection of the above mentioned vehicle on 29-06-2017 at the premises of M/s CHUNNI MOTOR and have the following to report:-

The vehicle sustained damages at the front and rear portion.

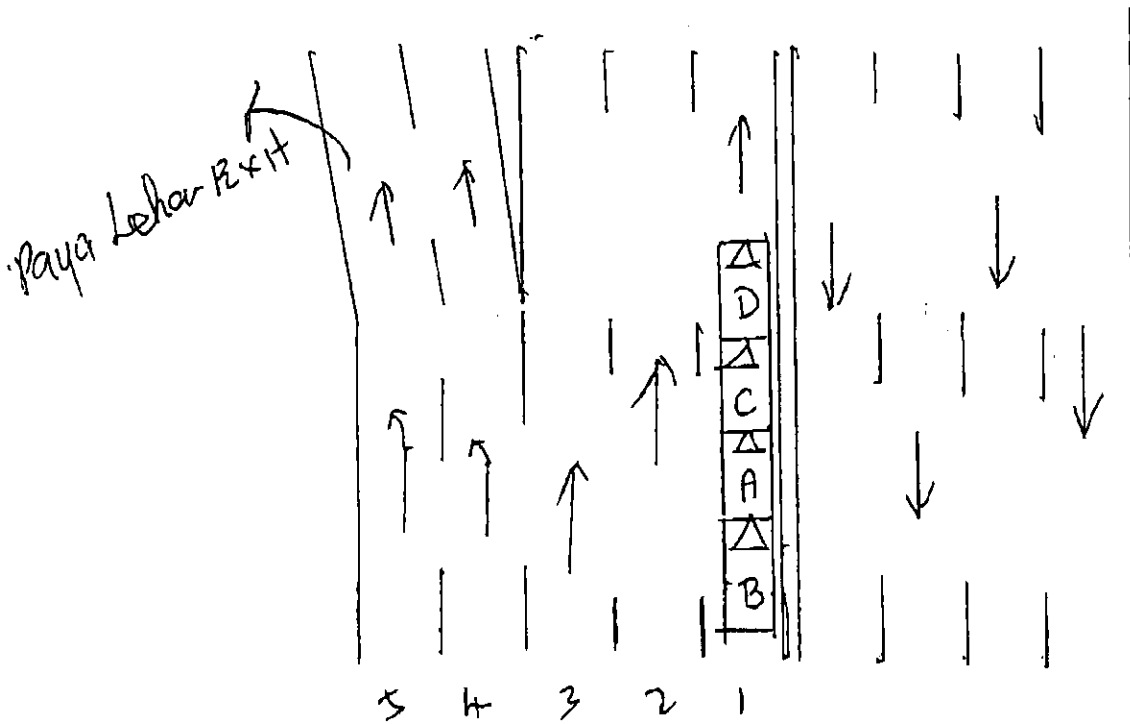
## PIE TOWARD CHANGII AIRPORT.

On 25/6/2017 @ about 17:05hrs, my taxi (A) was travelling along PIE (Changi) with 4 passengers. Before Paya Lebar exit, the front vehicle (B) suddenly stopped. I could not stop in time and hit onto its rear. When checking the damage, then realised veh C & D was involved too. No injury at the point of accident.

1. D - SKC-6099-E
2. C - SLM-119-G
3. A - SHC-2453-C
4. B - SHC-133-P.

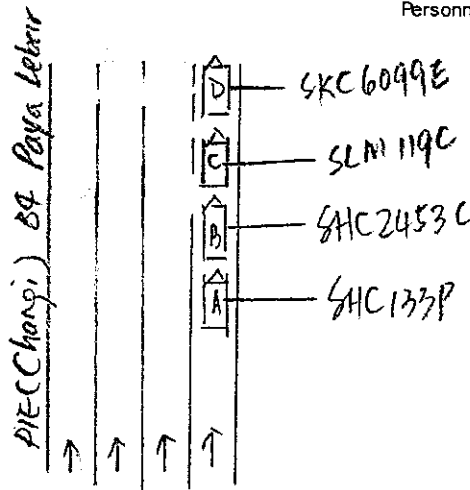
Sketch Plan

Type Of Accident	COLLISION- HEAD TO REAR (INSURED HIT TP)
Weather Conditions	CLEAR
Road Surface	DRY
