VEHICLE DAMAGE INSPECTION REPORT

Our File No: CS/AXA17014549/CRBS2

Handling Insurer:	AXA Insurance Pte Ltd	Policy No:	P1670742
Claimant Vehicle No :	PZ56M	Insured Vehicle No :	XD1907Y
Date of Loss:	19/07/2017	Nature of Claim:	TP
		Claim No:	C0445131

Reg No:	PZ56M	Engine No:	6425141
Make & Model:	SCANIA KIB4X2, 11.7 D (M)	Chassis No:	YS2K4X20001865918
Reg. Date:	29/10/2010 (Man. Year: 2009)	Odometer:	499319 km
Colour:	White		
Engine Capacity:	11705 cc		
Market Value/New Car Price:	N/A		
Sum Insured (S\$):	Market Value/New Car Price

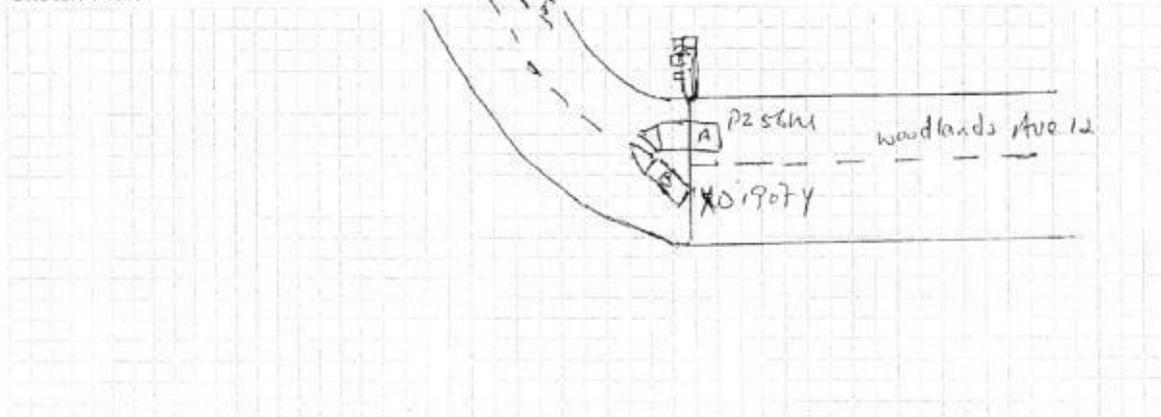
Sketch Plan

while the traffic light turn green, I continue to drive turn to SLE, out of sudden A trailer had hit my vehicle front left side. (side mirror).

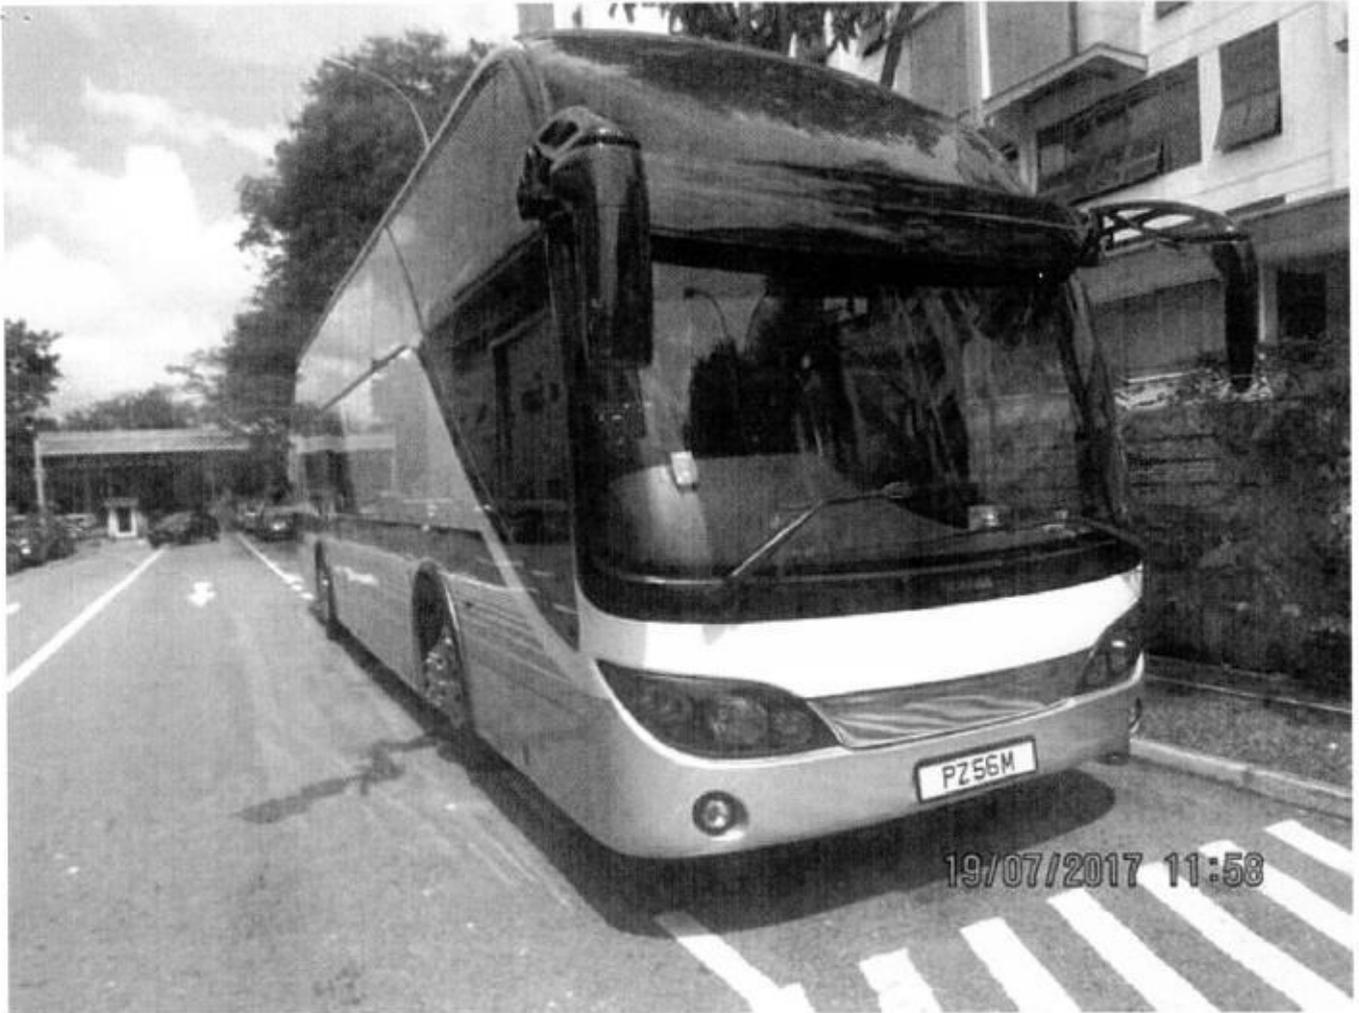
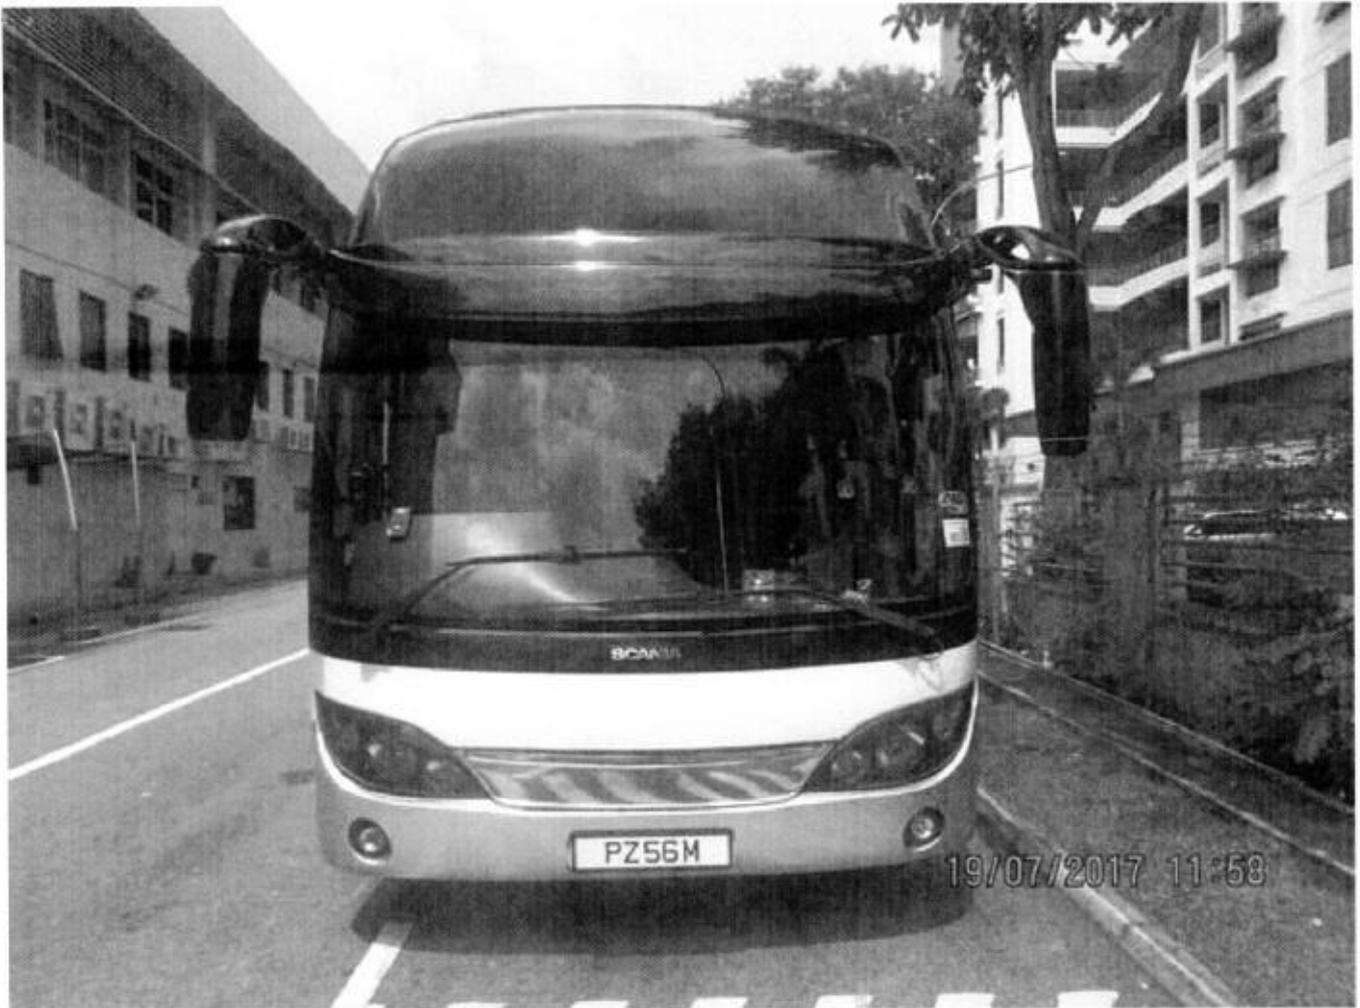
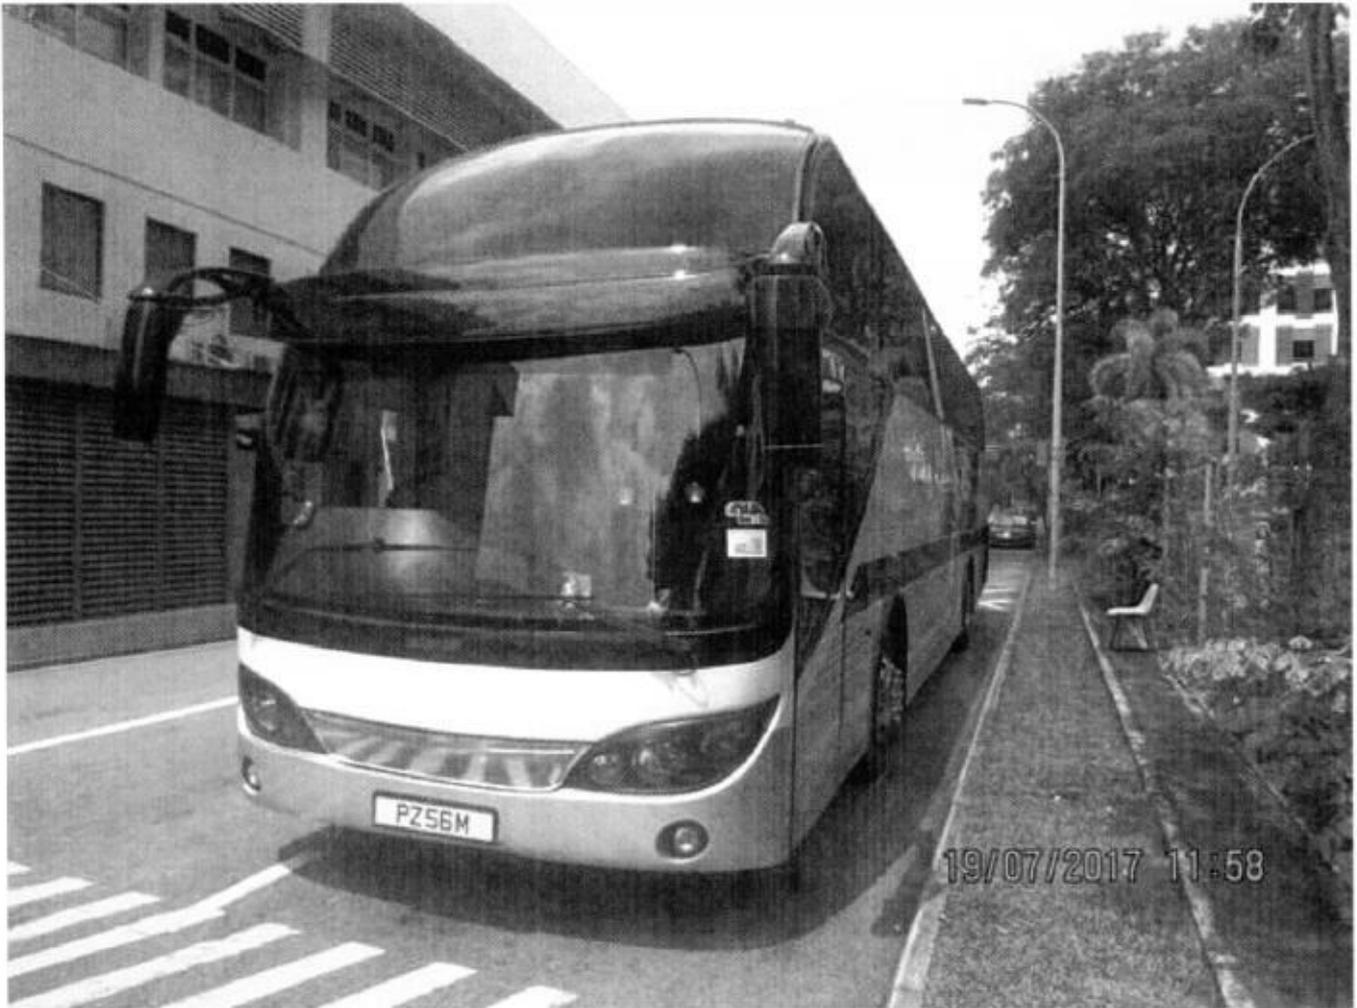
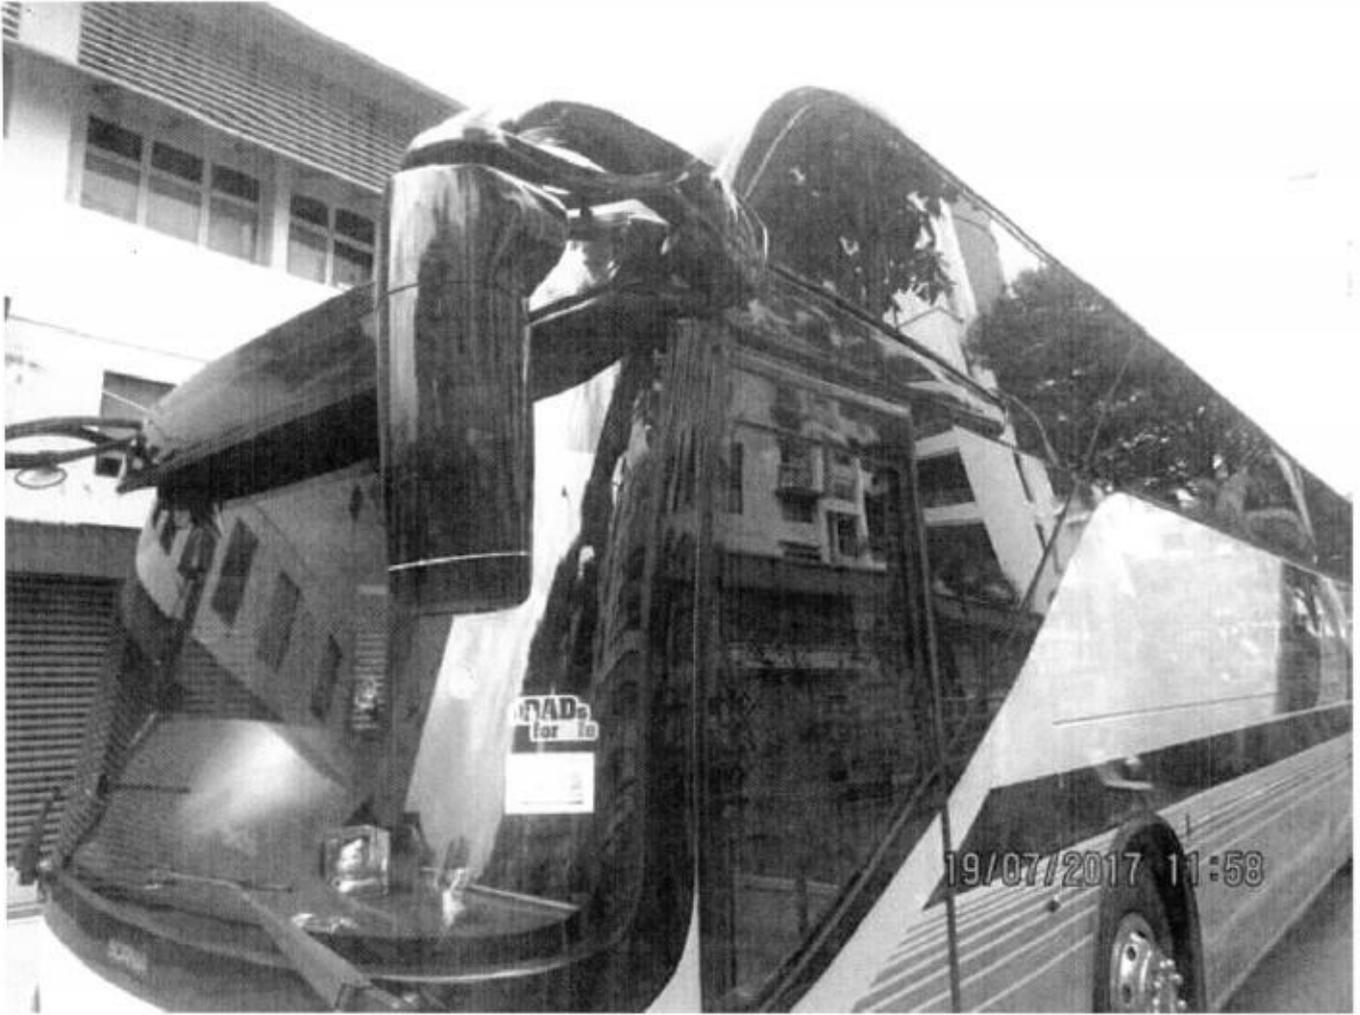
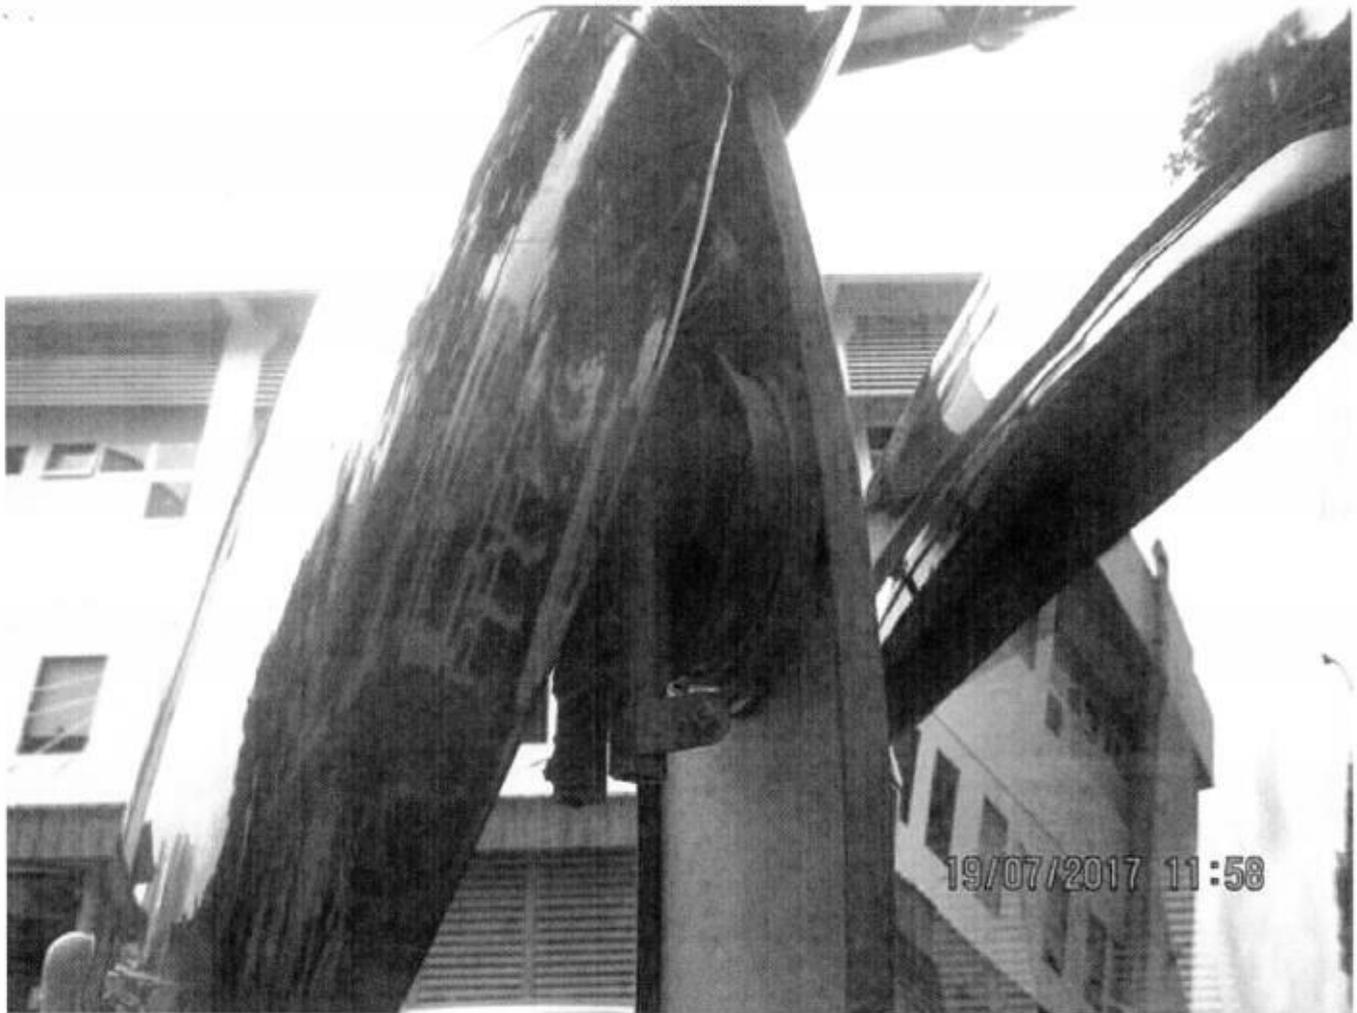
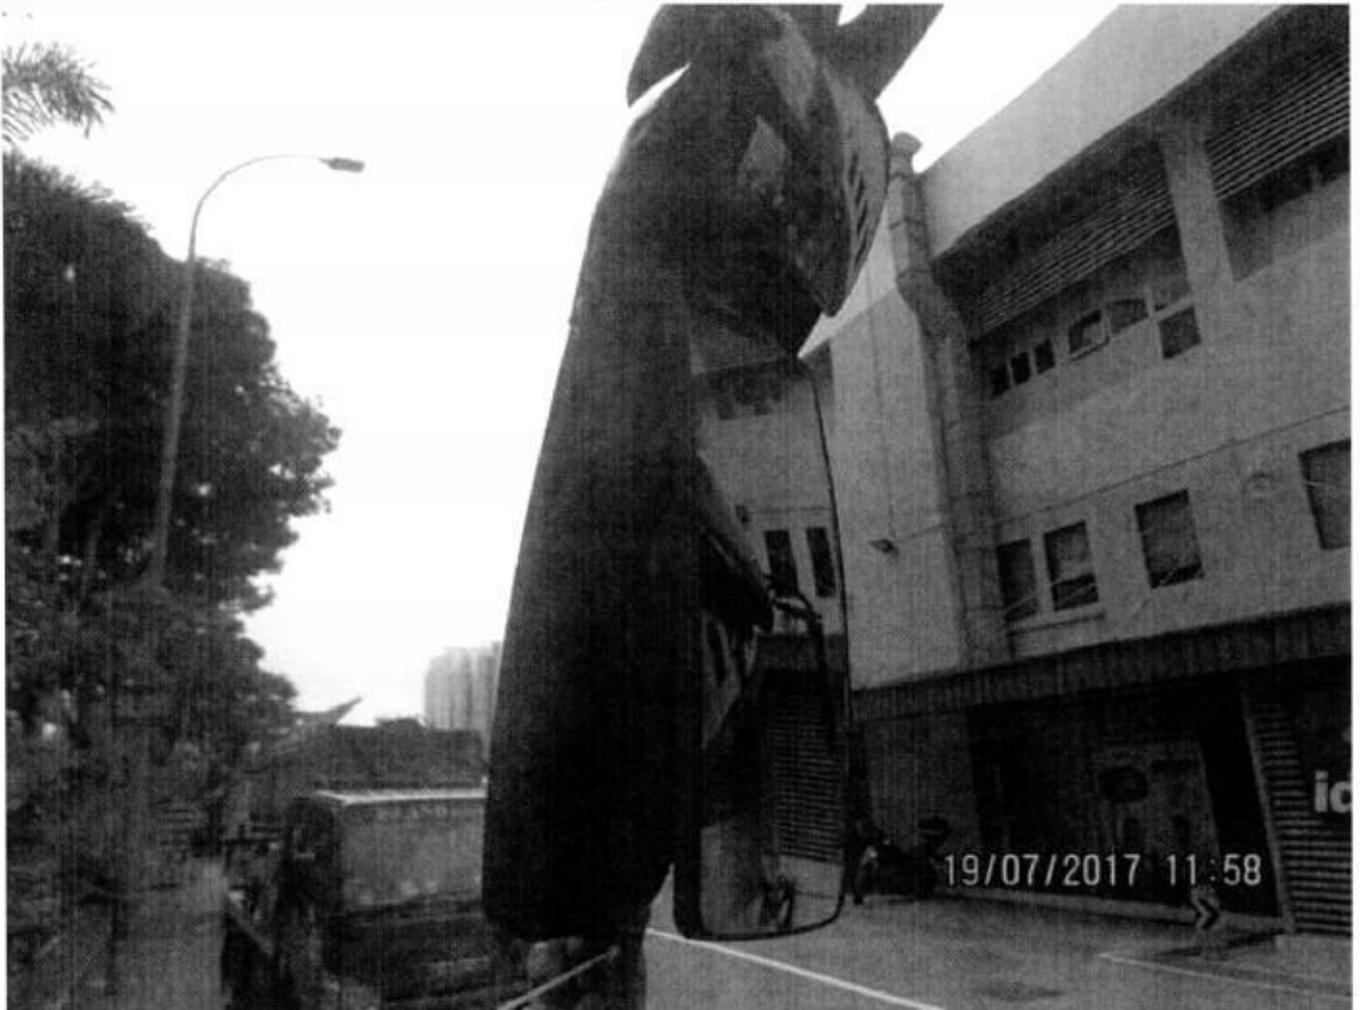
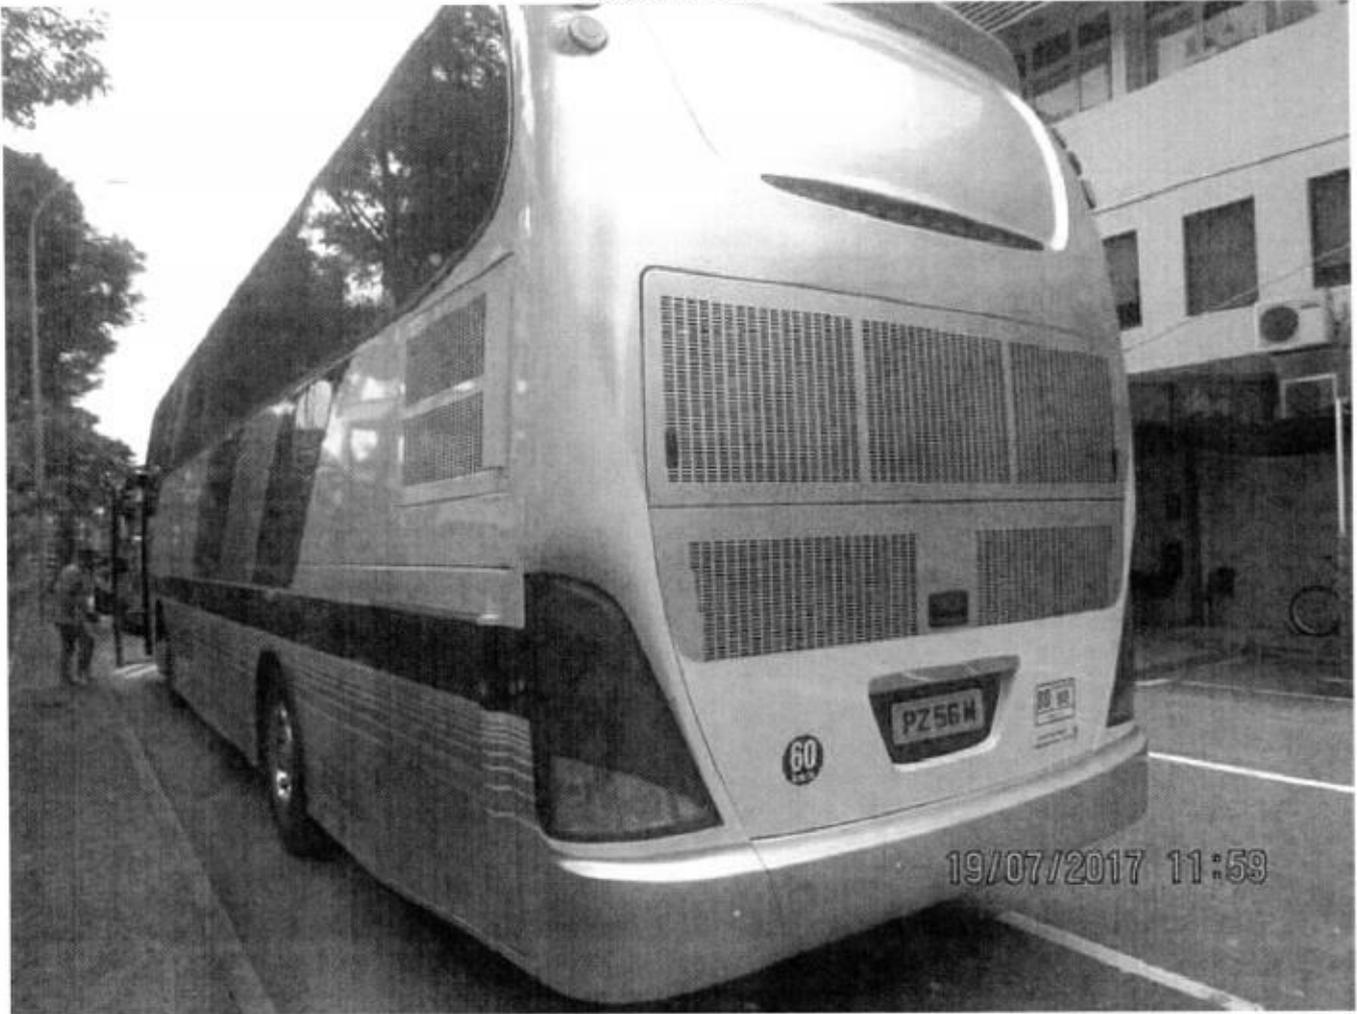
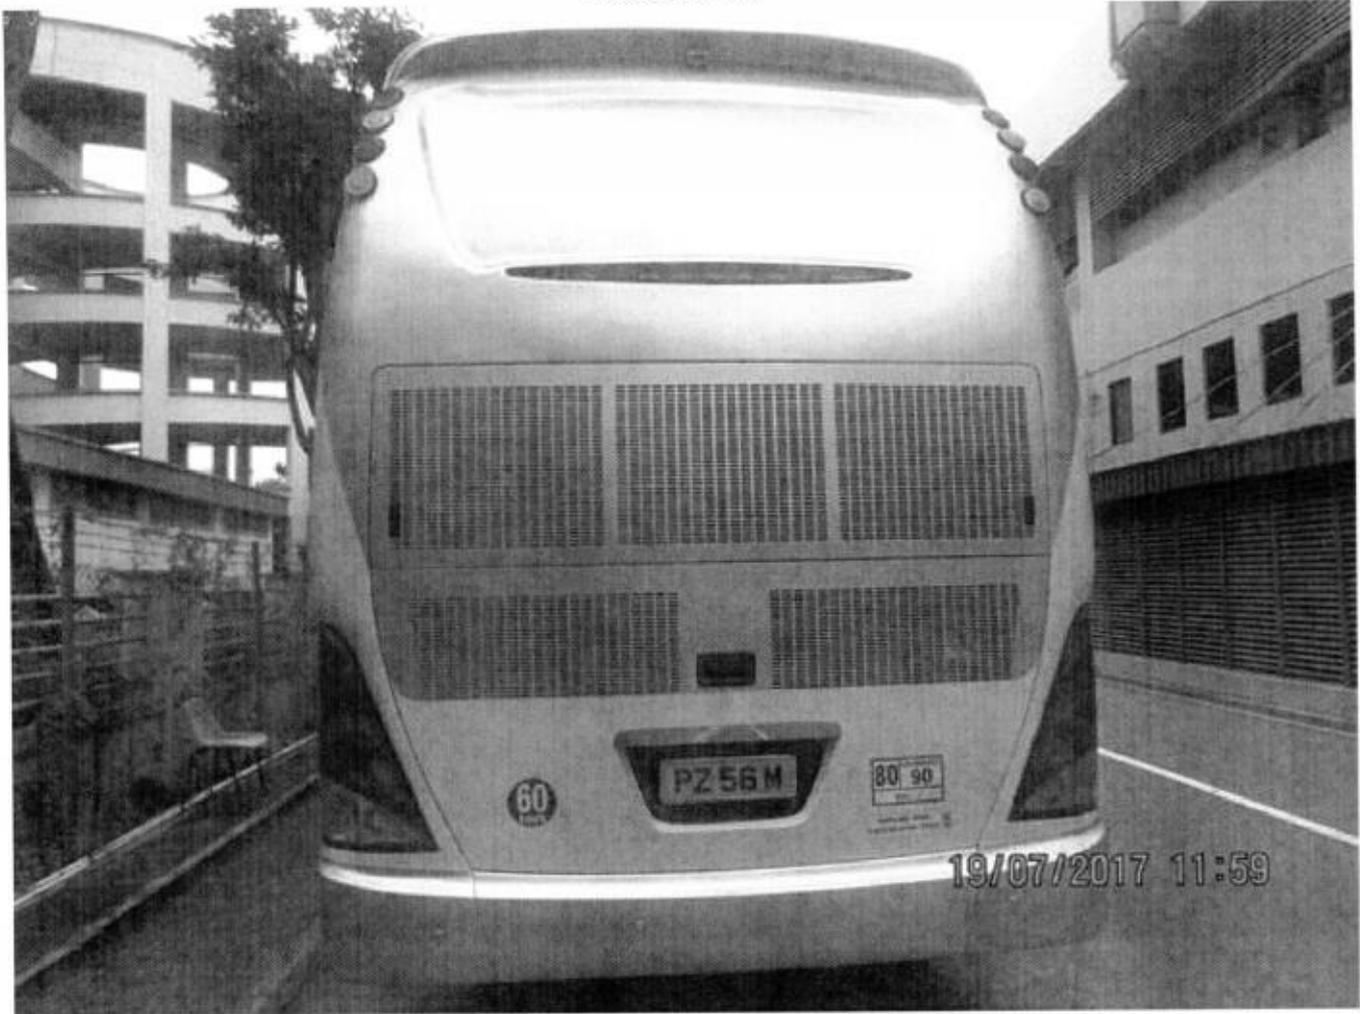
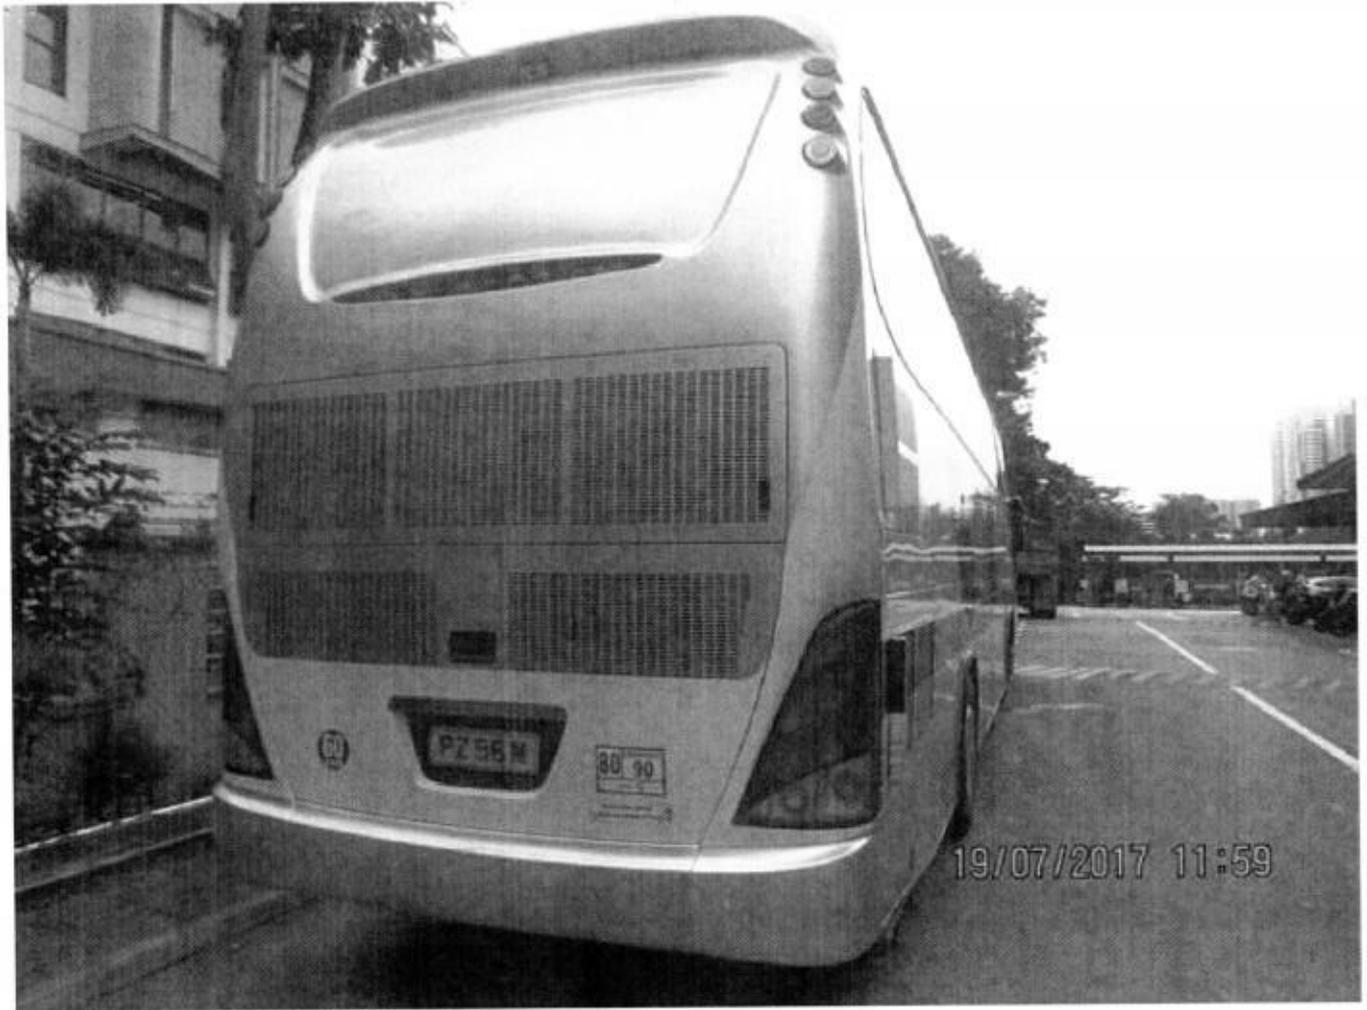
Accident Photo

No.	Qty	Part No.	Particulars	Condition	Repairer's	Amount	
1	1		*FRONT LEFT ELECTRICAL WING MIRROR ASSY (CONSISTENT)	Cracked	2,900.00 FL	*2,900.00 FL	
						F=Franchise part, L=ListItemDisc.	
					Sub Total (S\$)	2,900.00	2,900.00
					- List Item Discount on L Items 10.00/10.00% (S\$)	290.00	290.00
					Total Parts (S\$)	2,610.00	2,610.00

No	Particulars	Lab.Type	Repairer's	Amount
Labour Items				
1	TO REMOVE DAMAGED FRONT LEFT ELECTRICAL WING MIRROR AND REFIT NEW INCLUDING CHECKING OF ITS WIRING SYSTEM.	New	180.00	120.00
2	TO PUTTY AND SPRAY PAINTING ON FRONT LEFT WING MIRROR CASING ASSY.	New	450.00	210.00
Gross Labour Cost (S\$)			630.00	330.00
