VEHICLE DAMAGE INSPECTION REPORT

Our File No: CS/CTI17015065/T1TBE2

Handling Insurer: China Taiping Insurance (Singapore) Pte. Ltd. Policy No: DMPCSN1607151701
 Claimant Vehicle No: SJP8210E Insured Vehicle No: SJN5935C
 Date of Loss: 28/07/2017 Nature of Claim: TP Claim No: SNM17D04478C02/5

Reg No: **SJP8210E**
 Make & Model: HONDA ODYSSEY, 2.4 (A) Engine No: HIDDEN
 Reg. Date: 01/04/2009 (Man. Year: 2009) Chassis No: JHMRB38309C200694
 Colour: Maroon Odometer: 258670 km
 Engine Capacity: 2354 cc
 Market Value/New Car Price: N/A
 Sum Insured (S\$): **Market Value/New Car Price**

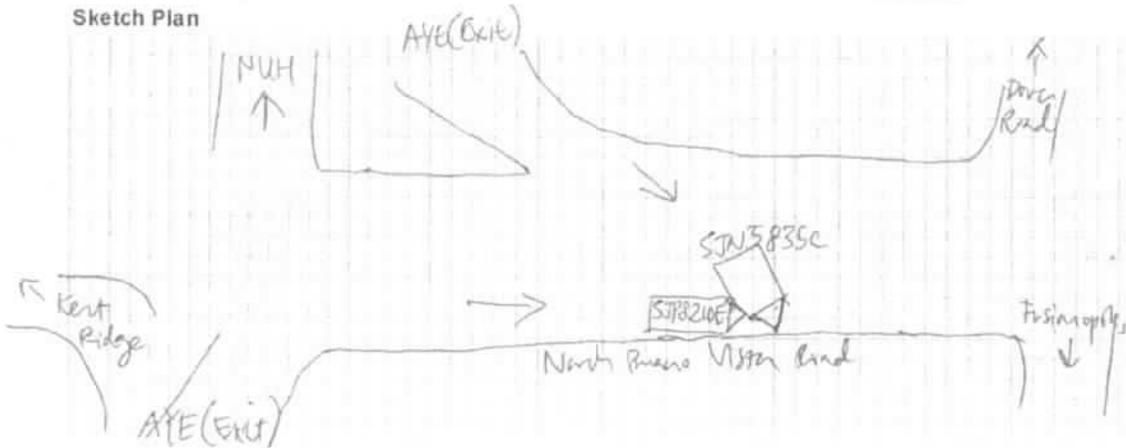
Sketch Plan #2 Pg. 1

At 7.00am on 28 July 2017, I was taking my usual route of sending my daughter to school at Dover Road. After exiting from the AYE (towards Tuas) at the 4th exit, I was on the extreme right lane. After passing the main traffic light at North Brown Vista Road (still on the extreme right lane of the 4/5 lane road), vehicle STN 5935 C (Toyota Corolla Altis) cut into my lane all a sudden right into my path. I braked heavily (my children and wife were in my car) unfortunately, his sudden entry into my path resulted in the left side of my car damaged, my left front bumper, the left light lamp and scratches on the front (left) of my car including now resistance to the left front door of my vehicle. The driver Mr Chen Yunjie (S2721689G) was apologetic and surrendered his IC for me to note his particulars. Thankfully my children and wife were safe.
