PRE-REPAIR INSPECTION FOR SJU9133L
ACCIDENT INVOLVING SJU9133L & GBC9256E ON 11.08.2017

3RD PARTY CLAIM ESTIMATION

THE VEHICLE SUSTAINED DAMAGES AT THE FRONT AND REAR PORTION.
DAMAGES SEE DETAILS.

ADJUSTMENT ON REPAIR COST FOR VEHICLE NO. SJU 9133L

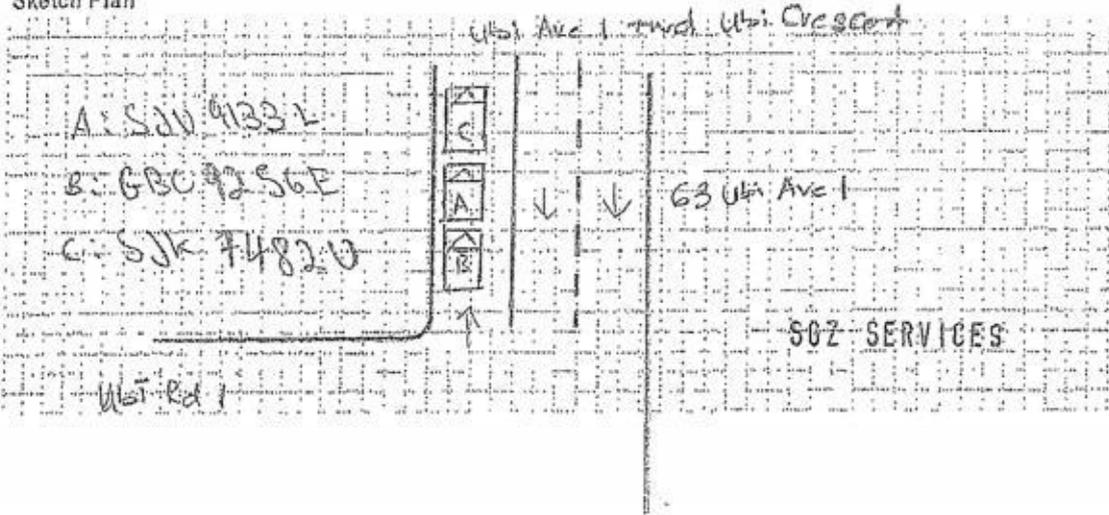
Sketch Plan

My car was completely stationary without any contact with the front stationary vehicle. All of sudden, I felt a huge impact from my car rear. The huge impact from the rear caused my car to thrust forward and hit onto the front vehicle. After the accident, I came out of my car and found that total 3 vehicles involved in the accident.
