To Inspect Vehicle No: STT31478 Insured: SHA47247at Workshop m/s HUPLEY Huat motor.

Veh No: ST3147S Yr Regn: 01 Oct 2009Type: M.Car / M.Cycle / Bus / Van / Lorry / Taxi / Prime Mover /

VEHICLE DAMAGE INSPECTION REPORT

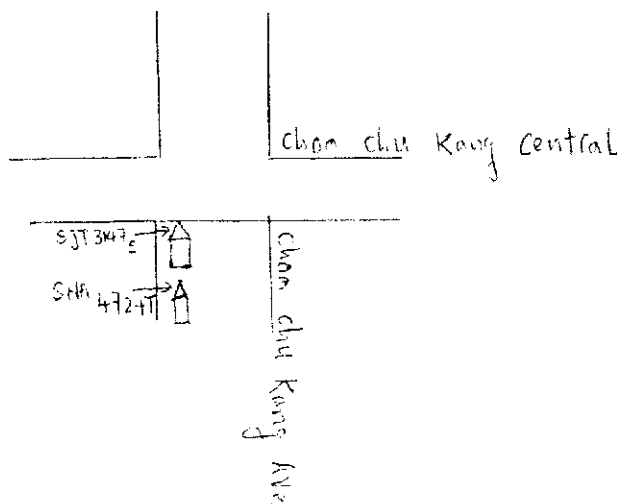
Sketch Plan

I STOPPED MY CAR ALONG CHOA CHU KANG AVE 3 JUNCTION DUE TO TRAFFIC TURNED RED. SUDDENLY A TAXI(SHA4724T) CAME FROM BEHIND, HIT ONTO THE REAR OF MY CAR. THE IMPACT CAUSED MY CAR TO SURGE FORWARD. ATTENDED BY AINI
