t de l'		Amiliated to Federation I	nternationale Des Experts En Autor	nobile
ERG	O INSURANCE F	PTE LTD	Ref : CS/EGI170169	915/Sgb
#04-	MASEK BOULEV 01 SUNTEC TOW 3APORE 038985		Date : 31-08-2017 Code : EGI	
<u> </u>		Policy Part	iculars :- THIRD PARTY CLA	<u> </u>
	Insured Veh.	YN 4387M	Veh. Inspected	SJC 6003T
	Policy No.		Coverage (\$)	0.00
	Claim No.	YN4387M/SE/pl	Excess (\$)	0.00
	Assign From	SITI	Assign Date	31/08/2017

PRELIMINARY A	ADVICE OF	VEHICLE NO.	SJC 6003T

Please be informed that we had conducted the inspection of the above mentioned vehicle on <u>04-09-2017</u> at the premises of M/s <u>GOLD AUTOWORKS</u> and have the following to report:-

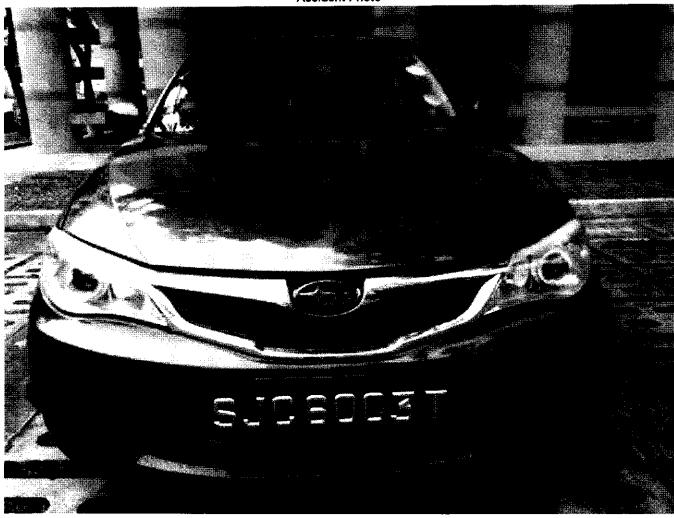
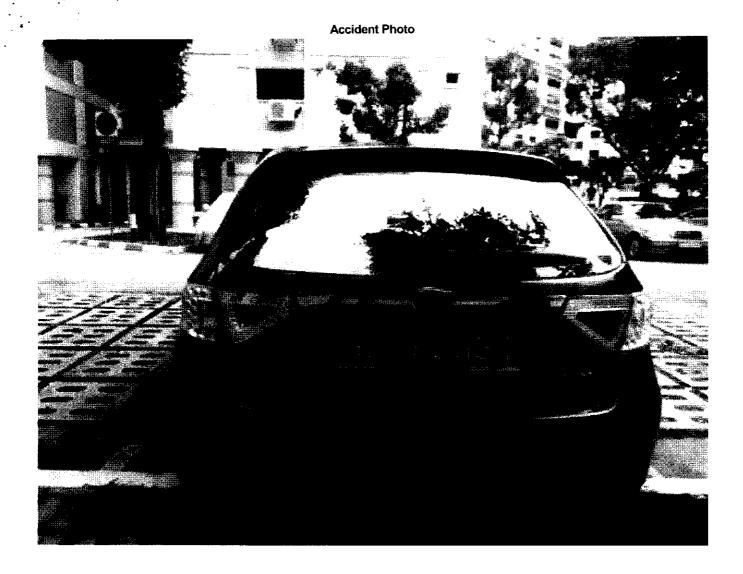
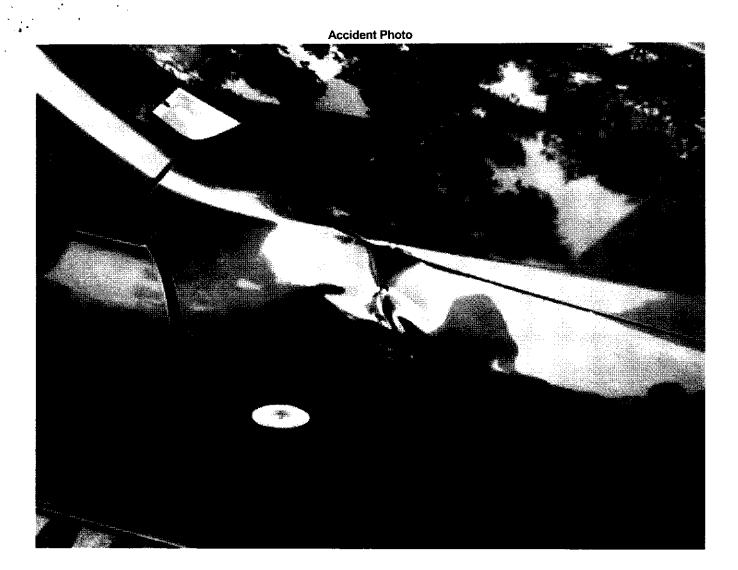
The vehicle sustained damages at the front portion.

3.		Conditions of Tyres	
	Size	Make	Balance
R/H Front 1	Tyre 195/65 R15	GOODYEAR	6 mm
L/H Front T	yre 195/65 R15	GOODYEAR	6 mm
R/H Rear T	yre 195/65 R15	GOODYEAR	6 mm
L/H Rear Ty	<u> </u>	GOODYEAR	6 mm
	-CONTROL OF THE PROPERTY AND THE PROPERTY OF T	scription of Damages	State of the second
THE VEHICL	E SUSTAINED DAMAGES AT 1	THE O/S FRONT PORTION.	
DAMAGES S	SEE DETAILS.

Qty	The second secon	Description of Parts		Condition	Estimate By Workshop (5)	Our Adjusted (5)
	AREA AND DAMA REPAIR OF FROM	REPAIR, REALIGN ON AFF GED PARTS. INCLUSIVE O IT BUMPER, FRONT SIDE N H, FRONT BONNET AND FR	F THE MIRROR R/H,		800.00	600.00
	TO SPRAY PAINT	ING ON AFFECTED AREA.			950.00	650.00
	REMOVE AND RE	-INSTALL MUDGUARD TO	NECESSARY		120.00	30.00
					2,050.00	1,385.00
	GRAND TOTAL	· · · · · · · · · · · · · · · · · · ·			6,666.94	1,722.09

RECOMMENDED COST OF LUMP SUM REPAIRS	1,400.00
(TO ITS PRE-ACCIDENT CONDITION)
