VEHICLE DAMAGE INSPECTION REPORT

Our File No: CS/MSG17018460/GRBE2

Claimant Vehicle No : SKE3797H

Make & Model: VOLKSWAGEN NEW GOLF 5K13G5, 1.4 (A)

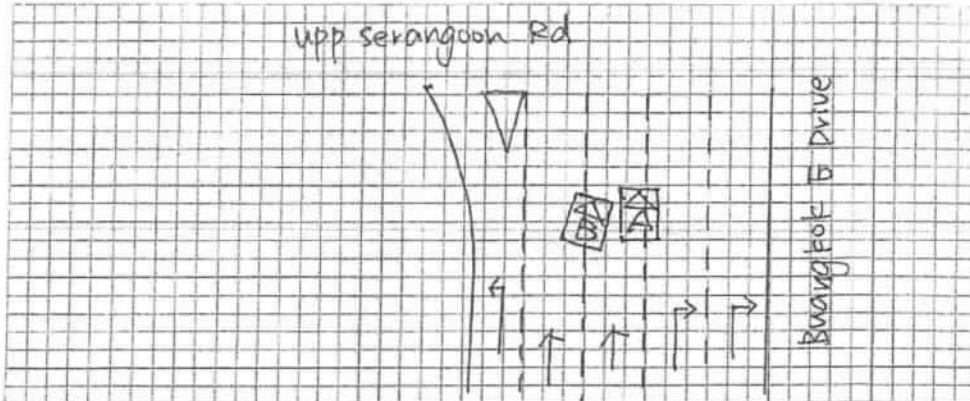
SKETCH PLAN

one the stated date and time. I vehicle A was traveling on the stated Rd. As I was moving forward suddenly vehicle B cut in from my left side and collided with my front left portion.
