## 1. Policy Particulars :- THIRD PARTY CLAIM

**Preliminary Advice**

Insured Vehicle No	: SJK3053B	Accident Date	: 26/09/2017
TP Vehicle No	: SDM1817M	Assignment Date	: 28/09/2017
Make	: BMW 520I	Est. Duration of Repair	: 13.00
Date of Inspection	: 29/09/2017		
Inspection At	: PERFORMANCE MOTORS LIMITED (ALEXANDRA) 303 ALEXANDRA ROAD, SIME DARBY PERFORMANCE CENTRE SINGAPORE 159941

## VEHICLE DAMAGE INSPECTION REPORT

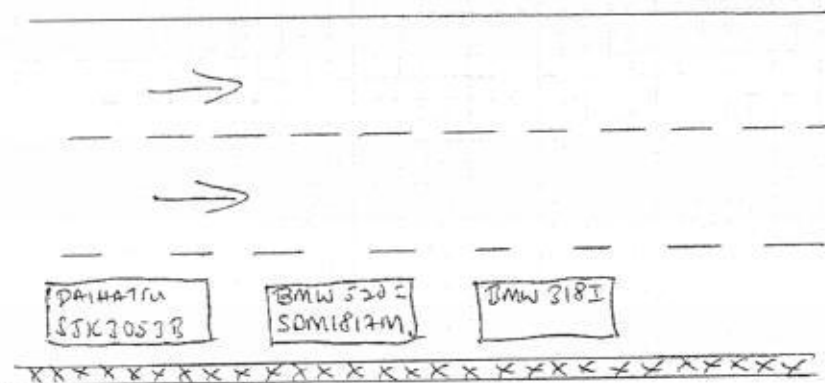
**Sketch Plan**

WHILE DRIVING ON THE FIRST LANE OF PIE HEADING TOWARDS PAYA  
LEBAR EXIT, I BRAKE TO STOP AS THE CAR IN FRONT OF ME, A WHITE  
BMW 318I, HAD ALSO BRAKE.

I STOPPED IN TIME.

HOWEVER, THE CAR BEHIND ME DID NOT MANAGE TO STOP. IT HIT THE  
REAR OF MY CAR AND CAUSED MY CAR TO PUSH FORWARD AND HIT THE  
CAR IN FRONT OF ME.
