Preliminary Advice

Vehicle No	: YP1617J	Accident Date	: 18/09/2017
Make	: MITSUBISHI CANTER	Policy No.	: DMCPHQ17-001588
Assignment Date	: 28/09/2017	Excess	: S\$3,750.00
Date of Inspection	: 29/09/2017	Est. Duration of Repair	: 30.00
Inspection At	: WAH HONG MOTORS & CREDIT PTE LTD (HQ) 38 TOH GUAN ROAD EAST, #01-57, ENTERPRISE HUB SINGAPORE 608581

VEHICLE DAMAGE INSPECTION REPORT

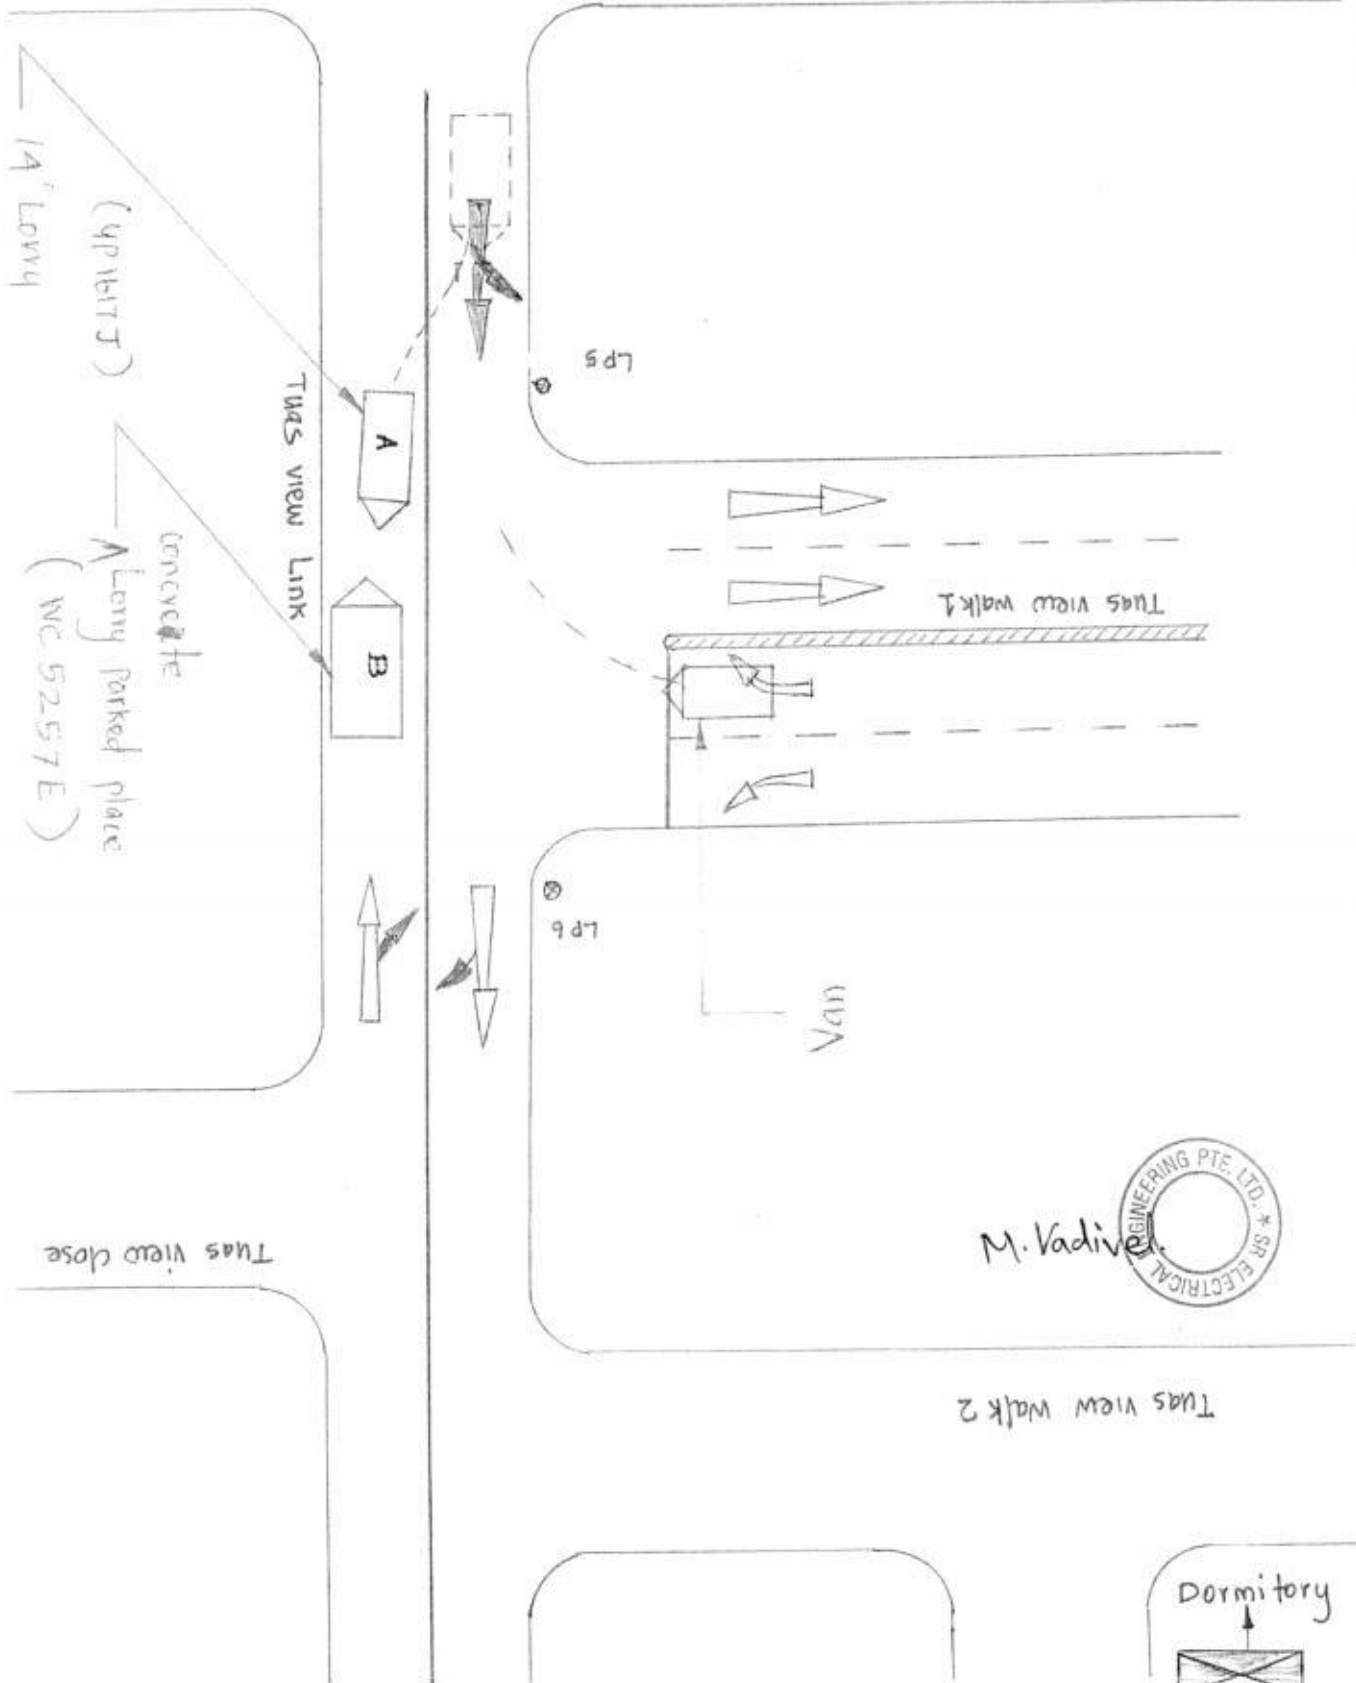
SKETCH PLAN

Date Of Report	19/09/2017 16:13
Date Of Accident	18/09/2017 03:30
Exact Location Of Accident	JUNCTION OF TUAS VIEW LINK & TUAS VIEW WALK 1
Country/State of Loss	SINGAPORE

Type Of Accident COLLISION - HEAD ON COLLISION
