Preliminary Advice

VEHICLE DAMAGE INSPECTION REPORT

Our File No: CS/MSG17018938/T1TBN2

Handling Insurer:	MSIG Insurance (Singapore) Pte. Ltd.	Policy No:	28992407QMY
Claimant Vehicle No :	SLF6121X	Insured Vehicle No :	SCH9111B
Date of Loss:	02/10/2017	Nature of Claim:	TP
		Claim No:	531587

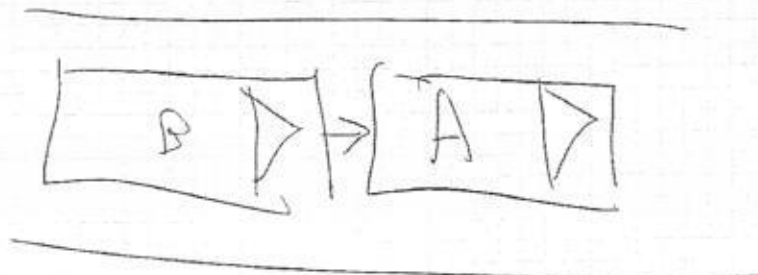
Sketch Plan

Type Of Accident COLLISION - HEAD TO REAR

At Traffic Junction, when traffic light turn green, I about to move off, I felt an impact and notice a car hit me from behind.
