1. Policy Particulars :- THIRD PARTY CLAIM

1. Policy Particulars : THIRD PARTY CLAIM				
Insured Veh.	EN 16Y	Veh. Inspected	SHC 106T	
Policy No.	BVPPSB0549051700	Coverage (\$)	0.00	
Claim No.	NSV170116/BT	Excess (\$)	0.00	
Assign From	TAN KAH LEONG	Assign Date	16/10/2017

4. Description of Damages				
THE VEHICLE SUSTAINED DAMAGES AT THE FRONT AND REAR PORTION. DAMAGES SEE DETAILS.				
5. General Information				
Accident Date	14/10/2017	Inspection Date	19/10/2017	
Survey held at	SOON HOCK MOTOR PTE LTD BLK 10 ANG MO KIO INDUSTRIAL PK 2A #01-05/06 AMK AUTOPOINT . SINGAPORE 568047			
5a. Remarks				
A)THE INSPECTION WAS CONDUCTED ON A"WITHOUT PREJUDICE" BASIS. B)IN ACCORDANCE TO YOUR INSTRUCTIONS, WE HAVE NOT AUTHORISED REPAIRS.				
5b. Estimate Days of Repair				
ESTIMATED NORMAL PERIOD FOR REPAIR:		13 Working Days

ADJUSTMENT ON REPAIR COST FOR VEHICLE NO. SHC 106T

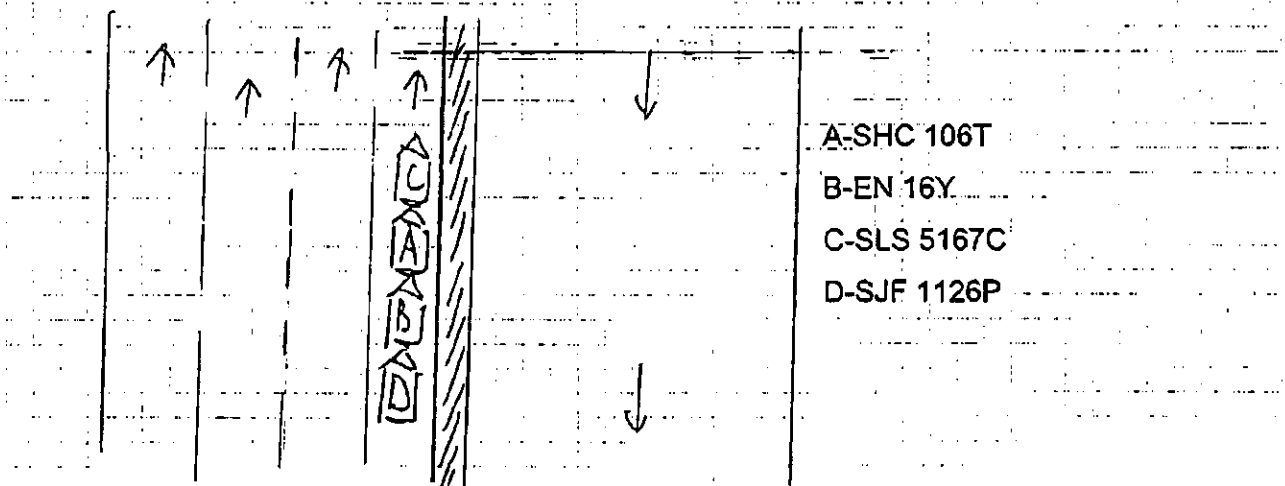
SKETCH PLAN

Along PIE Twds Changi Airport B/4 Lor 6 Toa Payoh Exit

On 14/10/2017@ 13:35hrs,My taxi (A) was travelling along PIE twds Changi Airport B/4 Lor 6 Toa Payoh Exit.With 1 male 1 female passenger on board.
I was on the extreme right lane 1,I saw infront of me vehicle slow down and stopped,so I follow too.Out of sudden,there was a loud impact coming from the rear portion and caused my taxi (A) to lose control and surge forward,and hit onto the veh (C) rear portion.My taxi (A) front and rear portion was damaged.
I assessed the damages to my taxi (A) and come to know that were 4 vehicles involved in the chain accident.
A-SHC 106T
B-EN 16Y male driver
C-SLS 5167C Mr Gunasegaran,S 7244676C.
D-SJF 1126P male driver
After the accident,I felt pain back,neck and body,will consult doctor later on.
