NTUC INCOME INSURANCE CO-OPERATIVE LTD Ref: NS/INC17020026/R1gb				
73 BRAS BASAH ROAD #05-01 NTUC TRADE UNION HOUSESINGAPORE 189556			Date: 19-10-2017

1. Policy Particulars :- THIRD PARTY CLAIM				
Insured Veh.	SJN 231H	Veh. Inspected	SHF 353E	
Policy No.	5085687248	Coverage (\$)	0.00	
Claim No.		Excess (\$)	0.00	
Assign From		Assign Date	17/10/2017

4. Description of Damages				
THE VEHICLE SUSTAINED DAMAGES AT THE N/S FRONT PORTION. DAMAGES SEE DETAILS.				
5. General Information				
Accident Date	16/10/2017	Inspection Date	17/10/2017	
Survey held at	SMRT AUTOMOTIVE SERVICES PTE LTD 60 WOODLANDS INDUSTRIAL PARK E4 SINGAPORE 757705			
5a. Remarks

ADJUSTMENT ON REPAIR COST FOR VEHICLE NO. SHF 353E

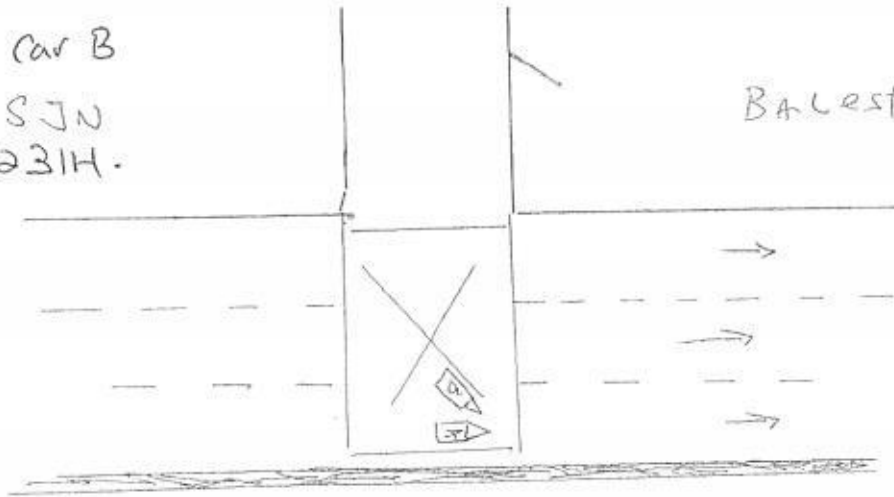
Sketch Plan Pg. 1

I WAS TRAVELLING STRAIGHT ALONG BALESTIER ROAD TOWARDS LAVENDAR STREET IN THE EXTREME RIGHT LANE. SUDDENLY A VEHICLE SJV231H CAME OUT ON MY LEFT AND COLLIDED ONTO THE LEFT FRONT PORTION OF MY TAXI.

car B
S J N
231H.

BALCESTIER Rd TOWARDS
LAVERDE/ST

CAR A:
SHRF 353 E.
