## LKK Auto Consultants Pte Ltd

**Preliminary Advice**

Vehicle No	: SJJ2100K	Accident Date	: 24/10/2017
Make	: MITSUBISHI LANCER	Policy No.	: PNPV2017-00001584
Assignment Date	: 27/10/2017	Excess	: S\$800.00
Date of Inspection	: 30/10/2017	Est. Duration of Repair	: 7.00
Inspection At	: PROGRESSIVE AUTOMOTIVE PTE LTD (HQ) BLK 3022A UBI ROAD 1, #01-45/46 SINGAPORE 408716

## VEHICLE DAMAGE INSPECTION REPORT

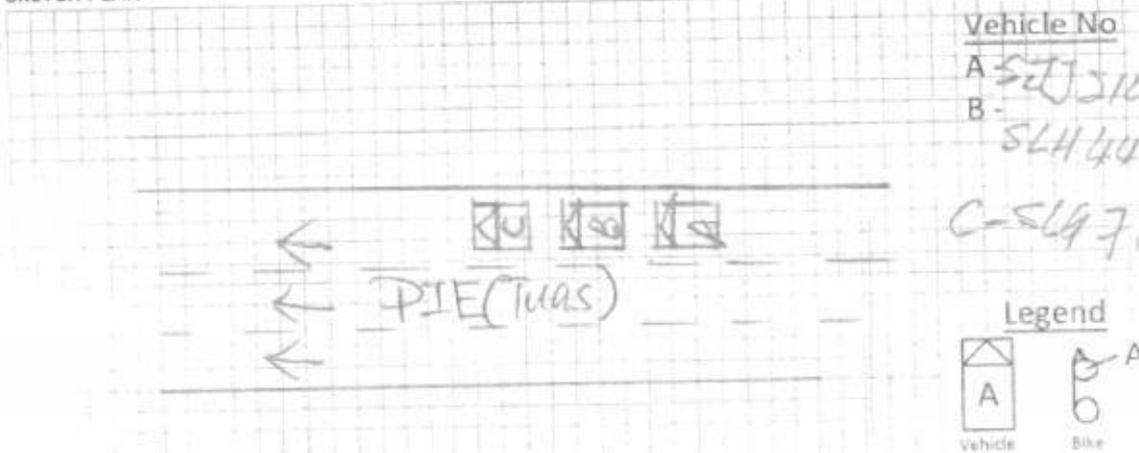
Sketch Plan #2

- I was travelling at 75 km/h to 80 km/h
- ~~WEDIA~~ MEDIUM TRAFFIC
- I colided 3 to 5 seconds ~~at~~ after they colided. ~~at~~ ~~approximately~~ approximately 40 km/h to 50 km/h.
