**1. Policy Particulars :- THIRD PARTY CLAIM**

**2. Vehicle Particulars & Condition**

**4. Description of Damages**

## ADJUSTMENT ON REPAIR COST FOR VEHICLE NO. SHB 1953M

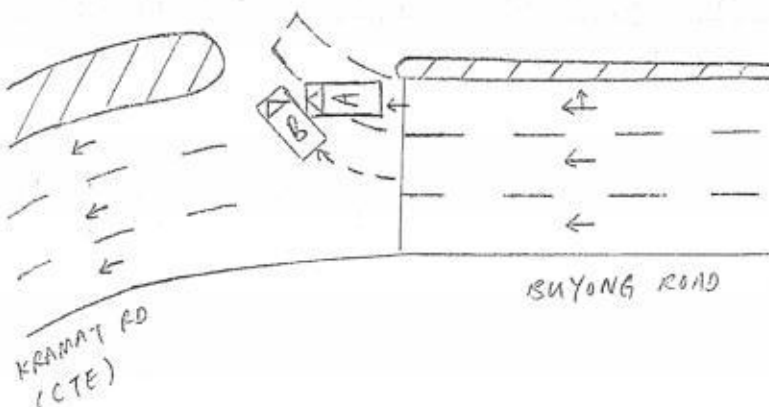
**Sketch Plan**

I WAS TRAVELLING ALONG BUYONG ROAD AT THE RIGHT MOST LANE (THE LANE MEANT FOR GOING STRAIGHT AND TURN RIGHT) WITH PASSENGER ON BOARD AND HAD SLOWED DOWN TO STOP TO WAIT FOR THE FRONT VEHICLE TO TURN RIGHT. AFTER THE FRONT VEHICLE MOVED OFF, I THEN PROCEED TO GOING STRAIGHT. SUDDENLY THE VEHICLE SDB6808P FROM MY LEFT LANE CUT INTO MY LANE WITH AN INTENTION TO TURN RIGHT AND AS A RESULT, ITS RIGHT PORTION COLLIDED ONTO THE LEFT FRONT PORTION OF MY TAXI.

A- SHB 1953M  
B- SDB 6988P
