LKK Auto Consultants Pte Ltd

FW: Appointment of LKK Auto Consultants as SJE in MC Suit No. 3529/2017 Alan

AUTOMOBILE INSPECTION REPORT

ADJUSTMENT ON REPAIR COST FOR VEHICLE NO. SJG 3252P

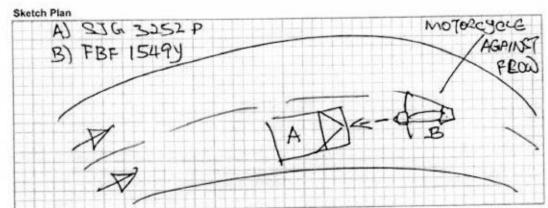
SKETCH PLAN

Describe Circumstances of the Accident was driving at normal speed on Magno street towards station. Et in far lanes, one way traffic.
