## Policy Particulars :- THIRD PARTY CLAIM

**Preliminary Advice**

| Make | : HONDA SHUTTLE HYBRID | Est. Duration of Repair | : 6.00 |

## VEHICLE DAMAGE INSPECTION REPORT

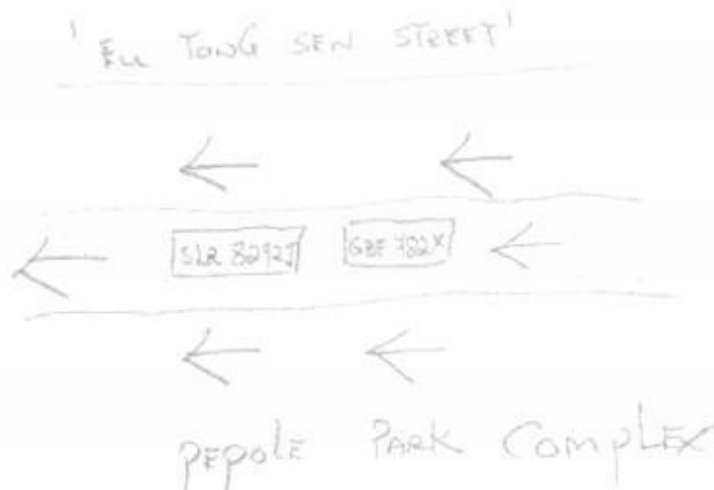
Sketch Plan

ON DATE 30-10-2017 AT ABOUT 14.15 PM I WAS TRAVELING ON ELA YONG SEN STREET. AND THE WEATHER WAS CLEAR AND THE ROAD WAS DRY. THE TRAFFIC WAS MOVING SLOW. OUT OF SUDEN I HEAR A SHARP SOUND FROM BEHIND AND ONE A NISSAN VAN HIT DIRECT AT MY VEHICAL BACK. THE NISSAN VAN NO/PLATE IS GBT 782 X MY VEHICAL NO PLATE IS SLR 8292 J HONDA SHUTTLE. AFTER THE ACCIDENT, I FILL MY BACK AND NECK WAS PAIN.
