VEHICLE DAMAGE INSPECTION REPORT

Our File No: CS/MSG17021342/R1TBQ2

Claimant Vehicle No: SV30Y

Make & Model: BMW 520i, 2.0 D/AB 2WD 4DR GAS/D NAV (A)

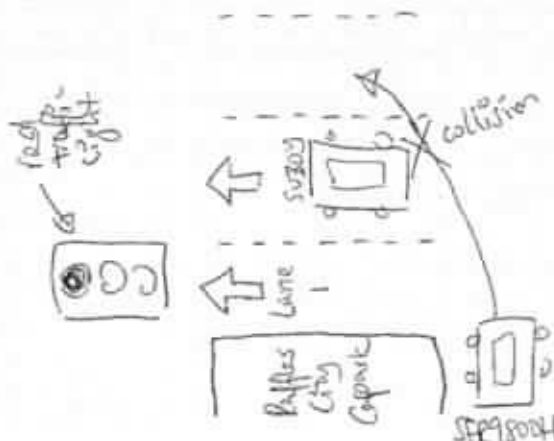
Sketch Plan

At about 2:00 - 2:04pm on Friday, 03/11/17, I was waiting at the traffic junction of Beach Road (outside Raffles Cray).

A car (SFR 9800H) was turning out of the car park to go to the lane on my right. As the driver of SFR 9800H did not ~~the~~ make a wide enough turn, the front left of his vehicle knocked / scratched the rear right of my vehicle. The driver of SFR 9800H has acknowledged fault for the accident.
