VEHICLE DAMAGE INSPECTION REPORT

Our File No: CS/CT17021402/M1TBE2

Reg No: **GQ171S**

Make & Model: TOYOTA DYNA 150, 3.0 D (M)

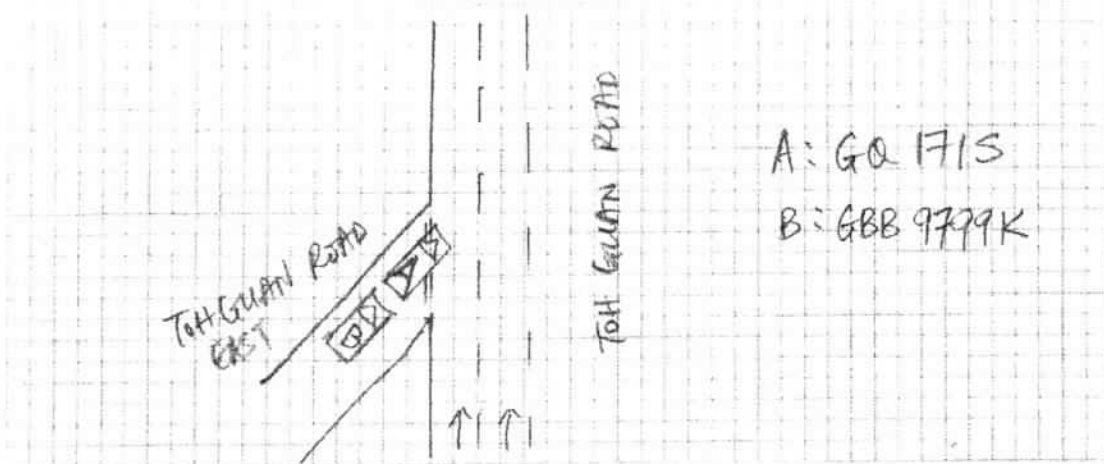
SKETCH PLAN

DRIVING TO EXIT TO H GUAN ROAD EAST
AND STOPPED AT SLIP ROAD TO CHECK TRAFFIC.
SUDDENLY VEHICLE B HIT MY VEHICLE REAR
PORTION.
