OD(TP Re-inspection) / Evaluation

To Inspect Vehicle No: SKW 6217B Insured: SLA 18111C
at Workshop m/s Eng Hup Auto Tel:
of Bk No. 387J Woodlands Road Yew Tee
Policy No: Claim No: 4212047787SG (005)
Sum Insured: Excess:
Make of Veh: D.O.A. 09.11.2017
(Client's Record)

1. Policy Particulars :- (THIRD PARTY CLAIM)				
Insured Veh.	SLA 1844C	Veh. Inspected	SKW 6217B	
Policy No.		Coverage (\$)	0.00	
Claim No.	4212047787SG(005)	Excess (\$)	0.00	
Assign From	NORSIAH	Assign Date	10/11/2017

VEHICLE DAMAGE INSPECTION REPORT**Our File No:** CS3/AIG17021591/R1RBE2**Date:** 16/03/2018**REFERENCE**

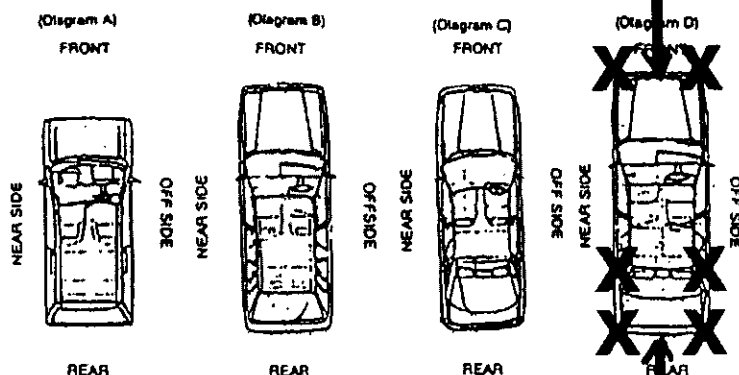
Direction of impact/damage marked (→) (X)

The vehicle sustained impact on its Front & Rear Portion.
(see Diagram D)

A static inspection was carried out on 10/11/2017 & our report is here with enclosed for your perusal. The Repairs Estimate submitted by M/s Eng Hup AutoParts Accessories Co as per attached Appraisalment Schedule have been revised and scrutinised thoroughly by us & in our opinion, we consider it to be fair and reasonable. The repairer has agreed to effect repairs to the owners satisfaction & to roadworthy condition on an agreed Part by Part Repair Basis of \$ 16,983.36 after deducting the Policy Excess Clause of \$ NA. As instructed, we have not authorised any of the repairs on your behalf.
