# National Assessment Centre Services

## 1. Policy Particulars :- THIRD PARTY CLAIM

## 4. Description of Damages

**ADJUSTMENT ON REPAIR COST FOR VEHICLE NO. SHB 760J**

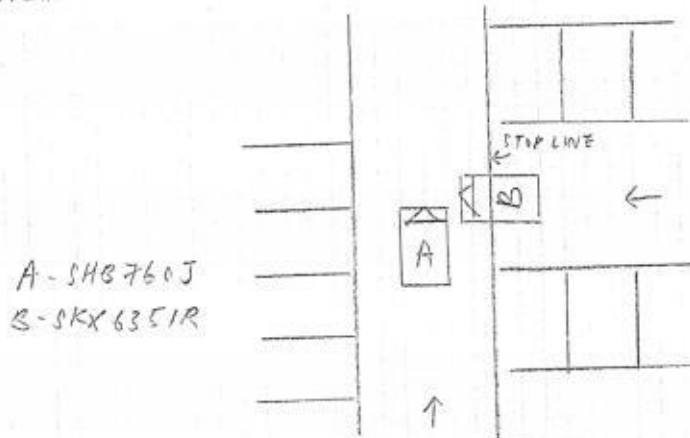
### SKETCH PLAN

I WAS DRIVING STRAIGHT ALONG THE CAR PARK DRIVE WAY WHEN THE VEHICLE SKX6351R SUDDENLY DAHSED OUT OF THE MINOR ROAD WITHOUT STOPPING AT THE STOP LINE AND COLLIDED ONTO THE RIGHT FRONT PORTION OF MY TAXI.
