Preliminary Advice

Insured Vehicle No : FBJ428Z
TP Vehicle No : SLD8645Z
Make : MAZDA 3
Date of Inspection : 16/11/2017
Inspection At : ETHOZ GROUP LTD (HQ)
30 BUKIT BATOK CRESCENT
SINGAPORE 658075

The vehicle sustained impact / damages o/s body and parts claimed are consistent to the accident.

VEHICLE DAMAGE INSPECTION REPORT

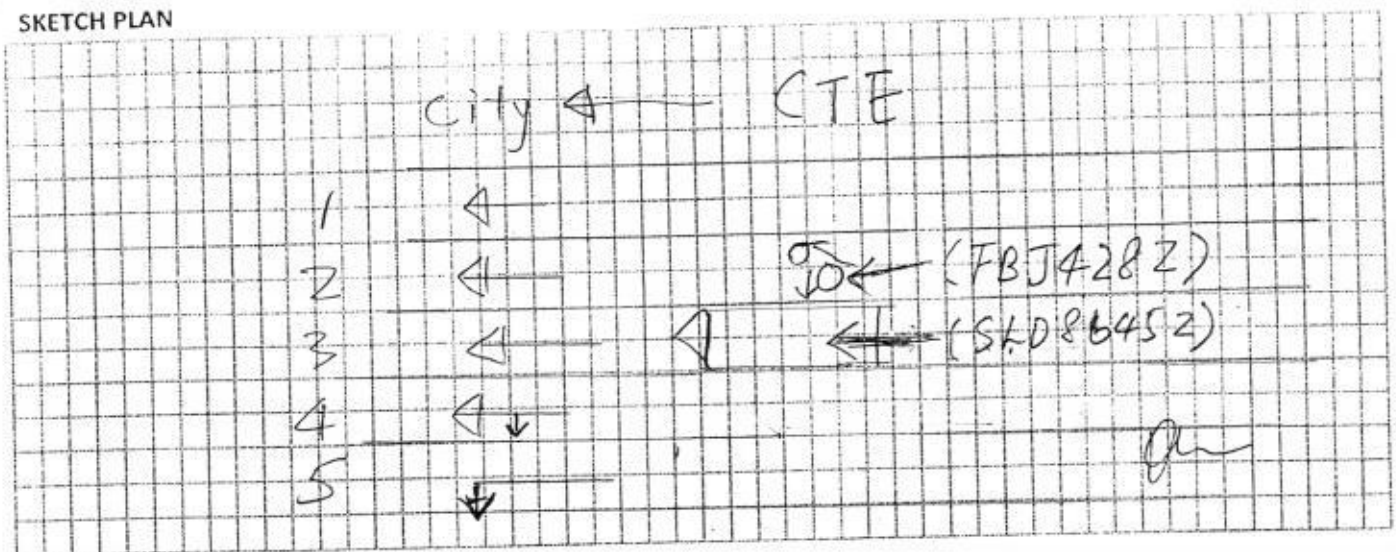
SKETCH PLAN

DESCRIBE CIRCUMSTANCES OF THE ACCIDENT

On 11/11/2017, I was driving Vehicle (SLD8645Z) with one passenger on board from Woodlands to Jalan Bahagia and traffic was heavy. While traveling along CTE towards City on the 2nd lane, the traffic moved very slowly so I on my Signal change to 3rd lane before the Tuas exit. After driving for a distance about 400m before the Balestier exit, suddenly I heard a loud bang sound on my rear right door, I immediately stopped and alighted to check and I saw one motor cycle (FBJ428Z) was fell next to my car on my right (2nd lane) and damaged onto my rear right door & driver door portion. Both party exchange particulars
