Preliminary Advice

Insured Vehicle No	: SKD2869X	Accident Date	: 14/11/2017
TP Vehicle No	: SKF5865B	Assignment Date	: 16/11/2017
Make	: BMW 320i	Est. Duration of Repair	: 3.00
Date of Inspection	: 05/12/2017		
Inspection At	: PERFORMANCE MOTORS LIMITED (ALEXANDRA) 303 ALEXANDRA ROAD, SIME DARBY PERFORMANCE CENTRE SINGAPORE 159941

VEHICLE DAMAGE INSPECTION REPORT

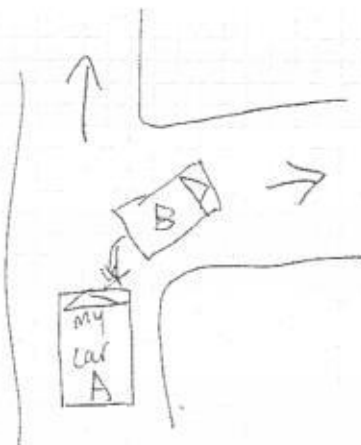
Sketch Plan

Policyholder, was waiting behind the car in front to turn right.
car

The car in front could not turn and reverse. The policyholder horn, but the car in front still reverse and ~~crashed~~ crashed into our car.
