RE: ESTIMATE COST OF REPAIR TO VEHICLE SHD2350K TOYOTA AXIO HYBRID (2016)

VEHICLE DAMAGE INSPECTION REPORT

CS/CTI17022012/R1TBN2

TOYOTA COROLLA, 1.5 G AXIO HYBRID (A) 13/01/2017 (Man. Year: 2016)

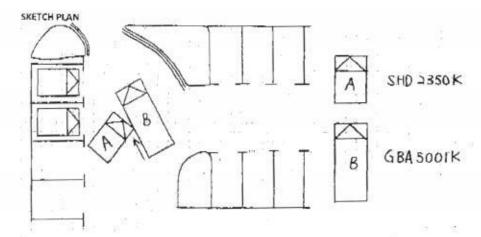
Individual Statement Pg. 1

On 16.11.2017 @1140 hrs, my taxi SHD2350K was stationary along Ang Mo Kio Avenue 10 Blk 449 carpark 37. I had on my reverse light and before I reversed into carpark lot, I checked for oncoming traffic. While stationary, one lorry GBA5001K came from my right rear attempted to overtake my taxi and as a result GBA5001K left side railing hooked against my front bumper and teared outward my taxi's front bumper.
