Insured Vehicle No	: SGS1370S	Accident Date	: 16/11/2017
TP Vehicle No	: SHC6915K	Assignment Date	: 20/11/2017
Make	: KIA OPTIMA	Est. Duration of Repair	: 3.00
Date of Inspection	: 21/11/2017		
Inspection At	: PREMIER TAXIS PTE LTD - CHANGI (HQ) 23 CHANGI SOUTH AVE 2 #03-02 SINGAPORE 486443

ESTIMATE REPAIR BILL FOR KIA OPTIMA REGN NO: SHC6915K

VEHICLE DAMAGE INSPECTION REPORT

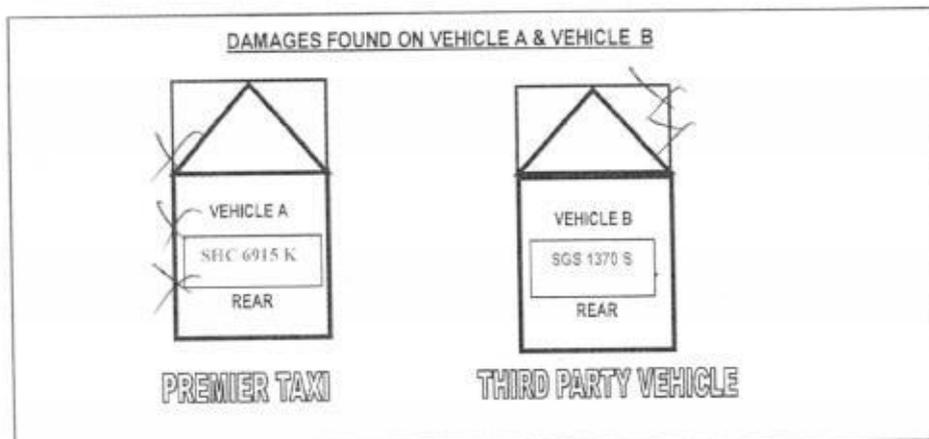
ON 16/11/2017 @ 1915 HRS, I WAS DRIVING MY TAXI (SHC 6915 K) TRAVELLING FROM CTE INTO MOULMEIN ROAD WITH A PASSENGER ONBOARD (FEMALE CHINESE) IN LANE 3 (ARROW ON ROAD SURFACE SHOWS RIGHT TURN ONLY)

TRAFFIC LIGHT AHEAD SHOWED GREEN ON MY ROUTE FAVOUR & I PROCEED AHEAD - TO TURN RIGHT, BUT SUDDENLY I FELT AN IMPACT FROM MY LEFT.

WHEN INSPECTED, I DISCOVERED THAT VEHICLE B (SGS 1370 S - NISSAN SUNNY) WHICH WAS INITIALLY IN LANE 4 (ARROW ON ROAD SURFACE SHOWS LEFT TURN ONLY) , FAILED TO KEEP FOR PROPER LOOK OUT & FAILED TO OBEY ROAD SIGNAGE - HAD CUTS & ENCROACHED ONTO MY PATH ON MY LEFT ABRUPTLY.

AS SUCH, THE FRONT RIGHT PORTION OF VEHICLE B COLLIDED ON THE LEFT PORTION OF MY TAXI.

DUE TO THE IMPACT, MY TAXI HAD DAMAGES ON THE ENTIRE LEFT PORTION AND VEHICLE B HAD DAMAGES ON THE FRONT RIGHT PORTION.
