**Preliminary Advice**

### VEHICLE DAMAGE INSPECTION REPORT

Our File No: CS/MSG17022165/KRBE2

Handling Insurer:	MSIG Insurance (Singapore) Pte. Ltd.	Policy No:	B28871928QMY
Claimant Vehicle No :	GBB9947A	Insured Vehicle No :	SKZ3532U
Date of Loss:	09/11/2017	Nature of Claim:	TP
			Claim No: 536403

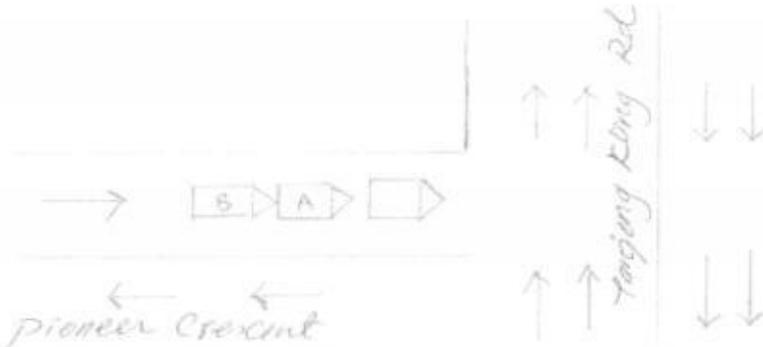
SKETCH PLAN

On 09/10/2017 at 15:36hrs while driving along Pioneer Crescent towards Tanjong Kling Road, I came to a complete stop behind a truck when vehicle SKZ 3532U rear-ended my vehicle. No injuries to either party.
