From: LKK
Sent: Wednesday, 27 December, 2017 7:38 PM
To: Irene Tan
Cc: Bryan Ang (LKKAuto); KK Lau; Jason Sim; Veron Chen (LKKAuto); Shiau Chan (LKKAuto); Admin-D (LKKAuto); Wilson (LKKAuto)
Subject: Re: Mr Wilson Teo's survey on GZ2179K; Our claim no.: 531386/IT

Our insured driver reported that the front car plate no. and the front bumper/front bumper reinforcement were originally damaged as confirmed by the 3rd party's driver. Please see insured driver's statement below under caption no. 1. Therefore, both were not damaged by our insured and not consistent with the subject accident on 28.9.17.

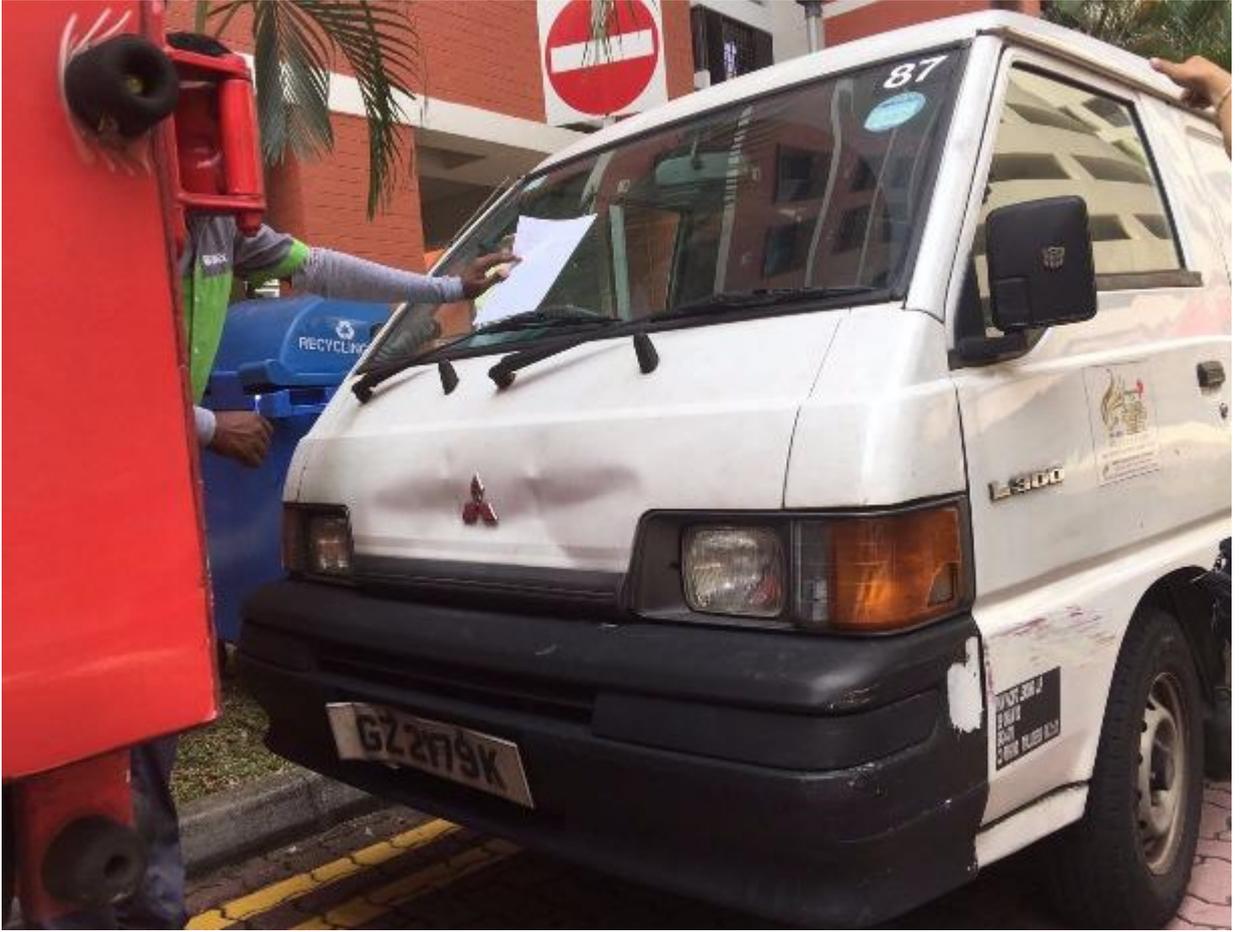
3) Accident scene pictures on both vehicles

在9月28日,后港11街,大牌159楼下,大概上午11点10分左右
 货,下完货坐回到车里,准备倒车调头,结果听到撞到东西的
 查看,是后面停了一辆面包车,撞到他的车了,因为我在停车所以
 有车的,倒车镜又看不到有车,是无意的,我下货不久,他的车
 的货车很近,我有拍照片,可以看到,我只是有撞到他车前
 园(车牌和保险杠)不是我的事,它原本就这样的,是他的司机
 C/P
 Plate no. 我的车牌号码是 YN1975K
 Front Bumper/Front Bumper Reinforcement
 对方的车牌号码是 GZ2179K

For this case, we need to interview the insured driver who made accident report in 'chinese', to understand more of the circumstances of the accident and the actual transpired between him and the TP driver. Also, height configuration measurements of both vehicles are necessary, in order to ascertain the inconsistencies of the damaged parts.

But the above inconsistently damaged part items have been recommended by your surveyor to be replaced and repaired as seen on items nos. 6, 7 and 9 which we have re-produced an extract from your survey report as below under caption no. 2.
