Affiliated to Federation Internationale Des Experts En Automobile				
TRANS-CAB AUTO SERVICES PTE LTD		Ref : CS/TP17022435/Kqb		
NO.2 ANG MO KIO STREET 63 SINGAPORE 569111		Date : 24-11-2017

1. Policy Particulars :- THIRD PARTY CLAIM

THE VEHICLE SUSTAINED DAMAGES AT THE FRONT N/S PORTION. DAMAGES SEE DETAILS.

ADJUSTMENT ON REPAIR COST FOR VEHICLE NO. SHD 266J

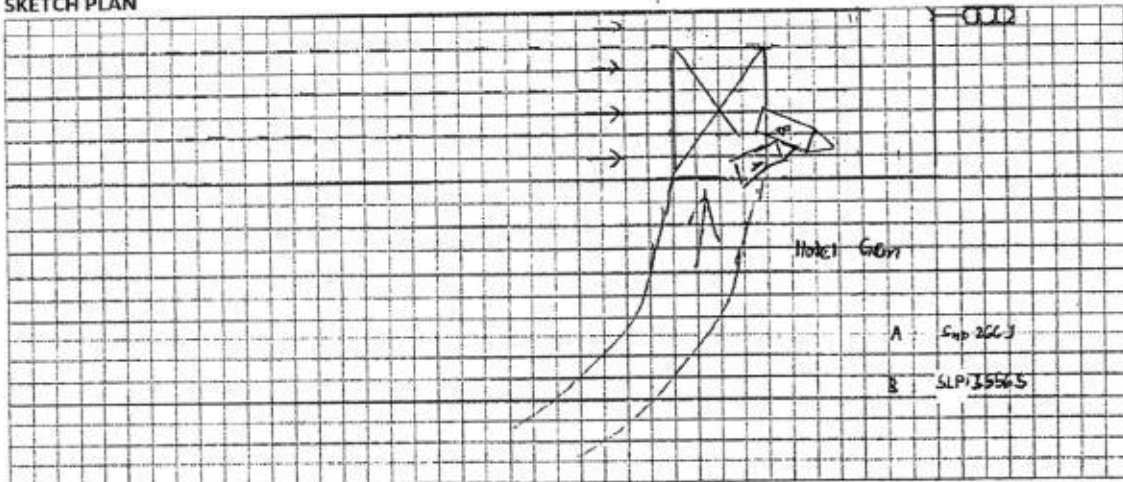
SKETCH PLAN

ON 20 NOVEMBER 2017 @ 1240HRS, I ALIGHTED A PASSENGER AT HOTEL JEN. WHEN I PROCEED TO EXIT FROM THE HOTEL JEN LOBBY AND ALREADY TURN OUT INTO THE MAIN ROAD. SUDDENLY A SALOON CAR, SLP 3556S FROM SECOND LANE JUST CUT INTO MY LANE WITHOUT ANY SIGNAL. THAT CAUSE SLP 3556S HIT ONTO MY FRONT LEFT PORTION OF MY TAXI. THERE IS 1 PASSENGER ON BOARD OF SLP 3556S.
