Preliminary Advice

TP Vehicle No : SLL3657E

Make : MINI COOPER S CLUBMAN

VEHICLE DAMAGE INSPECTION REPORT

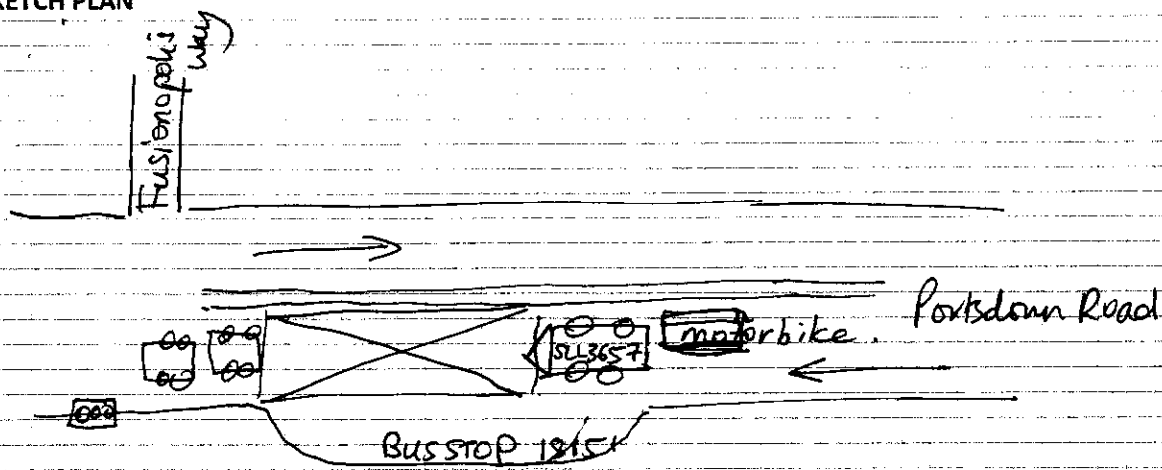
SKETCH PLAN

Accident happened at bus stop 18151. I (driver of SLL3657E) was driving on Portsdown Road, saw that there were cars stationary at traffic light ahead (and there was a bus at the bus stop) ^{and} so stopped just before the yellow box. Then motorcyclist of FBS7086E collided into ~~my~~ right rear of ^{my} car. She fell on the road to the ~~left~~ right ^{rear} of my car. There is a double white line divider on that road. She said that she did not see that there was a big yellow box in front of me and therefore did not anticipate me stopping. She said she was right behind me.
