# LKK Auto Consultants Pte Ltd

**INITIAL INSPECTION REPORT OF VEHICLE NO. SHD 4818R**

Please be informed that we had conducted the inspection of the above mentioned vehicle on 29/11/2017 at the premises of M/s CHUNNI NOTOR WORK PTE LTD and have the following to report:-

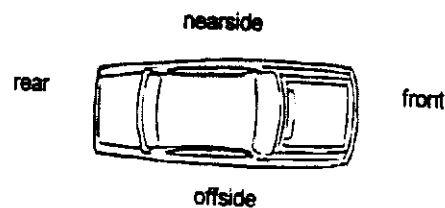
The vehicle sustained damages at the front and rear portion.

**Comments/Present Status:**  
Damages Consistent

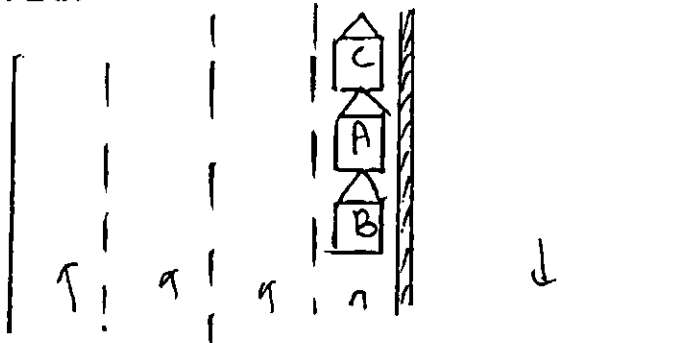
**SKETCH PLAN**

A - SHD 4818R.

B - SHD 3088L. (CTPL)

C - SJJ 5564K.

Along PIE (Changi) Before Thomson Exit.

On 27/11/2017 @ about 09:10hrs, my taxi (A) (SHD 4818R) was travelling
along PIE (Changi) before Thomson exit with one female passenger on board.
I saw in front of my vehicles slowing down and stopped, So I follow
too. Out of sudden, there was a loud impact coming from the rear portion and
caused my taxi (A), to lose control and surge forward, and colliding onto veh (C)
(SJJ 5564K) rear portion. My taxi (A) front and rear portion were damaged.
I assessed the damages to my taxi (A) and come to know that there were 3
vehicles involved in the chain accident.
No one was conveyed by the ambulance.
The parties involved in the accident are:
A - SHD 4818R.
B - SHD 3088L (CTPL). Mr. Hoo Yeow Gee. NRIC : S 1741904H. Hp : 9618 8429.
C - SJJ 5564K. Male driver.
No injury in this accident.
