OD (TP Re-inspection) / Evaluation

1. Policy Particulars :- THIRD PARTY CLAIM (RESURVEY INSPECTION)			
Insured Veh.	XD 8776L	Veh. Inspected	XE 1733B
Policy No.		Coverage (\$)	0.00
Claim No.	RKC/170489/p/mm	Excess (\$)	0.00
Assign From	SCARLETT LIM	Assign Date	30/11/2017

**SG SAGAWA AMEROID PTE LTD V PECK TIONG CHOON LEASING PTE LTD & ANOR
APPOINTMENT AS SINGLE JOINT EXPERT**

ADJUSTMENT ON REPAIR COST FOR VEHICLE NO. XE 1733B

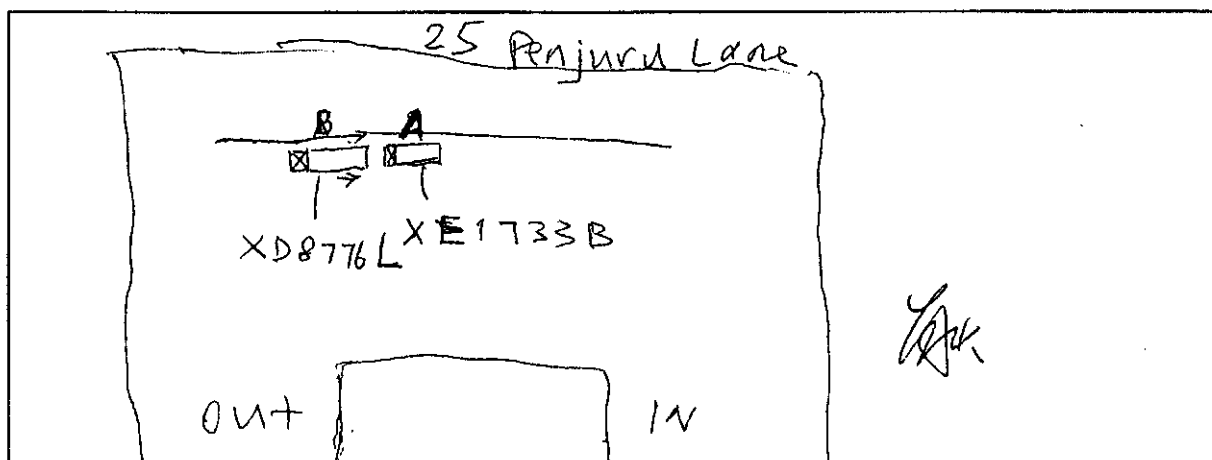
Sketch Plan

I was stop my vehicle XE 1733B at
 NO 25 Penjuru Lane inside the
 YARD. Suddenly Front vehicle NO XD8776L
 PECK TIONG CHON vehicle reverse
 and hit on to my vehicle Front
 Body damage.

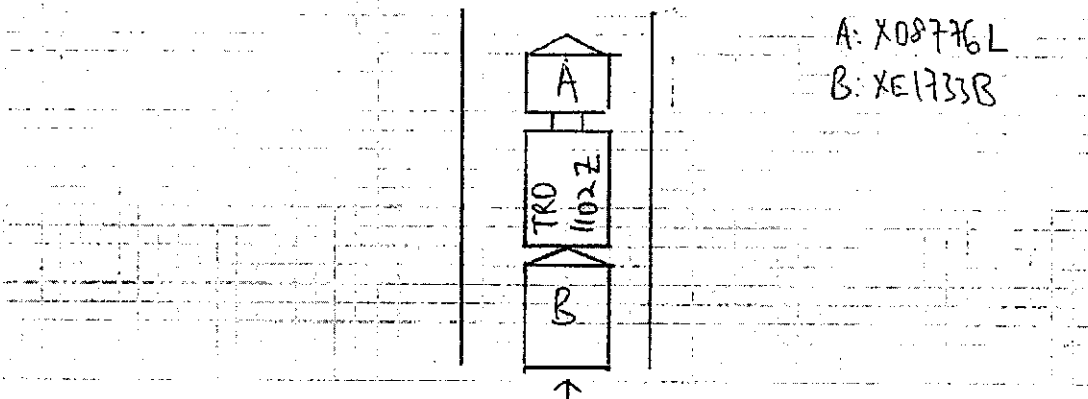
Sketch Plan

As per report
