Rear o/s

The U/C / Chassis frame / Body Structure affected due to collision.

Code : AIG	
1. Policy Particulars :- OWN DAMAGE			
Insured Veh.		Veh. Inspected	SKD 6777B
Policy No.	2100485764	Coverage (\$)	0.00
Claim No.		Excess (\$)	0.00
Assign From		Assign Date	01/12/2017
2. Vehicle Particulars & Condition			
Make & Model		c.c	0
Engine No.	HIDDEN	Year of Reg.	
Chassis No.		Colour	
Odometer	-	Steering	
Brakes		Modification	
General			
3. Conditions of Tyres			
	Size	Make	Balance
R/H Front Tyre			mm
L/H Front Tyre			mm
R/H Rear Tyre			mm
L/H Rear Tyre			mm
4. Description of Damages			
5. General Information			
Accident Date	28/11/2017	Inspection Date	01/12/2017
Survey held at	PREMIUM AUTOMOBILES PTE LTD 55 UBI ROAD 1 . SINGAPORE 408699		
5a. Remarks

VEHICLE DAMAGE INSPECTION REPORT

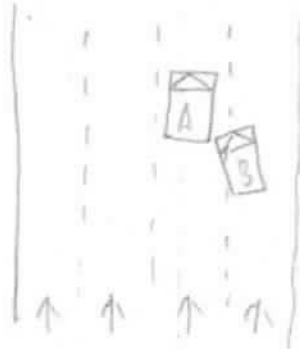
SKETCH PLAN

Was on 3rd lane filtering into 2nd lane for turning into CTE Outram when the taxi hit my rear right side (he was filtering out from the 1st lane)
