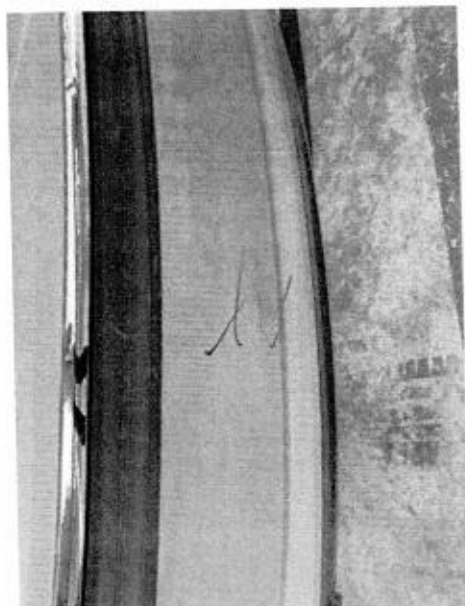
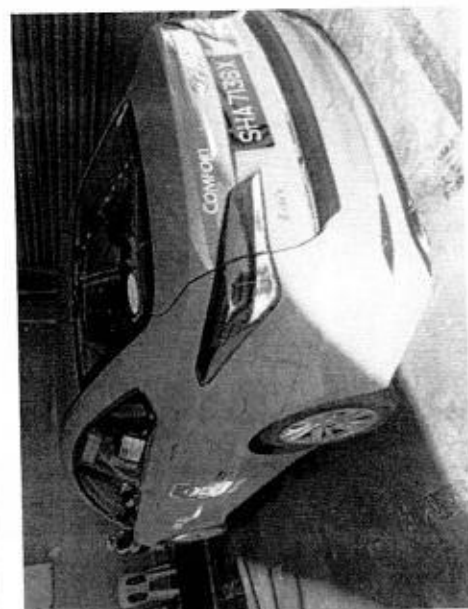
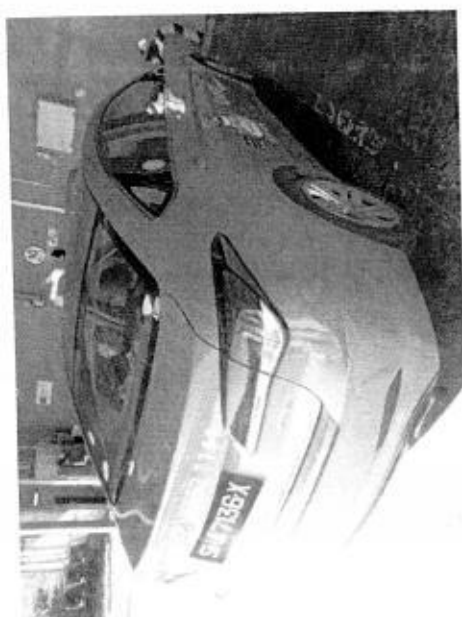
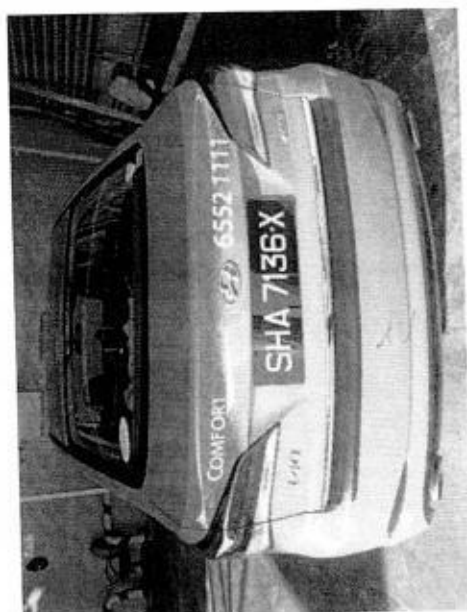
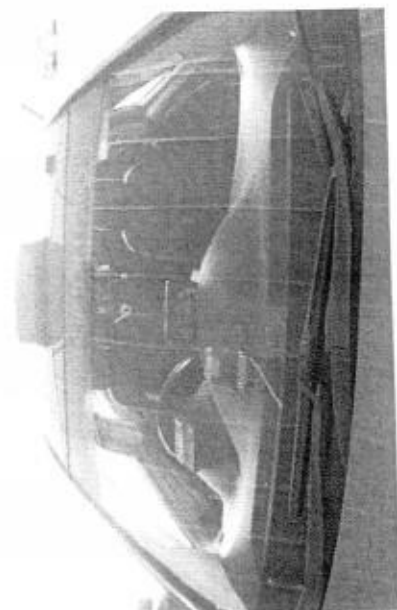
Photos

THE VEHICLE SUSTAINED DAMAGES AT THE REAR PORTION. DAMAGES SEE DETAILS.
--

Qty	Description of Parts	Condition	Estimate By Workshop (\$)	Our Adjusted (\$)
REPLACEMENT OF PARTS				
1	REAR BUMPER	DEFORMED	603.60	603.60
1	REAR BUMPER REINFORCEMENT	SERVICEABLE	504.35	-
2	REAR BUMPER REINFORCEMENT BRACKET (LH/RH) @\$180.00	SERVICEABLE	360.00	-
1	REAR BUMPER SIDE BRACKET	SERVICEABLE	49.00	-
10	REAR BUMPER CLIPS	NECESSARY	22.00	22.00
1	REAR BUMPER SPONGE	SERVICEABLE	143.40	-
1	REAR BUMPER UNDER COVER	SERVICEABLE	225.00	-
	LESS 20% DISCOUNT		-381.47	-125.12
			1,525.88	500.48
SPECIAL NETT ITEMS				
1	REAR BUMPER REVERSE SENSOR (SN)	NOT NECESSARY	135.70	-
1	REAR BUMPER RUBBER MAT (SN)	NECESSARY	50.00	50.00
			185.70	50.00
LABOUR				
	THATCHAM STANDARD REPAIR TIME ON BODY WORKS.		550.00	200.00
	THATCHAM TTS STANDARD SPRAY PAINTING COST AND LABOUR.		200.00	180.00
			750.00	380.00
GRAND TOTAL			2,461.58	930.48
RECOMMENDED COST OF REPAIRS (CONFIRMED)				930.48
