| Affiliated to Federation Internationale Des Experts En Automobile | | | |
|---|---|---|---|
| <b>1. Policy Particulars :- THIRD PARTY CLAIM</b> | | | |

**INITIAL INSPECTION REPORT OF VEHICLE NO. SLE 2018T**

### ADJUSTMENT ON REPAIR COST FOR VEHICLE NO. SLE 2018T

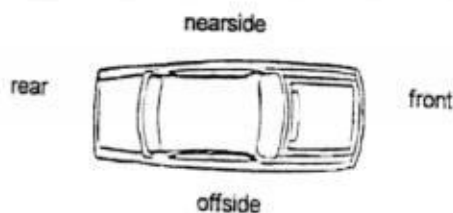
The vehicle sustained damages at the front o/s portion.

Comments/Present Status:  
Damages Consistent

| Affiliated to Federation Internationale Des Experts En Automobile | | | | |
|---|---|---|---|--|
| THE VEHICLE SUSTAINED DAMAGES AT THE FRONT O/S PORTION.<br>DAMAGES SEE DETAILS. | | | | |

| Qty | Description of Parts | Condition | Estimate By Workshop (\$) | Our Adjusted (\$) |
|---|---|---|---|---|
| 1 | FRONT HEAD LAMP RH | CRACKED | 868.70 | 868.70 |
| 1 | FRONT BUMPER | DISTORTED | 638.00 | 638.00 |
| 1 | FRONT BUMPER SIDE RETAINER RH | BENT | 14.70 | 14.70 |
| 1 | FRONT BUMPER FOG LAMP RH | BROKEN | 250.20 | 250.20 |

| Qty | Description of Parts | Condition | Estimate By Workshop (\$) | Our Adjusted (\$) |
|---|---|---|---|---|
| | PANEL BEATING.INCLUSIVE OF THE REPAIR OF FRONT BONNET,FRONT HEAD LAMP LOWER BRACKET RH AND FRONT BUMPER REINFORCEMENT. | | 850.00 | 400.00 |
| | <b>RECOMMENDED COST OF LUMP SUM REPAIRS (TO ITS PRE-ACCIDENT CONDITION)</b> | | | <b>1,000.00</b> |
