SLK 249A - CS / LCR17020700 / Alvbs2

2. Vehicle Particulars & Condition				
Make & Model	MITSUBISHI ATTRAGE 1.2	c.c	1193	
Engine No.	HIDDEN	Year of Reg.	2017	
Chassis No.	MMBSTA13AHH003453	Colour	BLUE	
Odometer	098397	Steering	IN ORDER	
Brakes	IN ORDER	Modification	SPORTS RIM	
General	FAIR

4. Description of Damages				
THE VEHICLE SUSTAINED DAMAGES AT THE N/S FRONT PORTION. DAMAGES SEE DETAILS.				
5. General Information				
Accident Date	22/11/2017	Inspection Date	05/12/2017	
Survey held at	CYCLE & CARRIAGE AUTOMOTIVE PTE LTD 209 PANDAN GARDENS SINGAPORE 609339			
5a. Remarks				
A)THE INSPECTION WAS CONDUCTED ON A"WITHOUT PREJUDICE" BASIS. B)IN ACCORDANCE TO YOUR INSTRUCTIONS, WE HAVE NOT AUTHORISED REPAIRS.				
5b. Estimate Days of Repair				
ESTIMATED NORMAL PERIOD FOR REPAIR:		4 Working Days

ADJUSTMENT ON REPAIR COST FOR VEHICLE NO. SLK 249A

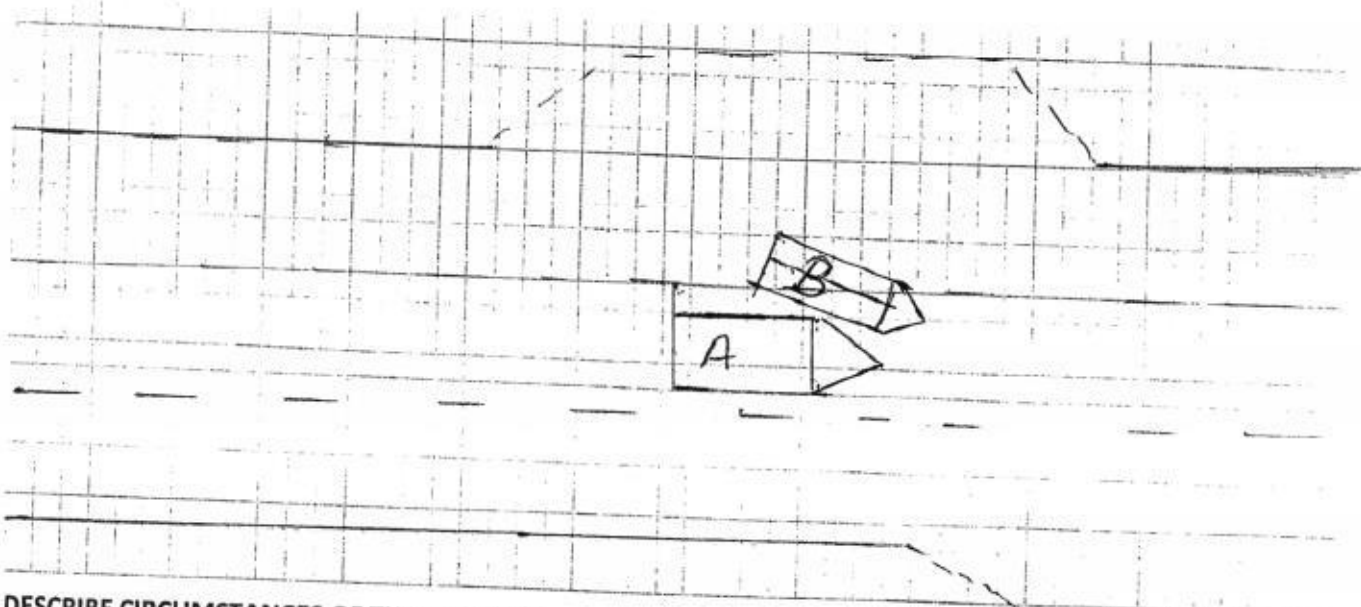
SKETCH PLAN

ON 22/11/17, I WAS TRAVELLING ALONG TAMPINES AVE 4 TOWARDS TAMPINES ST 91, THE VEHICLE SKN 4663G, DRIVEN BY MR NGA GUAN HING SUDDENLY CHANGED LANE. HE MOVED FROM THE LEFT LANE INTO THE RIGHT LANE ON WHICH I WAS TRAVELLING STRAIGHT. THIS DID NOT GIVE ME ENOUGH DISTANCE OR ROOM TO BRAKE ON TIME EVEN THOUGH I JAMMED MY BRAKES.
