1. Policy Particulars :- THIRD PARTY CLAIM

PRELIMINARY ADVICE OF VEHICLE NO. GBE 708S

Estimated repair cost for vehicle no: GBE708S ISUZU NHR85U

ADJUSTMENT ON REPAIR COST FOR VEHICLE NO. GBE 708S

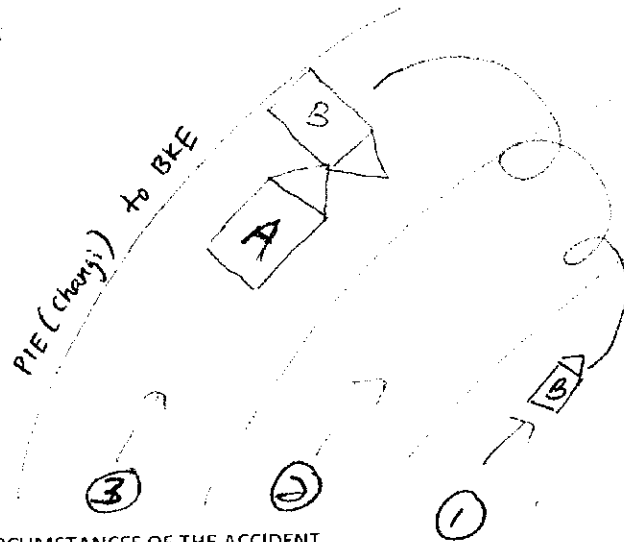
SKETCH PLAN

I WAS TRAVELLING ALONG PIE EXIT TO BKE AT LANE 3. SUDDENLY VEHICLE B (GBD1790B) SPIN FROM LANE 1 INTO MY LANE. I COULD NOT STOP IN TIME AND HIT HIS FRONT RIGHT SIDE OF HIS VEHICLE.

A : GBE708S

B : GBD1790B
