# TP Claims against NTUC Income: Follow-Through Survey

## SMRT Accident Vehicle Repair Estimates

THE VEHICLE SUSTAINED DAMAGES AT THE REAR N/S PORTION. DAMAGES SEE DETAILS.
--

**ADJUSTMENT ON REPAIR COST FOR VEHICLE NO. SHC 4121Y**

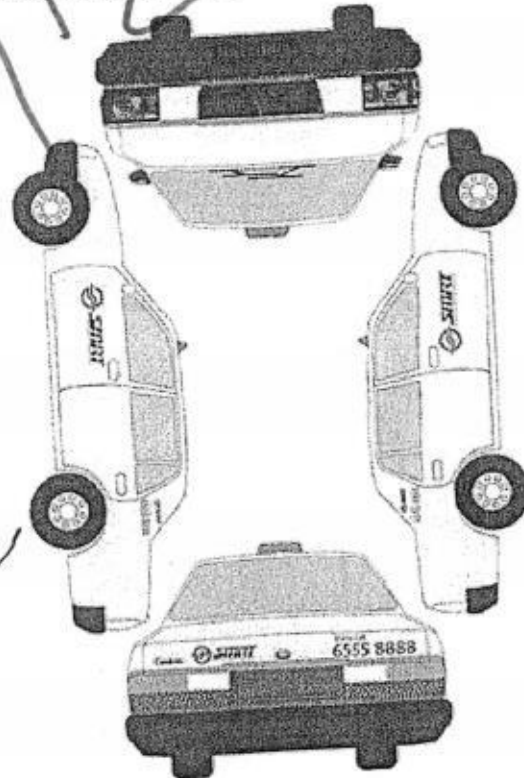
GBE7752S - NTUC IDAC  
BEFORE PAINT PHOTO AND AFTER PAINT PHOTO, FOR CHECK ITEM AND REPLACE ITEM PLEASE CALL  
SURVEYOR SEBASTIAN (LKK) & Email : sebastianyeang @lkkauto.com HP: 90036121  
LUMPSUM REPAIR

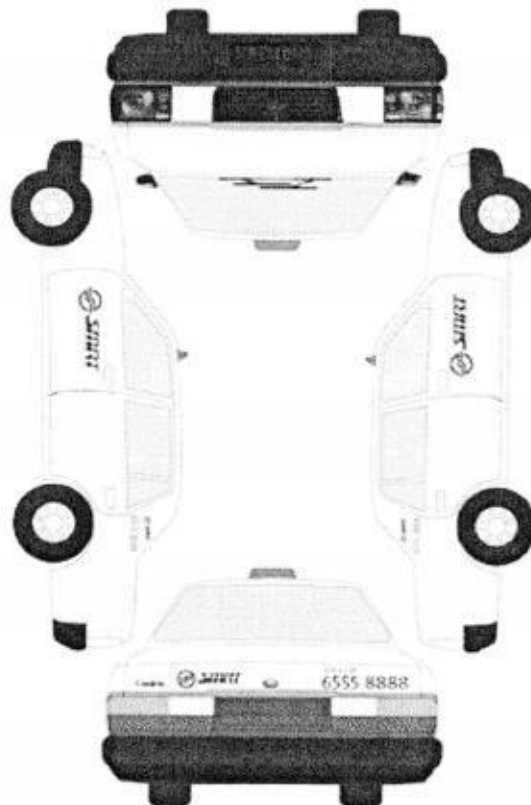
- Lump Sum Repair  
 - Photo After Paint.
