## MOTOR SURVEY ASSIGNMENT

**PRELIMINARY REVISED OF VEHICLE NO. SHD 1888H**

### ADJUSTMENT ON REPAIR COST FOR VEHICLE NO. SHD 1888H

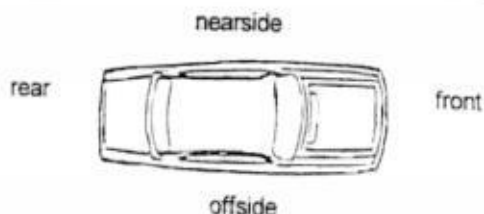
**Description of Damage:**

The vehicle sustained damages at the rear n/s portion.

**Comments/Present Status:**

Damages Consistent
