# LKK Auto Consultants Pte Ltd

## VEHICLE DAMAGE INSPECTION REPORT

Our File No: CS/MSG17023348/KTBN2

Reg No:	GW3031L	Engine No:	2KD1367417
Make & Model:	TOYOTA HIACE, 2.5 (M)	Chassis No:	JTFHS02P100030185
Reg. Date:	28/10/2005 (Man. Year: 2005)	Odometer:	273139 km
Colour:	Silver		
Engine Capacity:	2494 cc		
Market Value/New Car Price:	N/A		
Sum Insured (S\$):	Market Value/New Car Price

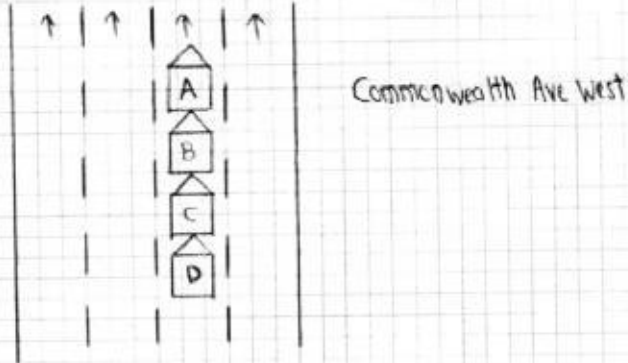
SKETCH PLAN Vehicle A: GW3031 L Vehicle B: SJX 2395C Vehicle C: SJN 9382X  
Vehicle D: SLH 6877M

DESCRIBE CIRCUMSTANCES OF THE ACCIDENT

Date of Accident: 05/12/2017 Time of Accident: 1:30pm

On the date and time above, I was travelling along Commonwealth Ave West. Traffic light was red so I stopped my vehicle. After few minutes, suddenly I felt an impact from rear portion. I alight and check on my vehicle and found out there were other 3 vehicles involved this accident.
