LKK Auto Consultants Pte Ltd

Preliminary Advice

Insured Vehicle No	: YP1341D	Accident Date	: 08/12/2017
TP Vehicle No	: SKT5838G	Assignment Date	: 11/12/2017
Make	: MAZDA 3	Est. Duration of Repair	: 6.00
Date of Inspection	: 12/12/2017		
Inspection At	: SIN HO AUTO BLK 3020A #01-33, UBI ROAD 1 SINGAPORE 408714

VEHICLE DAMAGE INSPECTION REPORT

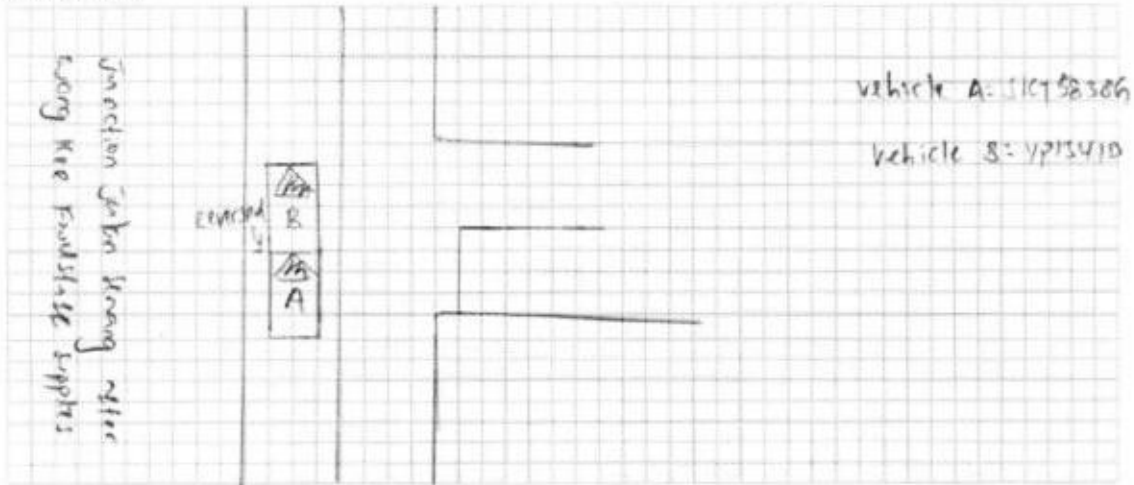
SKETCH PLAN

On 8/12/17 13:00 I was travelling along Junction Jalan Senang after Wang Kue Foodstuff Supplies. Suddenly vehicle B (YP13410) reversed along the road, I was trying to look him but in the end vehicle B (YP13410) ^{continue to reversed and} collided onto my vehicle front portion.
