INITIAL INSPECTION REPORT OF VEHICLE NO. SBL 8068R

ACCIDENT REPAIR ON: SBL8068R

ADJUSTMENT ON REPAIR COST FOR VEHICLE NO. SBL 8068R

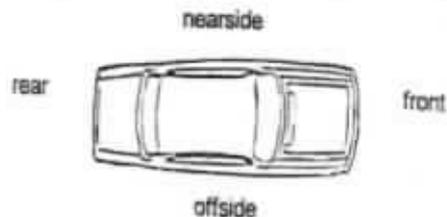
Description of Damage:

The vehicle sustained damages at the o/s body

Damages Consistent

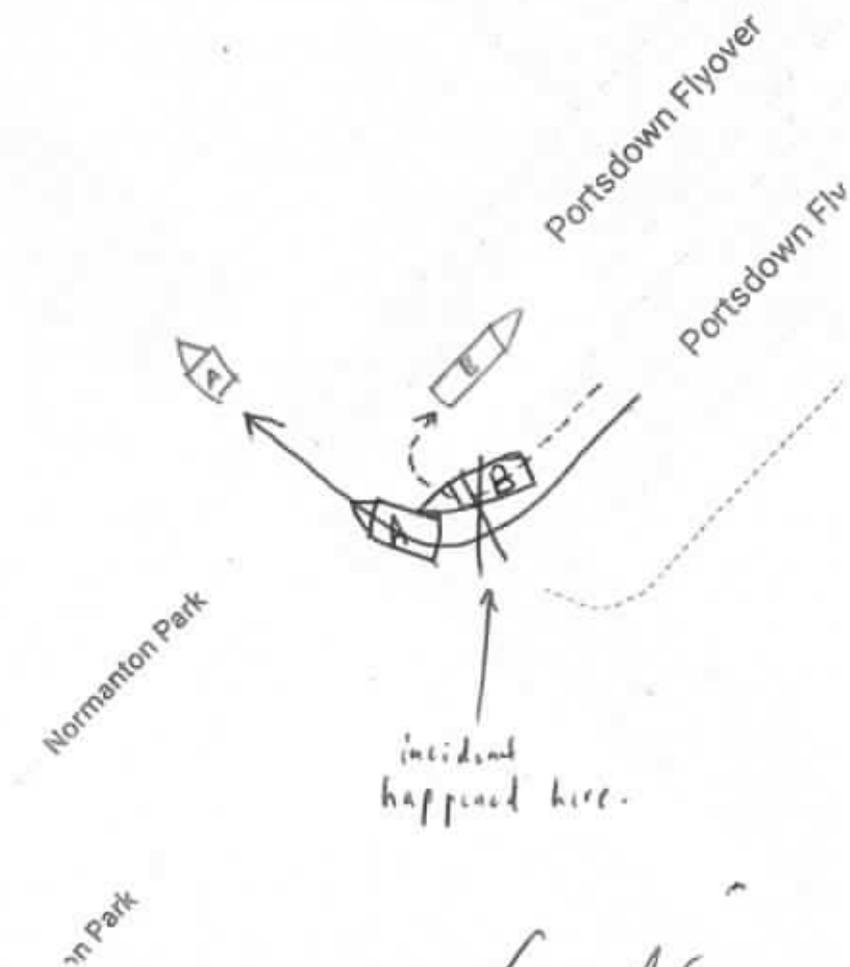
Sketch Plan & Statement.

On 1 Dec 2017 Friday, around 1700 hrs, I was travelling along Portsdown Avenue towards Science Park Driver. I was on Portsdown Flyover and had stopped at the intersection waiting to turn right onto the slip road leading to AYE towards Jurong. I was on the 2nd lane from the right (middle lane).

A light blue taxi was on my right (right lane) awaiting to U-turn back.

When the traffic light at the intersection turned green, I started to turn right into the AYE slip road. A few seconds later during the turn when I was in the middle of the intersection, I felt a bump on the right side of my car that caused my car to swerve a bit. It appears that when I was turning right, the car has moved out too far (to U-turn back) thus hitting my rear right wheel.

When I could stop my vehicle to check for damage, there were scratches on the paintwork on the body above the right rear wheel.
