VEHICLE DAMAGE INSPECTION REPORT

Our File No: CS/AIG17023631/KTD3N2

Handling Insurer: AIG Asia Pacific Insurance Pte. Ltd. Policy No:
 Claimant Vehicle No : GBF160R Insured Vehicle No : GBG7113B
 Date of Loss: 07/12/2017 Nature of Claim: TP Claim No: 8956492663SG

Reg No: GBF160R Engine No: ZD30011856N
 Make & Model: NISSAN CABSTAR, 3.0 (M) Chassis No: JN1SC2F24Z0858667
 Reg. Date: 02/06/2016 (Man. Year: 2016) Odometer: 64822 km
 Colour: White
 Engine Capacity: 2953 cc
 Market Value/New Car Price: N/A
 Sum Insured (S\$): Market Value/New Car Price

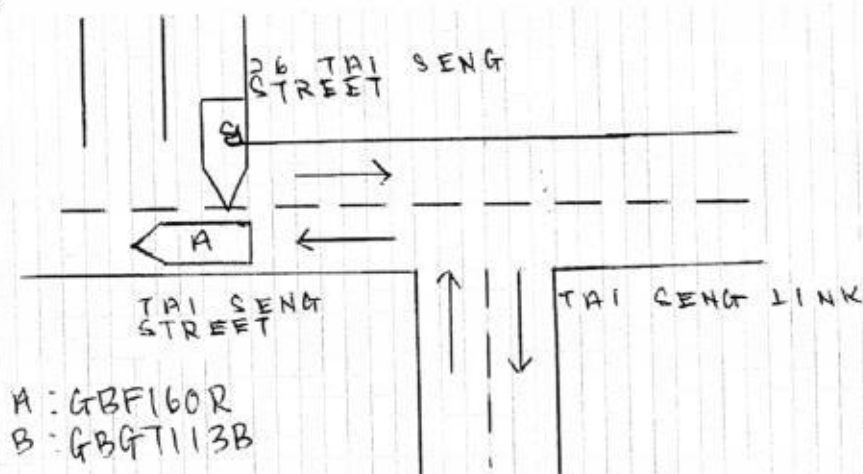
SKETCH PLAN

On 07/12/2017 about 15:15 HRS. I was driving along Tai Seng Street toward Pagar Lebar Road. Suddenly I felt impact from behind. Then I came down to check and realized a van (GBGT113B) hit onto my van (GBF160R) box rear right side from building way out address is 26 Tai Seng Street. Nobody was injured in the accident.
