1. Policy Particulars :- (THIRD PARTY CLAIM)

**- FW: PRE-REPAIR INSPECTION - ACCIDENT INVOLVING OUR INSURED
VEHICLE SLR8079J AND SGT6194X ON 12/12/2017**

**ACCIDENT INVOLVING SGT 6194X / SLR 8079J ON 12.12.2017 ALONG SLIP ROAD OF UPPER
SERANGOON ROAD TOWARDS HOUGANG AVE 3**

VEHICLE DAMAGE INSPECTION REPORT

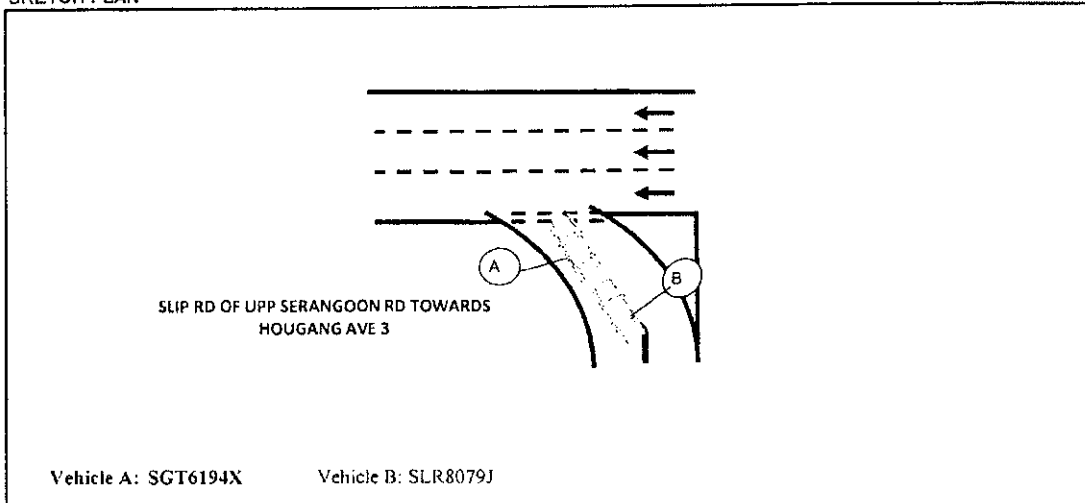
SKETCH PLAN

DESCRIBE CIRCUMSTANCES OF THE ACCIDENT

I was making a left turn at the slip road from Upper serangoon road towards hougang ave 3. upon reaching the give way lines, I slow down and stopped to give way to vehicles on the main road of Hougang ave 3. After stopping for a few seconds, suddenly there is an impact from my vehicle A's rear then i realized that vehicle B had hit onto my vehicle A's rear portion. No injuries reported at the scene.

Type Of Accident	COLLISION - HEAD TO REAR
Weather Conditions	CLEAR
Road Surface	DRY

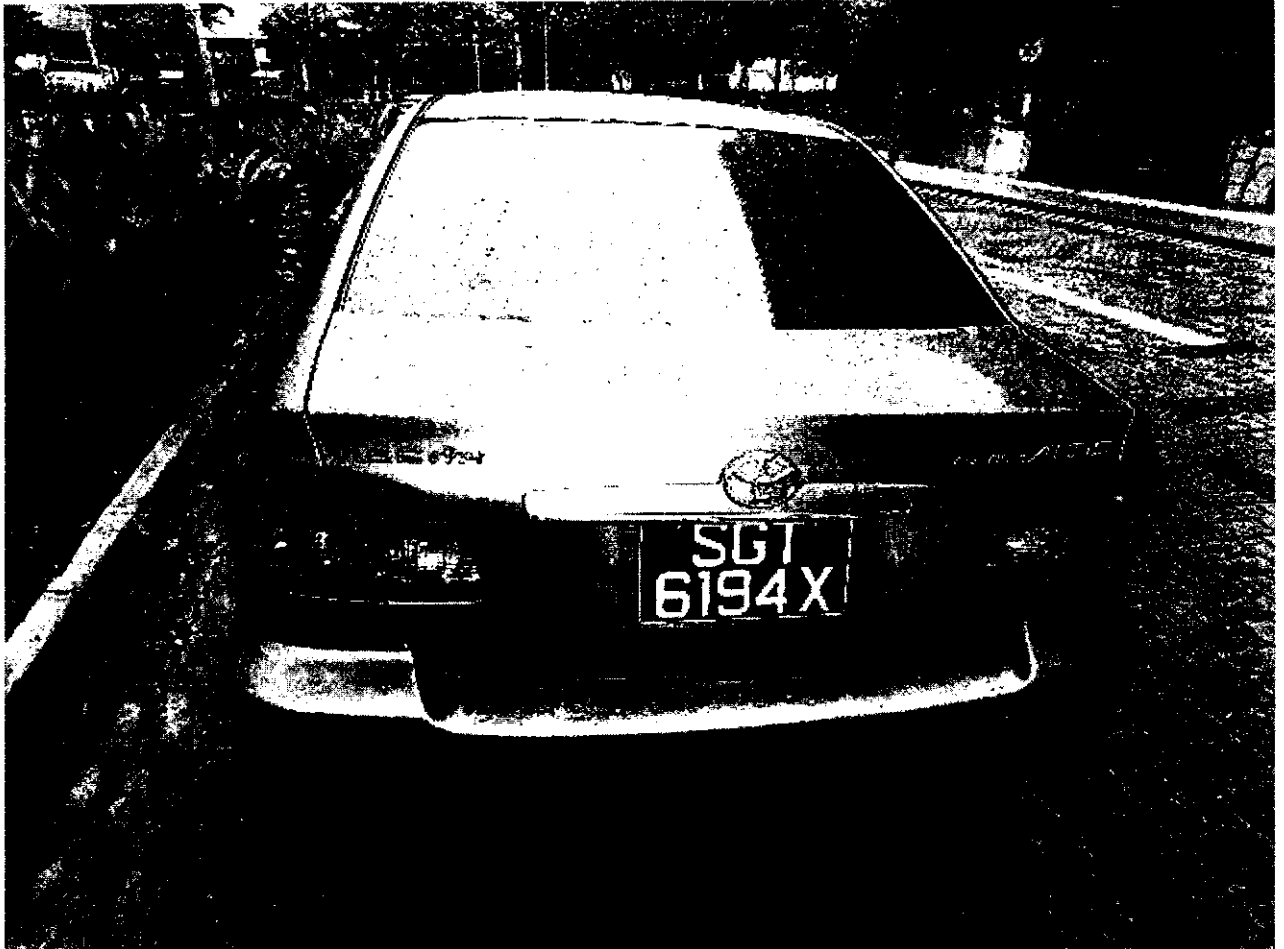
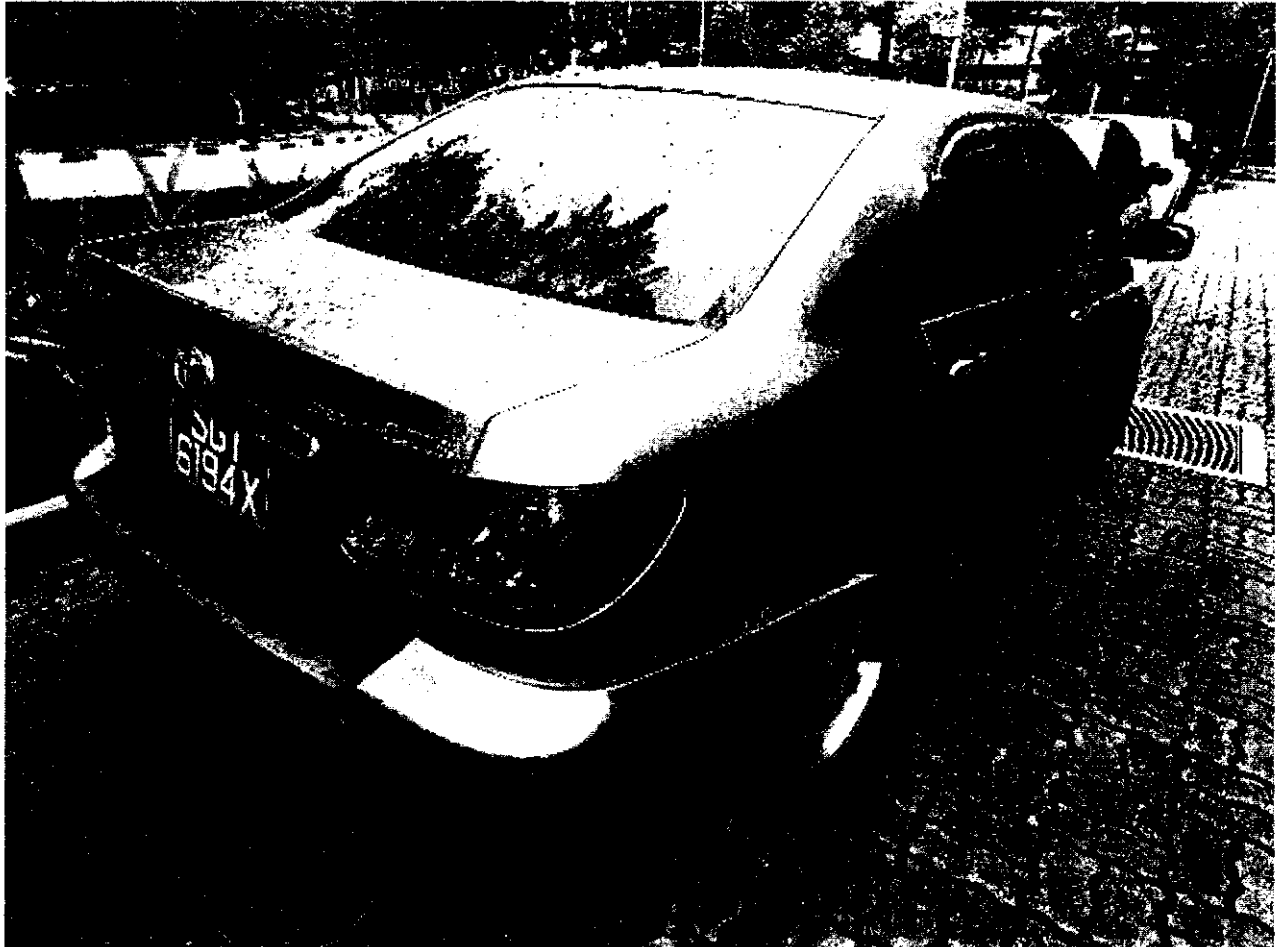
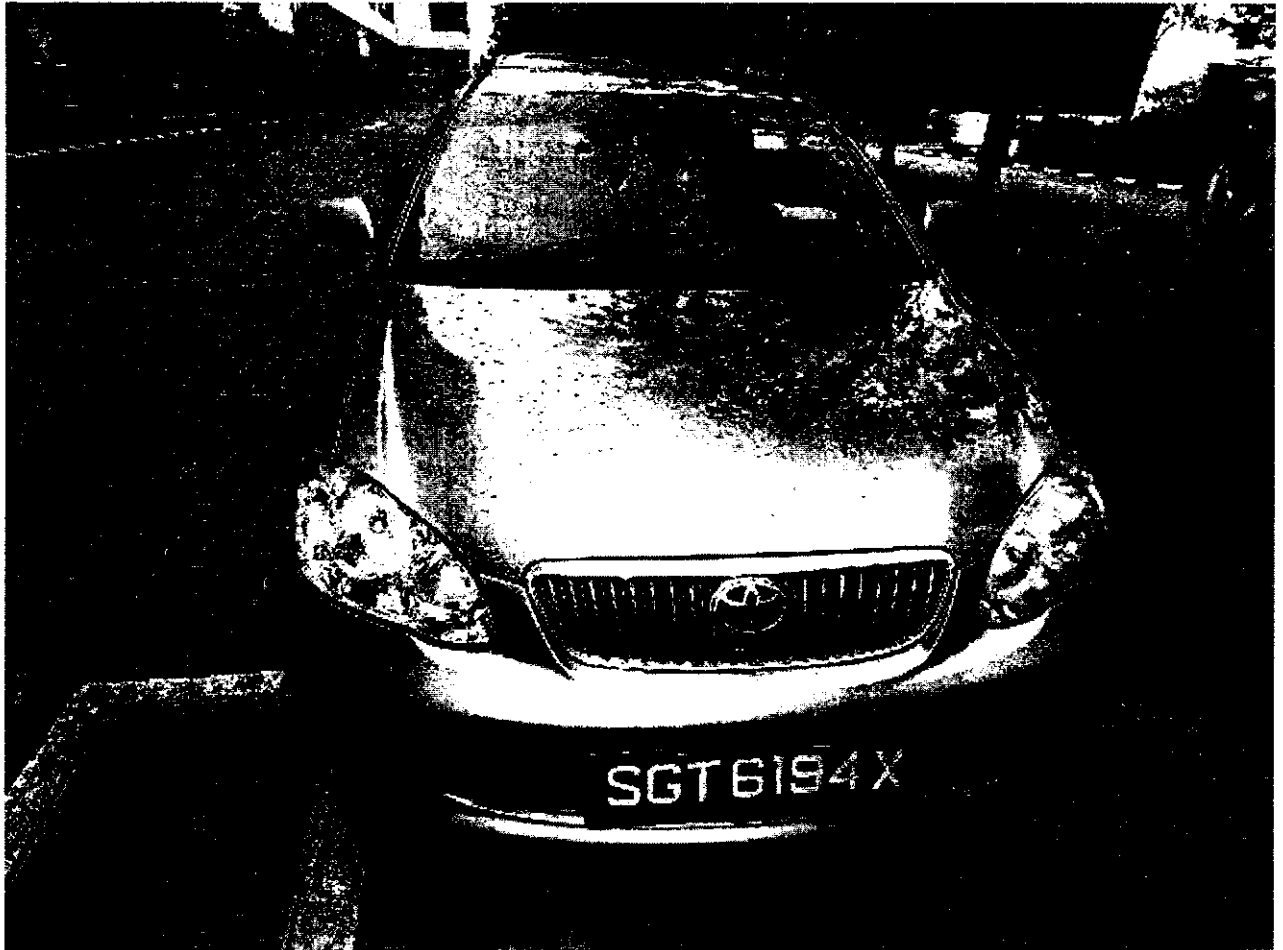
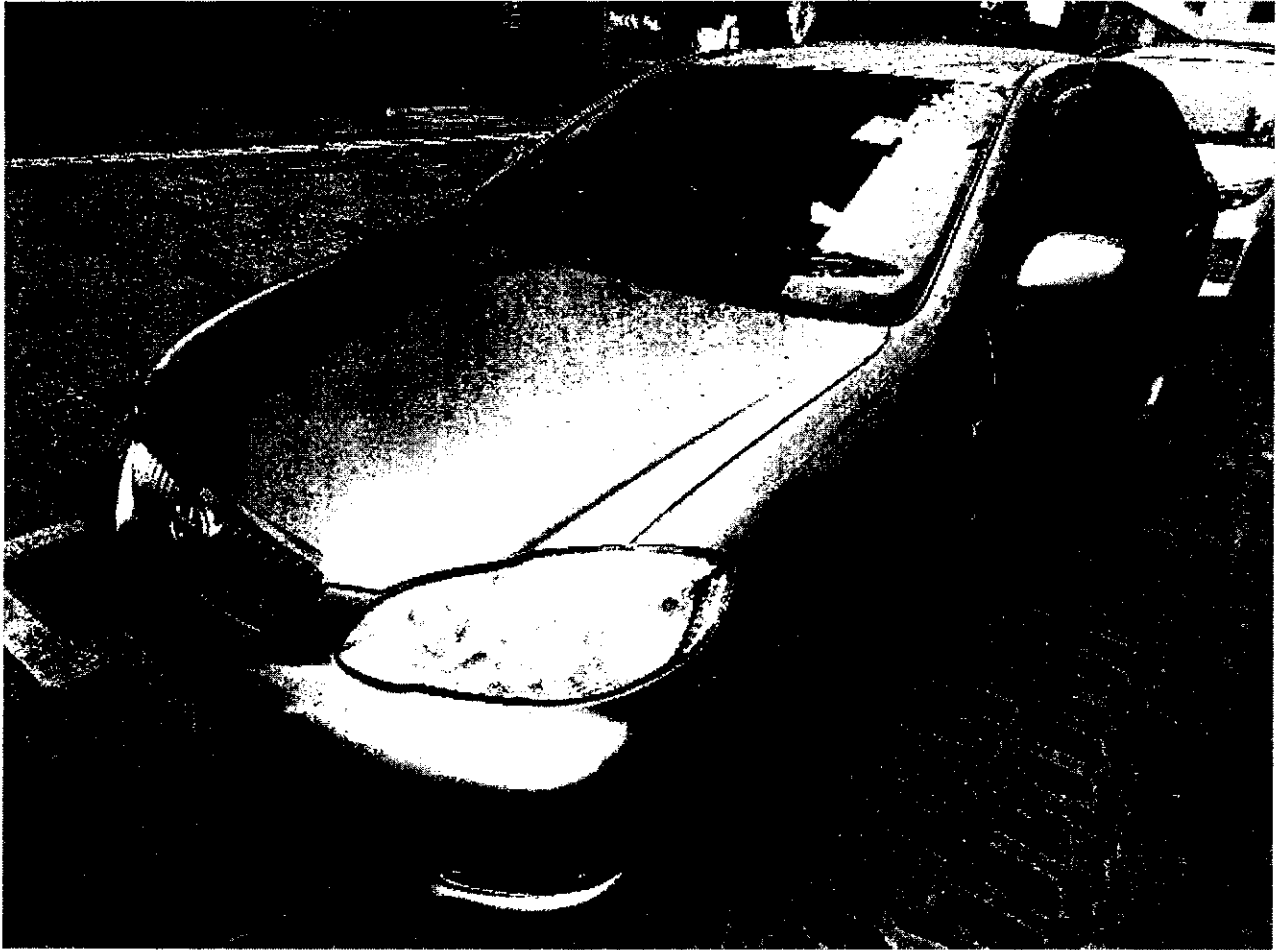
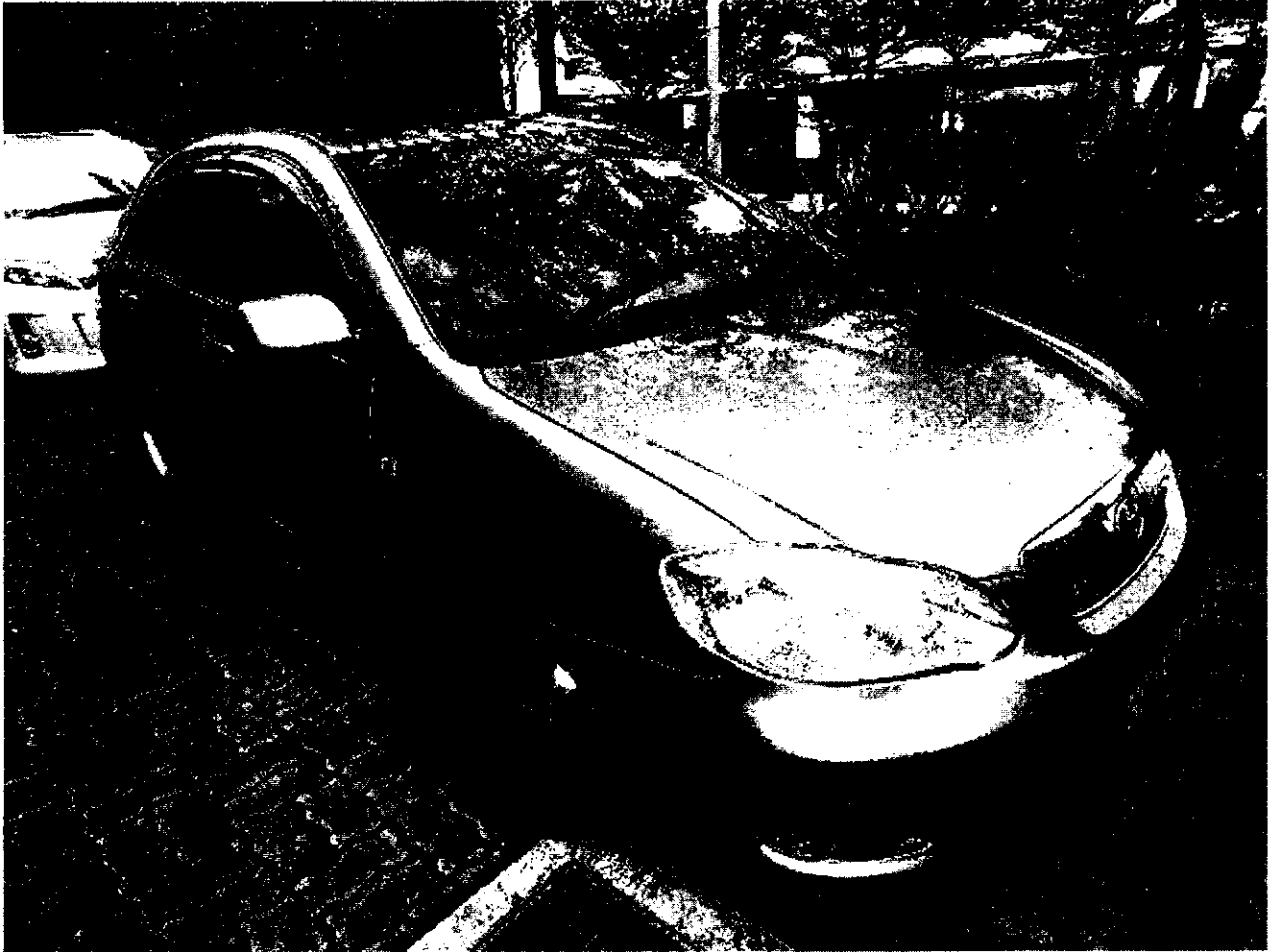
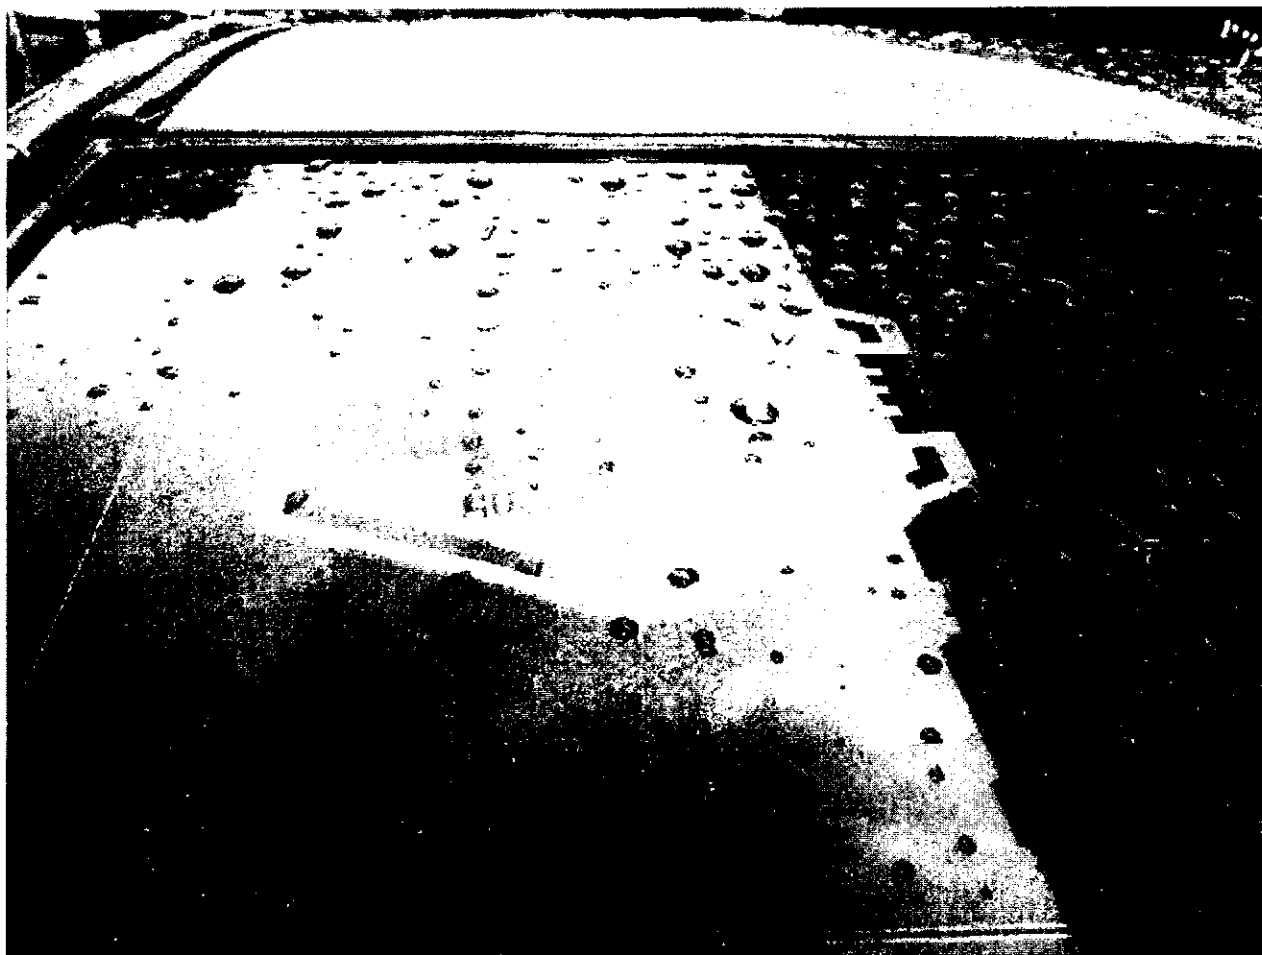
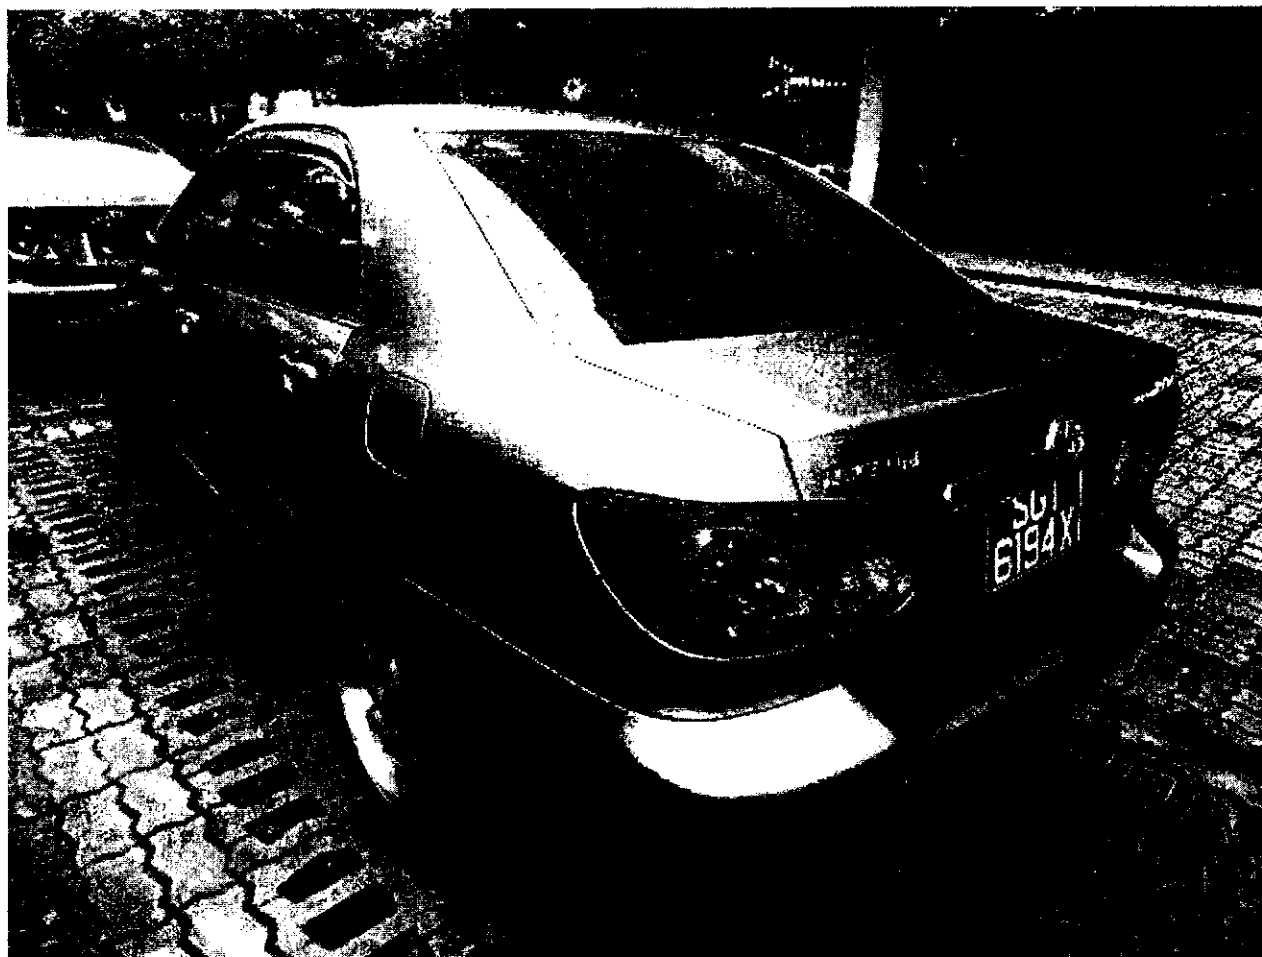
Accident Photo

No.	Qty	Part No.	Particulars	Condition	Repairer's	Amount
1	1		*REAR BUMPER	Warped	0.00 F	*- F
2	1		*REAR BUMPER CLIPS	Necessary	0.00 F	*- F
3	1		*REVERSE SENSOR	Shorted	0.00 F	*- F
4	1		*REAR END PANEL	Repair	0.00 F	*- F
5	1		*REAR END PANEL TOP GARNISH	Dented	0.00 F	*- F
6	1		*REAR LH TAILLAMP	Cracked	0.00 F	*- F
7	1		*REAR RH TAILLAMP	Cracked	0.00 F	*- F
8	1		*BOOTLID	Repair	0.00 F	*- F
9	1		*BOOTLID WEATHERSTRIP	Distorted	0.00 F	*- F
10	1		*BOOTLID LOCK	Bent	0.00 F	*- F
Total Parts (S\$)					0.00	0.00
