NTUC INCOME INSURANCE CO-OPERATIVE LTD Ref: NS/INC17023806/R1tbe2				
73 BRAS BASAH ROAD #05-01 NTUC TRADE UNION HOUSESINGAPORE 189556			Date: 22-01-2018

4. Description of Damages				
THE VEHICLE SUSTAINED DAMAGES AT THE N/S FRONT PORTION. DAMAGES SEE DETAILS.				
5. General Information				
Accident Date	13/12/2017	Inspection Date	13/12/2017	
Survey held at	SMRT AUTOMOTIVE SERVICES PTE LTD 60 WOODLANDS INDUSTRIAL PARK E4 SINGAPORE 757705			
5a. Remarks				
A)THE INSPECTION WAS CONDUCTED ON A"WITHOUT PREJUDICE" BASIS. B)IN ACCORDANCE TO YOUR INSTRUCTIONS, WE HAVE NOT AUTHORISED REPAIRS.				
5b. Estimate Days of Repair				
ESTIMATED NORMAL PERIOD FOR REPAIR:		7 Working Days

ADJUSTMENT ON REPAIR COST FOR VEHICLE NO. SHD 6490M

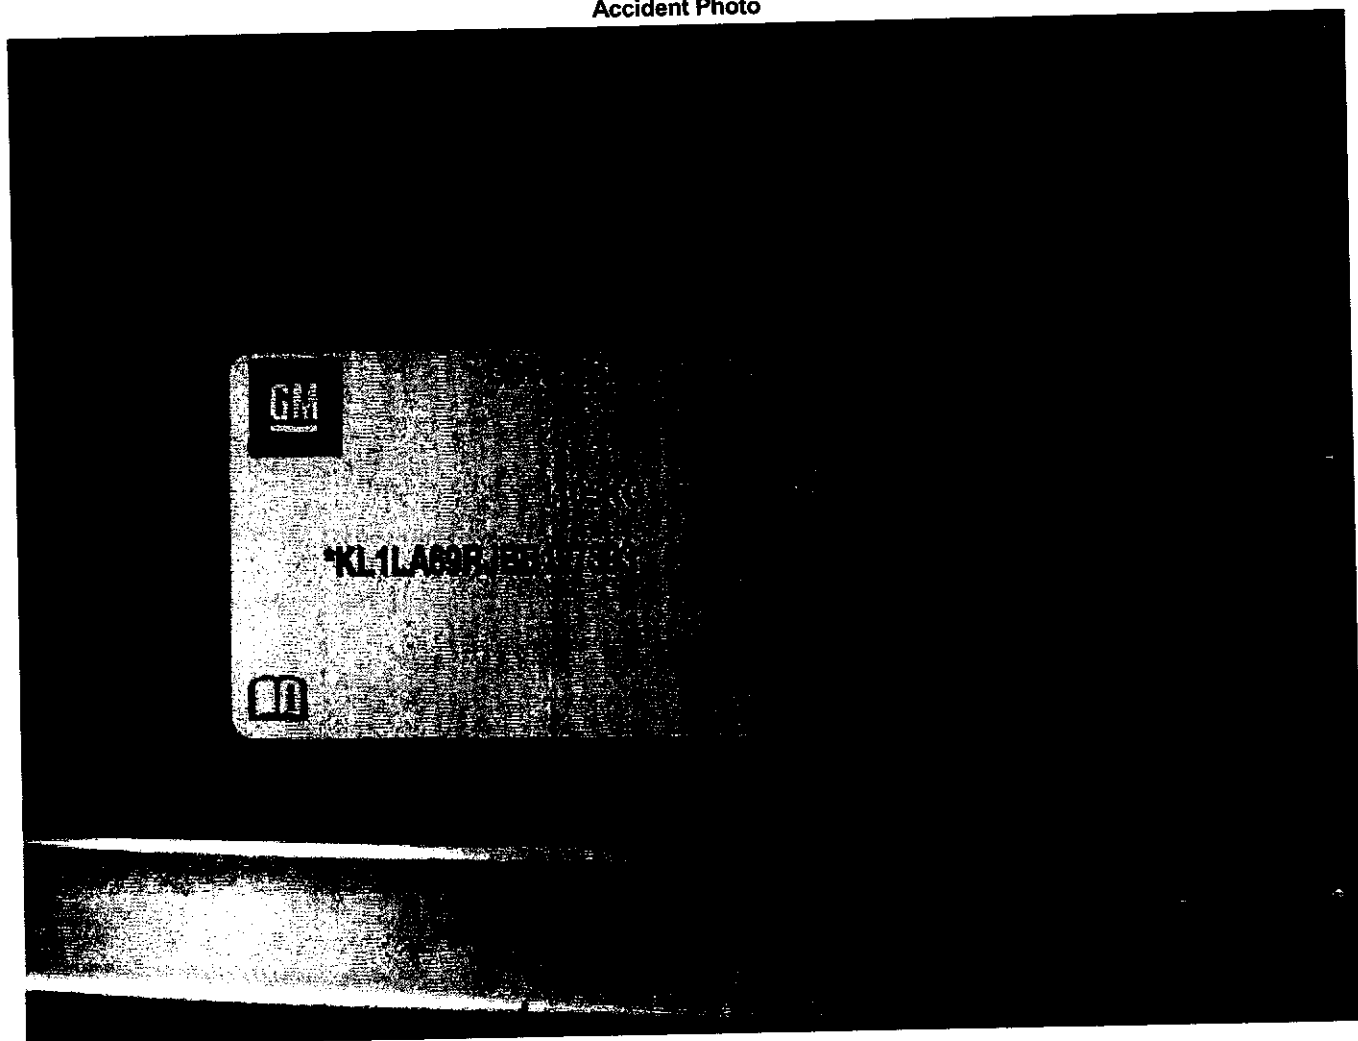
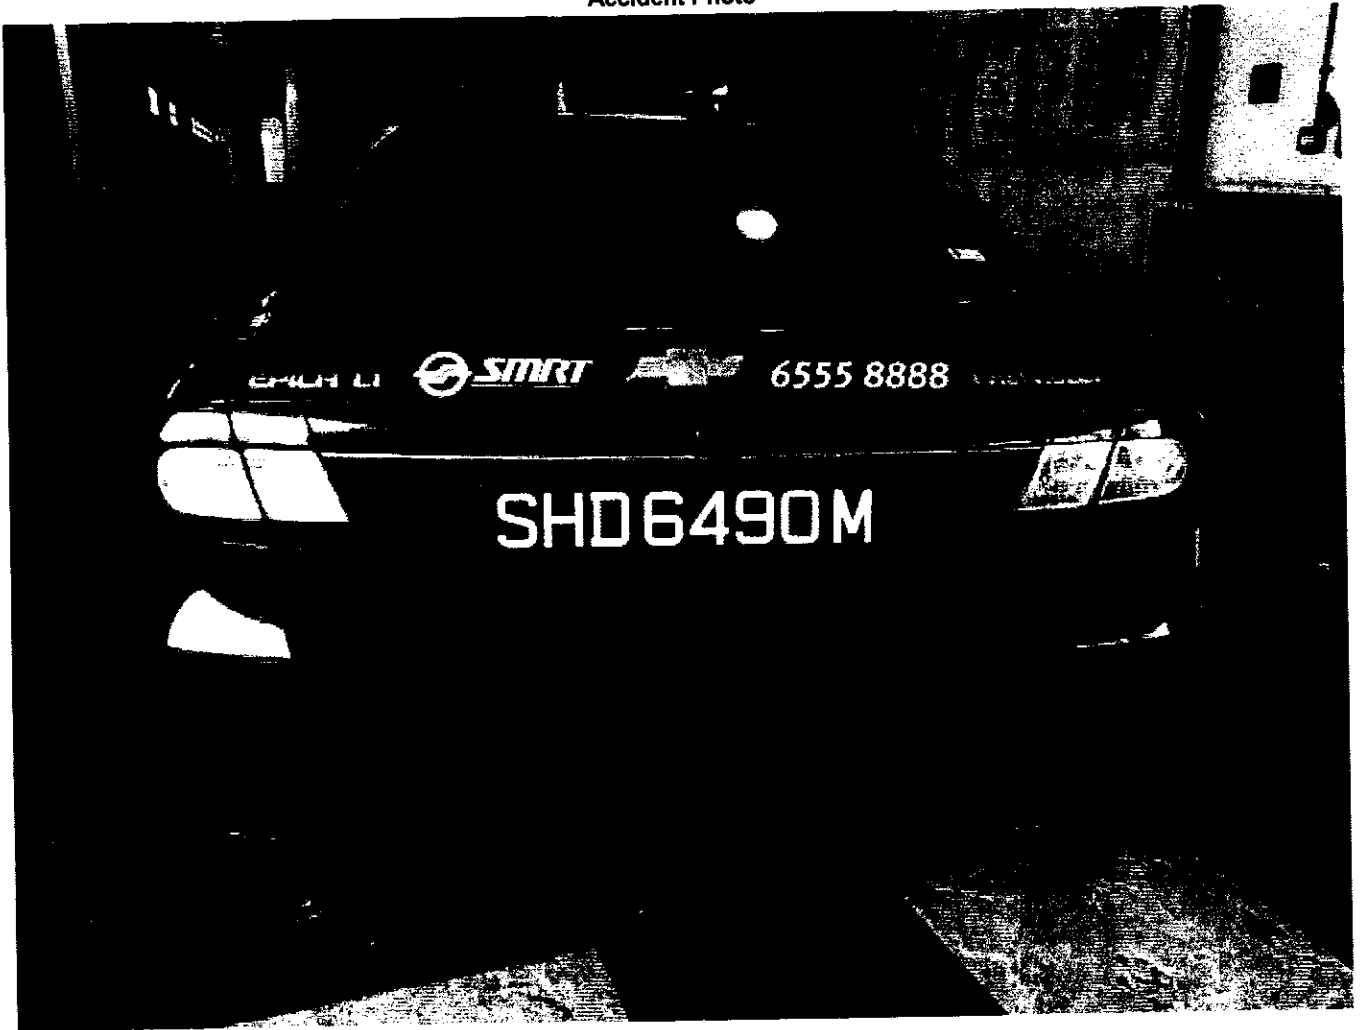
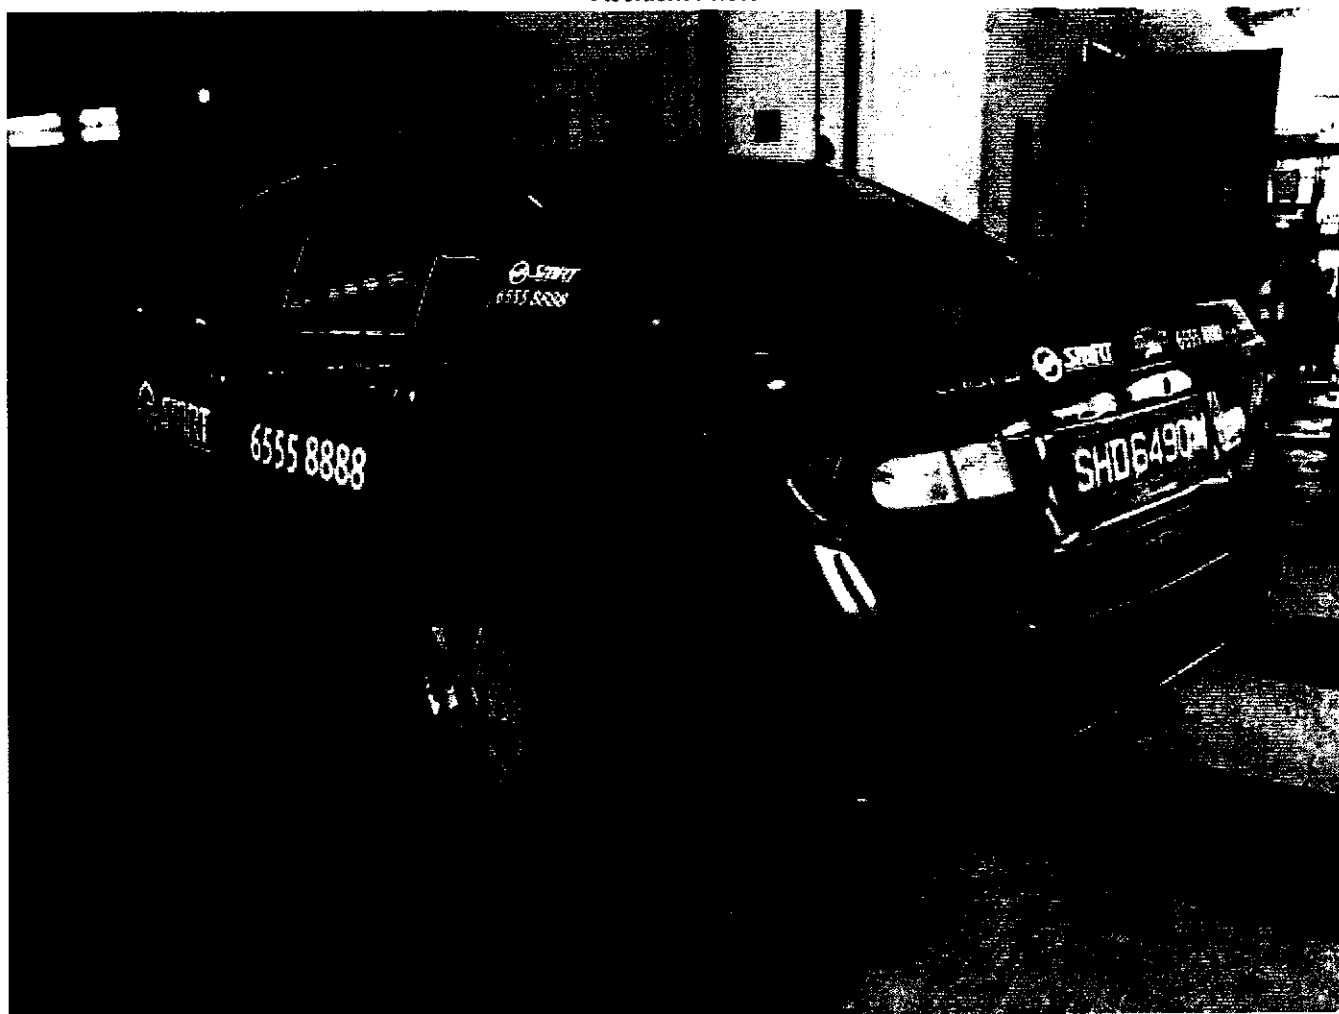
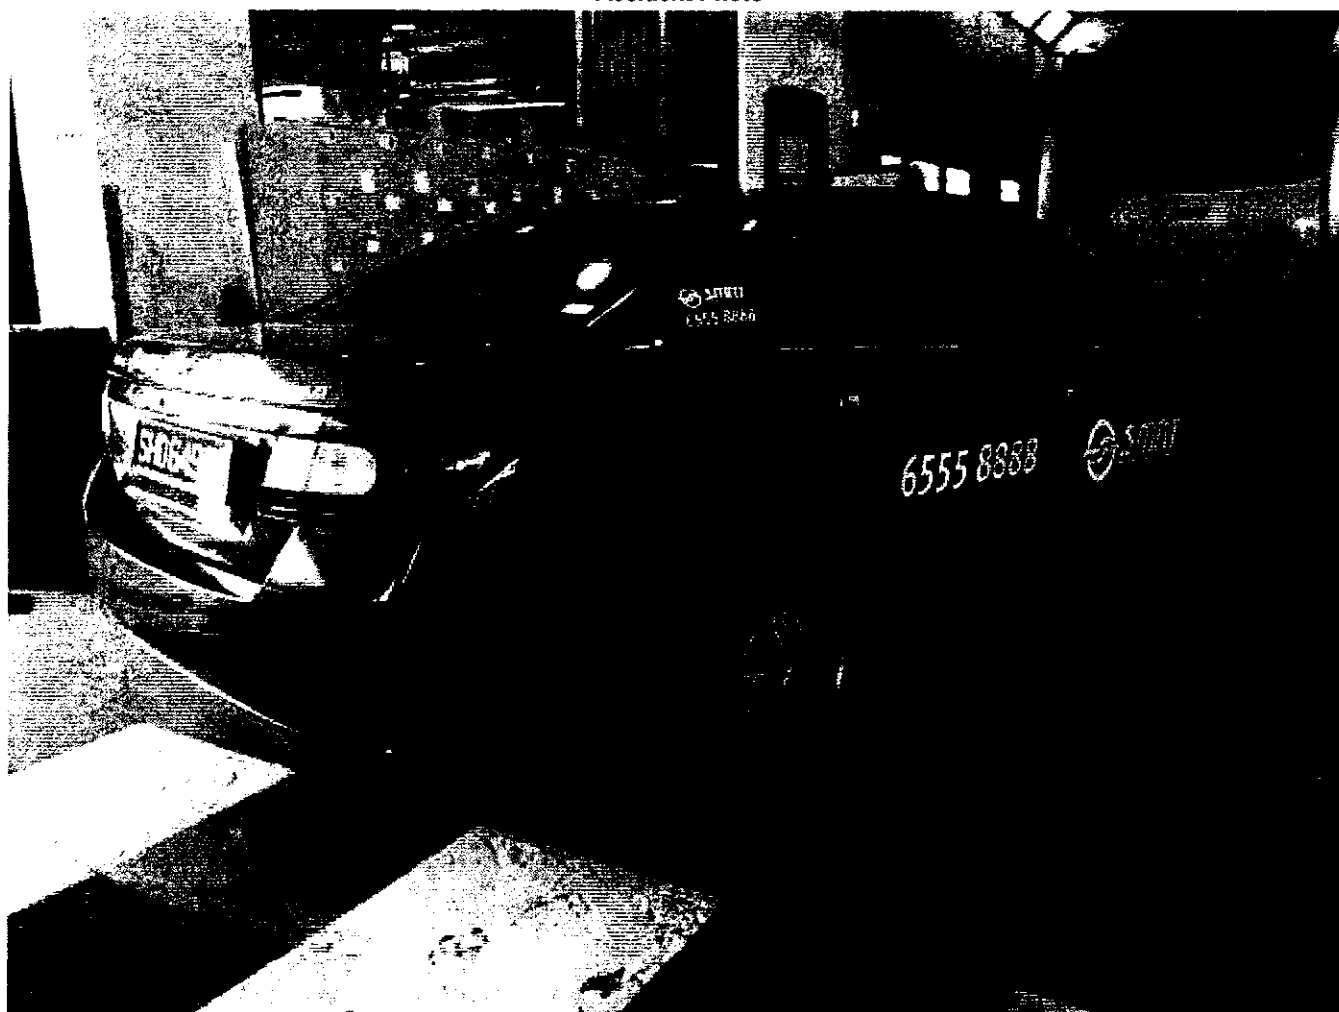
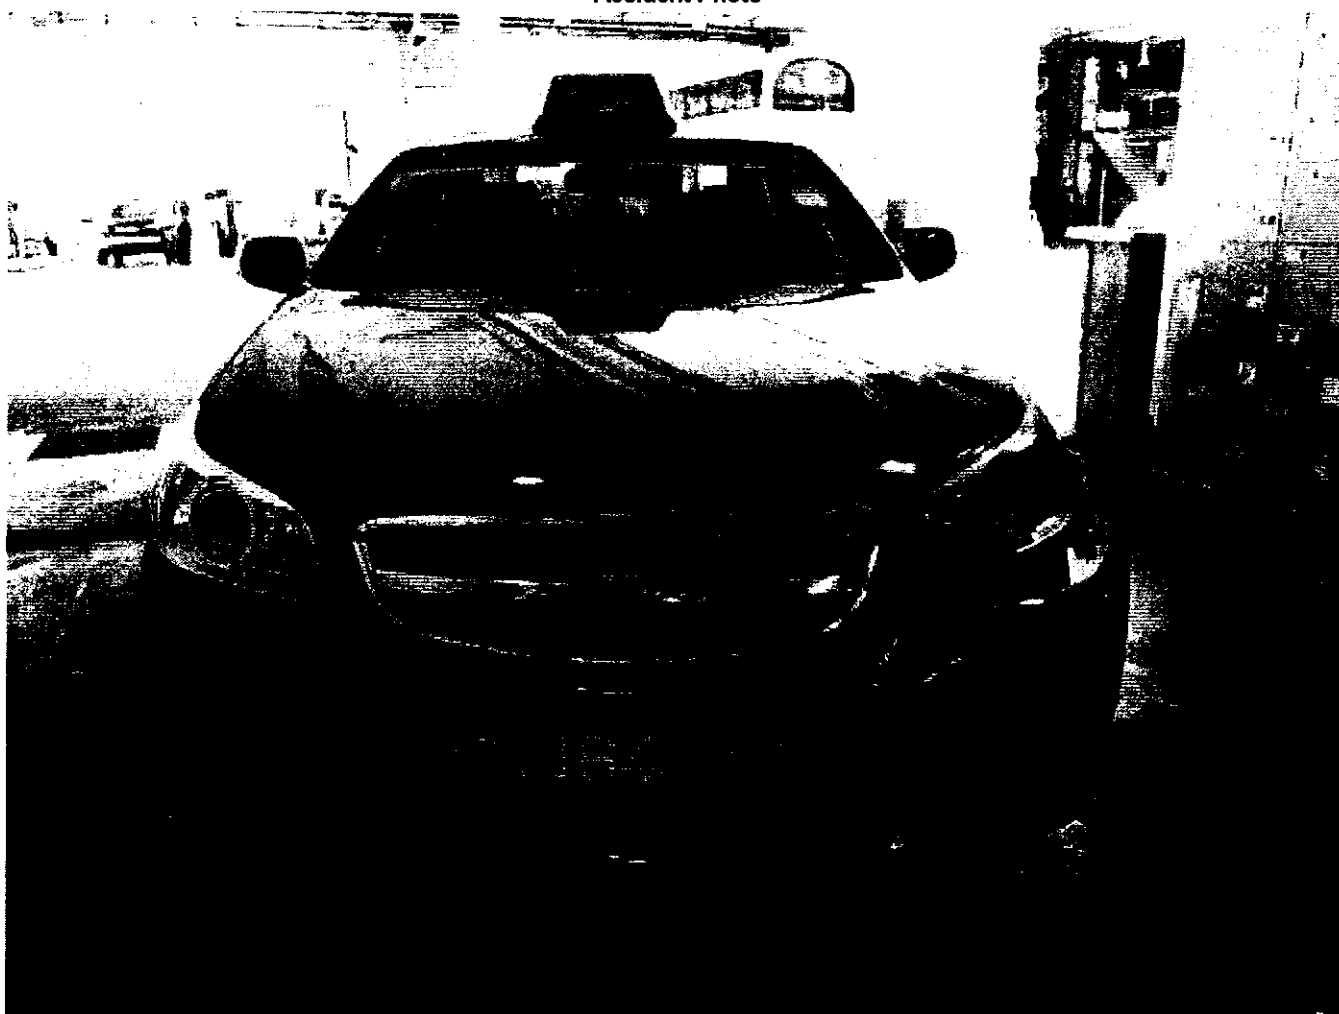
Accident Photo

Qty	Description of Parts	Condition	Estimate By Workshop (\$)	Our Adjusted (\$)
REPLACEMENT OF PARTS				
1	BUMPER FRY ASSY (DISC 10%)	DEFORMED	1,238.00	1,114.20
1	ABSORBER ENGY FRT BUMPER (DISC 10%)	CRACKED	219.00	197.10
1	BEAM FRT BUMPER IMPACT (DISC 10%)	BENT	465.00	418.50
1	BRACKET FRT BUMPER SIDE LH (DISC 10%)	NECESSARY	9.00	8.10
1	GRILLE RADIATOR (DISC 10%)	CRACKED	252.00	226.80
1	EMBLEM FRONT (DISC 10%)	NECESSARY	69.00	62.10
1	LAMP HEAD LH (DISC 10%)	CRACKED	841.00	756.90
1	PANEL FRT FENDER LH (DISC 10%)	BUCKLED	606.00	545.40
1	PNL FENDER APRON LH (DISC 10%)	BUCKLED	734.27	660.84
1	LINER FENDER FRT LH (PROTECTOR) (DISC 10%)	TORN	49.00	44.10
1	COVER RAD GRILL UPR (DISC 10%)	DEFORMED	18.00	16.20
6	CLIP, RAD OPG UPR CVR @\$1.00 (DISC 10%)	NECESSARY	6.00	5.40
1	SMRT LOGO DOOR (SN)	NECESSARY	60.00	60.00
1	STICKER DECAL 6555 8888 (DOOR) (SN)	NECESSARY	60.00	60.00
1	TYRE	SERVICEABLE	126.74	-
1	HANDLE DOOR OUTER LH	SERVICEABLE	60.00	-

1	MIRROR LH	SERVICEABLE	844.00	-
1	PANEL FRT HOOD	TO REPAIR	1,044.00	-
1	TYRE RIM	TO REPAIR	328.99	-
1	PANEL LH FRONT DOOR	TO REPAIR	2,020.00	-
1	PANEL LH REAR DOOR	TO REPAIR	1,863.00	-
			10,913.00	4,175.64
LABOUR				
THATCHAM STANDARD REPAIR TIME ON BODY WORKS.			1,405.00	770.00
THATCHAM TTS STANDARD SPRAY PAINTING COST AND LABOUR.			3,088.00	1,250.00
TO REPLACE SUNDRY PARTS.			100.00	20.00
TO WASH AND VACUUM.			60.00	40.00
			4,653.00	2,080.00
GRAND TOTAL			15,566.00	6,255.64

RECOMMENDED COST OF LUMP SUM REPAIRS (TO ITS PRE-ACCIDENT CONDITION) (CONFIRMED)			5,000.00
---	--	--	----------

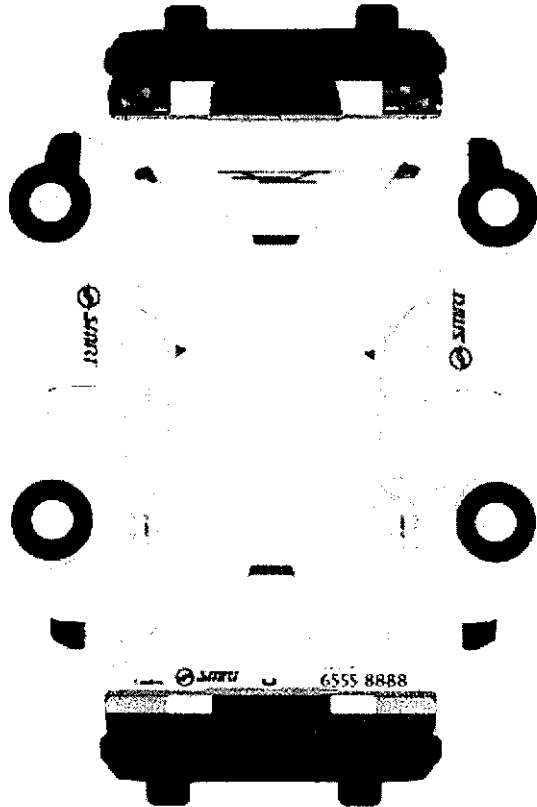
Reg. No : SHD6490M
Ref. No : TAX/12/17/2070
Reg. Date : 04/05/2012
Vehicle Type : TAXI
Make : CHEVROLET EPICA 2.0 VCDI
Model : EPICA-2.0
Name of Driver : TAN SOON CHIA
Type of Accident : SIDE SWIPE
Date / Time of Accident : 13/12/2017 03:18:00 AM
Accident Reported Date / Time : 13/12/2017 12:00:00 AM
Surveyor is Required? : Yes
Survey by :
Vehicle is Towed Back? : No
Towed Back Date/Time :
Replacement Vehicle issued? : No
Accident Repair Job Card No : 000024093583
Special Instruction to ARC, if any :
SLA532J - NTUC IDAC / *Returning after repair*
Prepared Date : 13/12/2017 09:57:16 AM

Job Scope	Quotation from ARC	Adjusted by Surveyor, if applicable
O REPAIR LH PORTION	845.00	0.00 700
Total Labour	845.00	0.00

Job Scope	Quotation from ARC	Adjusted by Surveyor, if applicable
O APPLY RUST-PROOFING ON AFFECTED REA	100.00	0.00 100
O TRANSFER DOOR MECHANISM	240.00	0.00 X
O REMOVE AND REFIT TYRE RIM (SPRAYING PURPOSE)	120.00	0.00 30
O CHECK WIRING AND SYSTEM FUNCTION	80.00	0.00 40
O REPLACE SUNDRY PARTS	100.00	0.00 20
O WASH AND VACUUM	60.00	0.00 40
O REMOVE AND REFIX WING MIRROR	120.00	0.00 X
Total Other Costs	820.00	0.00

Part Number	Portion	Stock No	Part Name	Qty	List Price (\$)	Discount (%)	Final Price (\$)	ARC Recommendation	Surveyor Approved	Photos Attached
3744489	FRONT	6504592	BUMPER FRT ASSY	1	1,238.00	10.00	1,114.20	Replace	Replace <i>DB</i>	No
6634053	FRONT	6504681	ABSORBER ENGY FRT BUMPER	1	219.00	10.00	197.10	Replace	Replace <i>CRA</i>	No
6634054	FRONT	6504593	BEAM FRT BUMPER IMPACT	1	465.00	10.00	418.50	Replace	Replace <i>DB</i>	No
6633983			BRACKET FRT BUMPER SIDE LH	1	9.00	10.00	8.10	Replace	Replace <i>DB</i>	No
6633843	FRONT		GRILLE RADIATOR	1	252.00	10.00	226.80	Replace	Replace <i>CRA</i>	No
6634188	FRONT		EMBLEM FRONT	1	69.00	10.00	62.10	Replace	Replace <i>DB</i>	No
6636551	FRONT	6504557	PANEL FRT HOOD	1	1,044.00	10.00	939.60	Replace	Replace <i>DB</i>	No
6644857	FRONT	6504613	LAMP HEAD LH	1	841.00	10.00	756.90	Replace	Replace <i>CRA</i>	No
6636324	FRONT	6504580	PANEL FRT FENDER LH	1	606.00	10.00	545.40	Replace	Replace <i>DB</i>	No

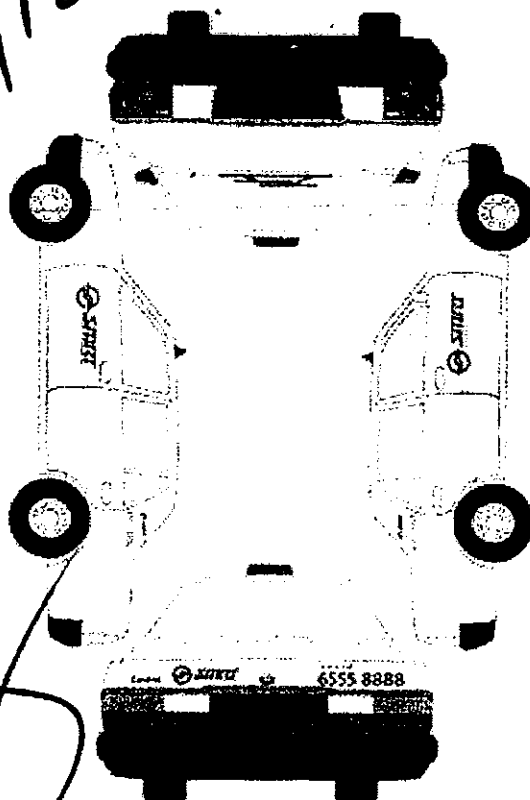
Reg. No : SHD6490M
 Ref. No : TAX/12/17/2070
 Reg. Date : 04/05/2012
 Vehicle Type : TAXI
 Make : CHEVROLET EPICA 2.0 VCDI
 Model : EPICA-2.0
 Name of Driver : TAN SOON CHIA
 Type of Accident : SIDE SWIPE
 Date / Time of Accident : 13/12/2017 03:18:00 AM
 Accident Reported Date / Time : 13/12/2017 12:00:00 AM
 Surveyor is Required? : Yes
 Survey by : Rasul
 Vehicle is Towed Back? : No
 Towed Back Date/Time :
 Replacement Vehicle issued? : No
 Accident Repair Job Card No : 000024093583
 Special Instruction to ARC, if any :
 SLA532J - NTUC IDAC
 Before paint photo, After repair photo FOR CHECK ITEM and REPLACE ITEM PLEASE CALL SURVEYOR RASUL / HP : 9001 0068. email: rasul@lkkauto.com
 Prepared Date : 13/12/2017 09:57:16 AM

Job Scope	Quotation from ARC	Adjusted by Surveyor, if applicable
TO REPAIR LH PORTION	845.00	700.00
Total Labour	845.00	700.00

Job Scope	Quotation from ARC	Adjusted by Surveyor, if applicable
TO APPLY RUST-PROOFING ON AFFECTED AREA	100.00	100.00
TO TRANSFER DOOR MECHANISM	240.00	0.00
TO REMOVE AND REFIT TYRE RIM (SPRAYING PURPOSE)	120.00	30.00
TO CHECK WIRING AND SYSTEM FUNCTION	80.00	40.00
TO REPLACE SUNDRY PARTS	100.00	20.00
TO WASH AND VACUUM	60.00	40.00
TO REMOVE AND REFIX WING MIRROR	120.00	0.00
ump Sum Adjustment by Surveyor	0.00	-1,255.64
Total Other Costs	820.00	-1,025.64

Part Number	Portion	Stock No	Part Name	Qty	List Price (\$)	Discount (%)	Final Price (\$)	ARC Recommendation	Surveyor Approved	Photos Attached
3744489	FRONT	6504592	BUMPER FRT ASSY	1	1,238.00	10.00	1,114.20	Replace	Replace	No <i>DE</i>
6634053	FRONT	6504681	ABSORBER ENGY FRT BUMPER	1	219.00	10.00	197.10	Replace	Replace	No <i>CRA</i>
6634054	FRONT	6504593	BEAM FRT BUMPER IMPACT	1	465.00	10.00	418.50	Replace	Replace	No <i>BT</i>
6633983			BRACKET FRT BUMPER SIDE LH	1	9.00	10.00	8.10	Replace	Replace	No <i>NEC</i>
6633843	FRONT		GRILLE RADIATOR	1	252.00	10.00	226.80	Replace	Replace	No <i>CRA</i>
6634188	FRONT		EMBLEM FRONT	1	69.00	10.00	62.10	Replace	Replace	No <i>NEC</i>
6636551	FRONT	6504557	PANEL FRT HOOD	0	1,044.00	10.00	0.00	Replace	Not given	No <i>XR</i>
6644857	FRONT	6504613	LAMP HEAD LH	1	841.00	10.00	756.90	Replace	Replace	No <i>CRA</i>
6636324	FRONT	6504580	PANEL FRT FENDER LH	1	606.00	10.00	545.40	Replace	Replace	No <i>BUC</i>
