Preliminary Advice

Insured Vehicle No	: SLM2375U	Accident Date	: 01/12/2017
TP Vehicle No	: FBE8346A	Assignment Date	: 15/12/2017
Make	: YAMAHA RXZ	Est. Duration of Repair	: 6.00
Date of Inspection	: 20/12/2017		
Inspection At	: A S PHOON PTE LTD (TOH GUAN) (HQ) BLK 36 TOH GUAN ROAD EAST ENTERPRISE HUB #01-35 SINGAPORE 408701

FBE8346A YAMAHA RXZ (5PV) RED REPAIR ESTIMATE

VEHICLE DAMAGE INSPECTION REPORT

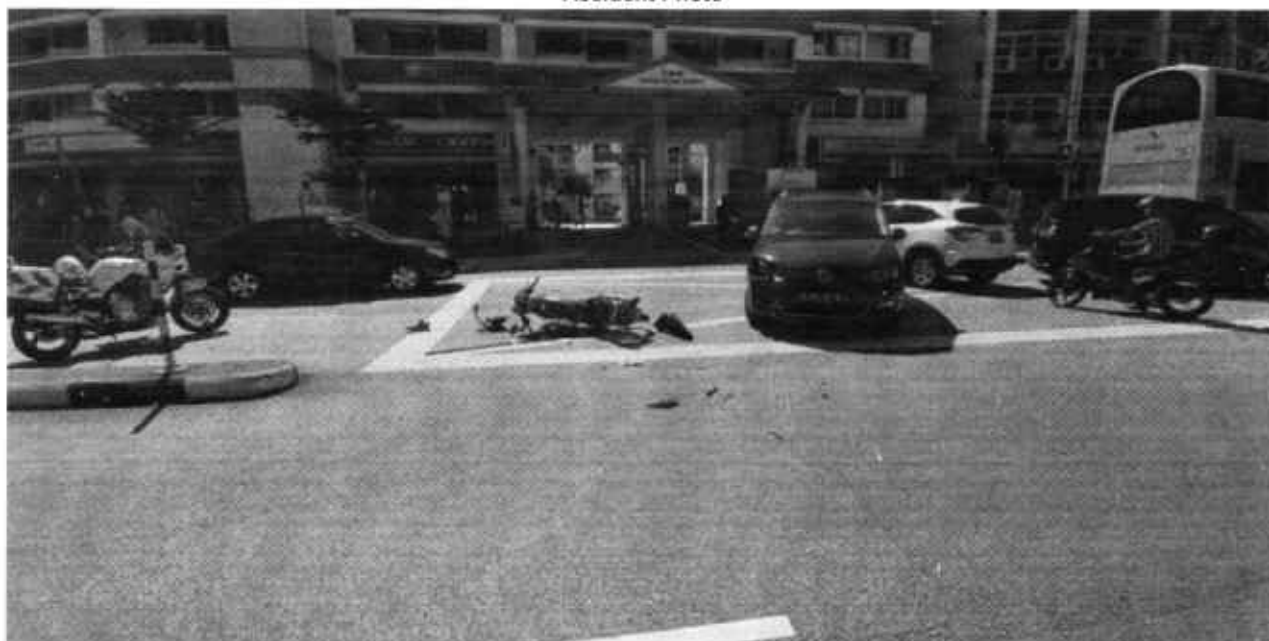
Accident Photo

The vehicle sustained impact / damages front portion, o/s & n/s body and parts claimed are consistent to the accident.
