To Inspect Vehicle No: SLP 2537D

Make: BMW 318i c.c. 1499

Ref : CS/MSG17023917/T1rd3

PRELIMINARY ADVICE OF VEHICLE NO. SLP 2537D

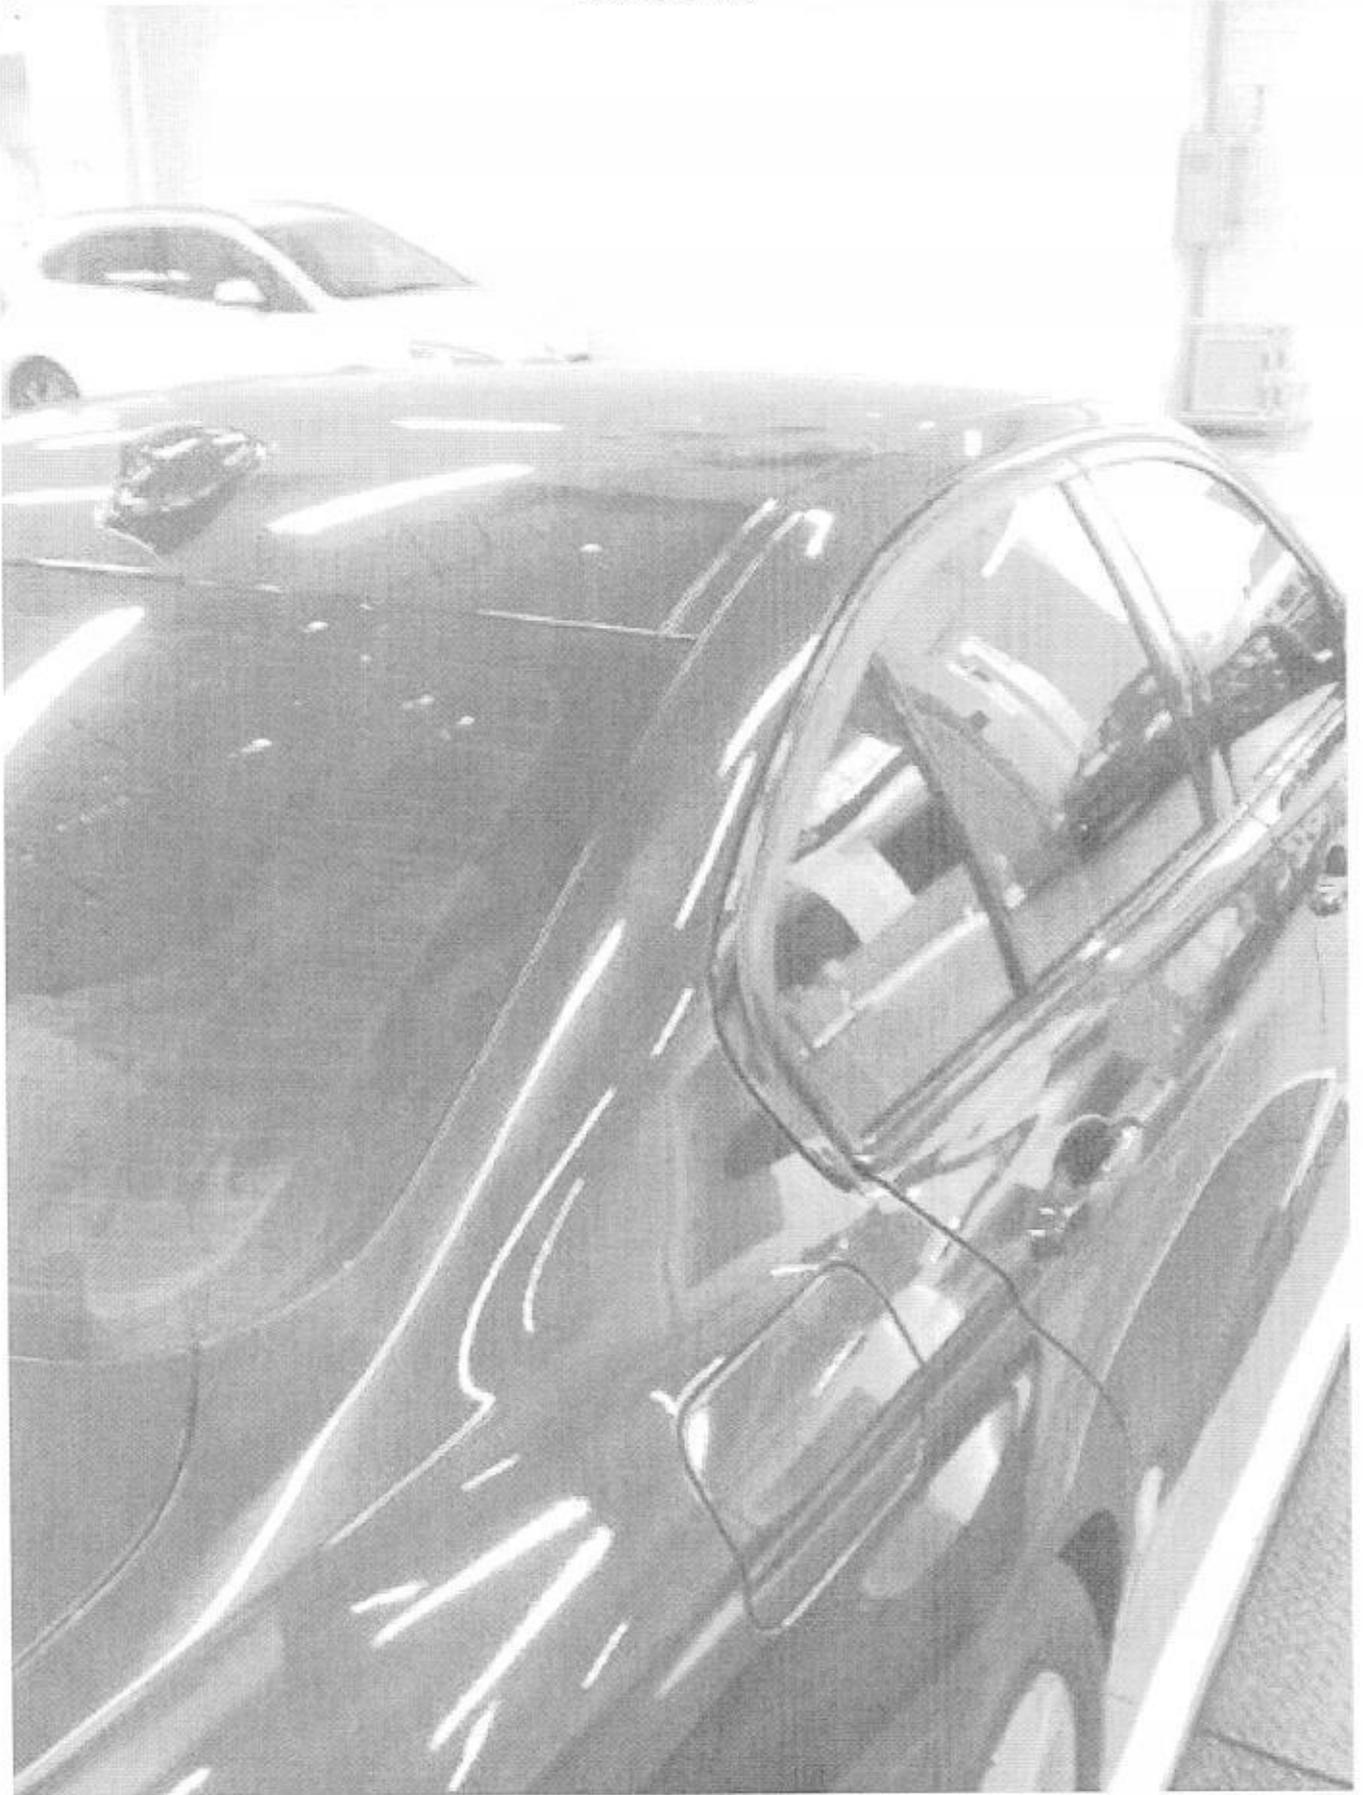
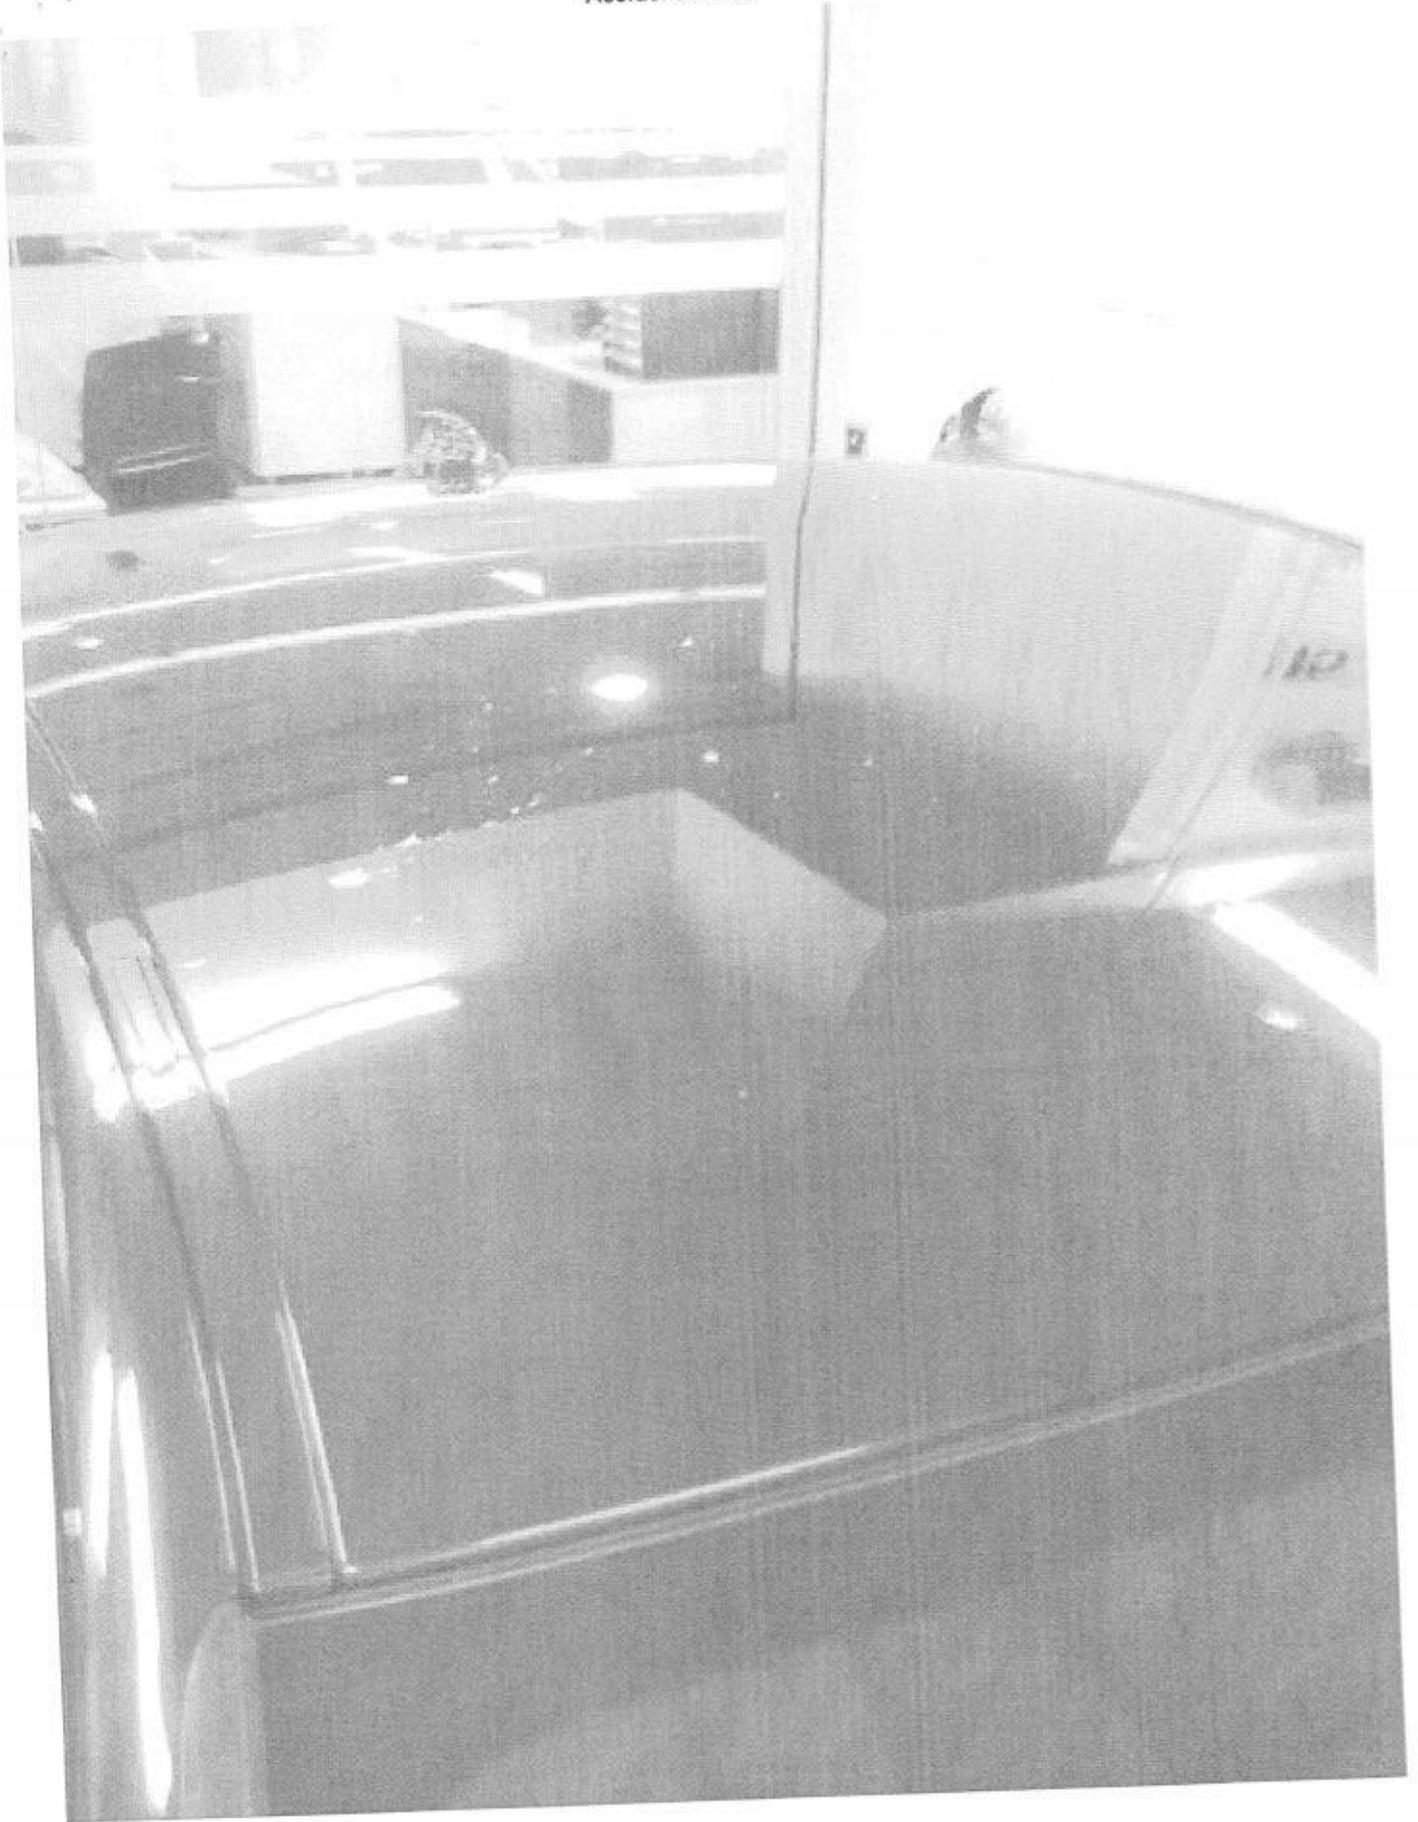
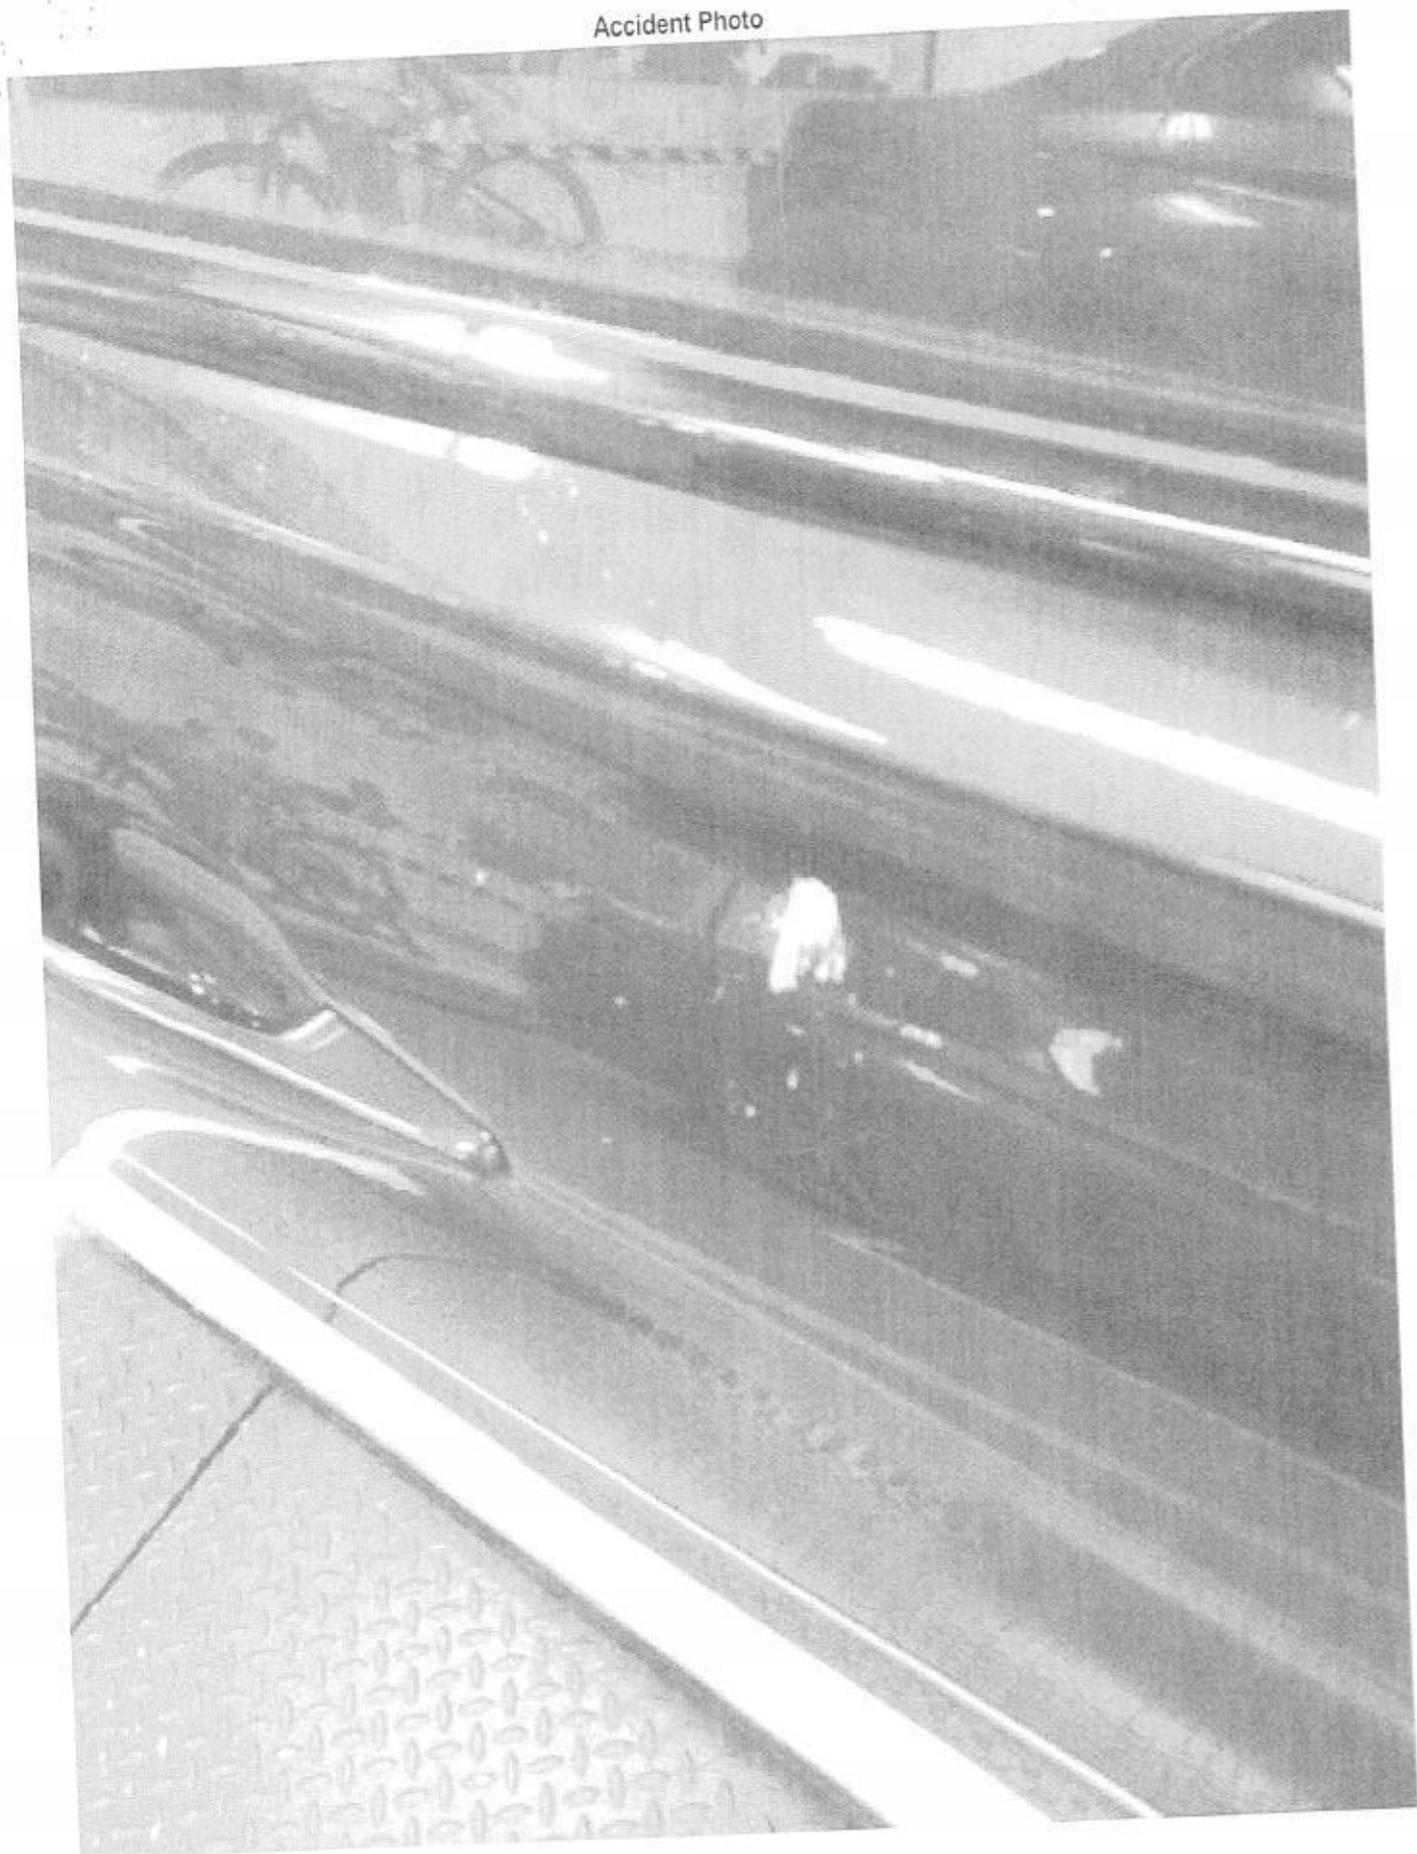
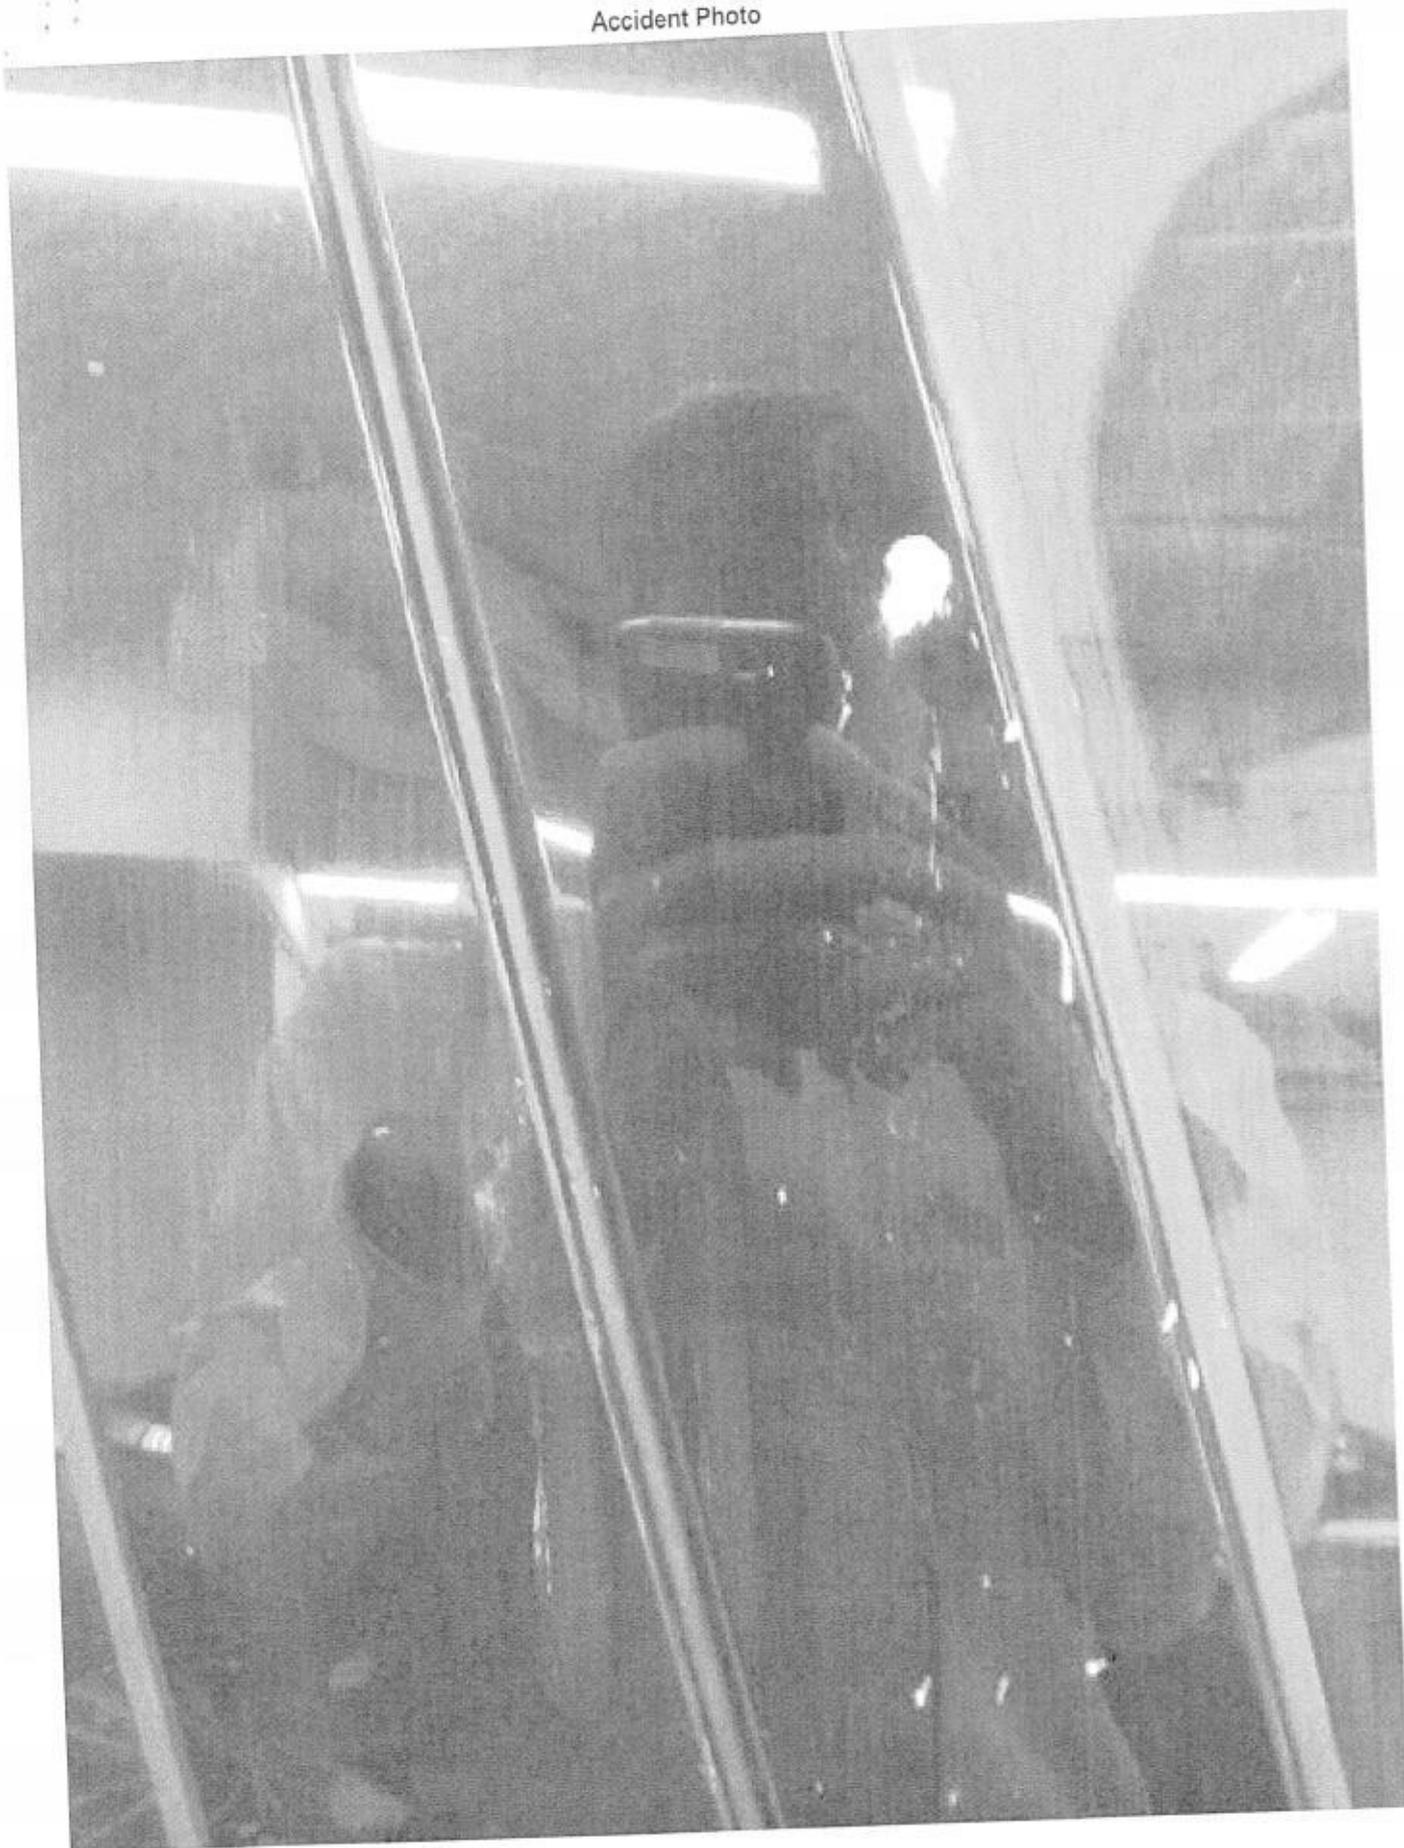
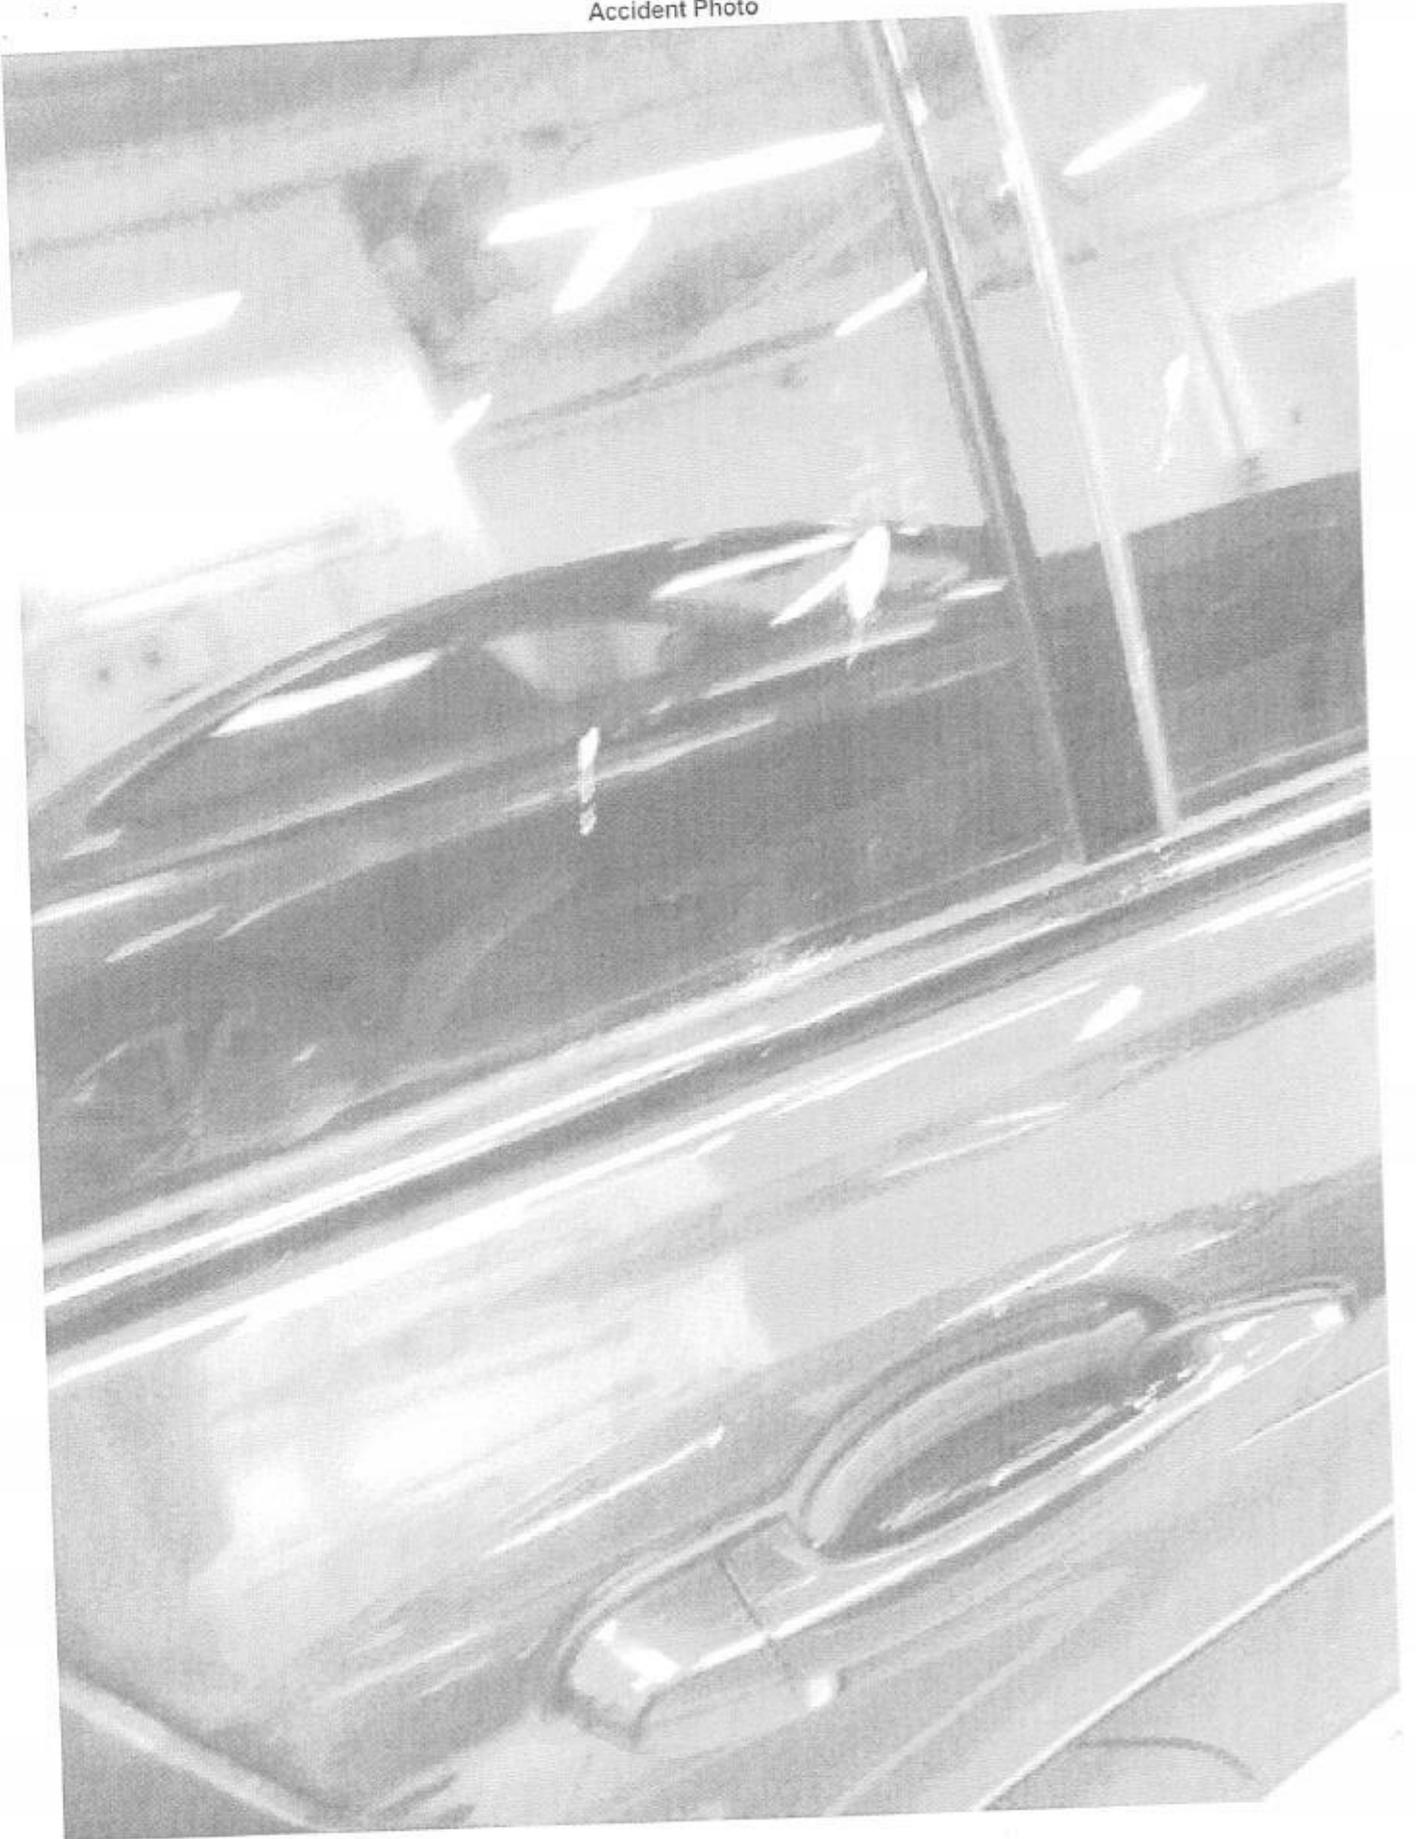
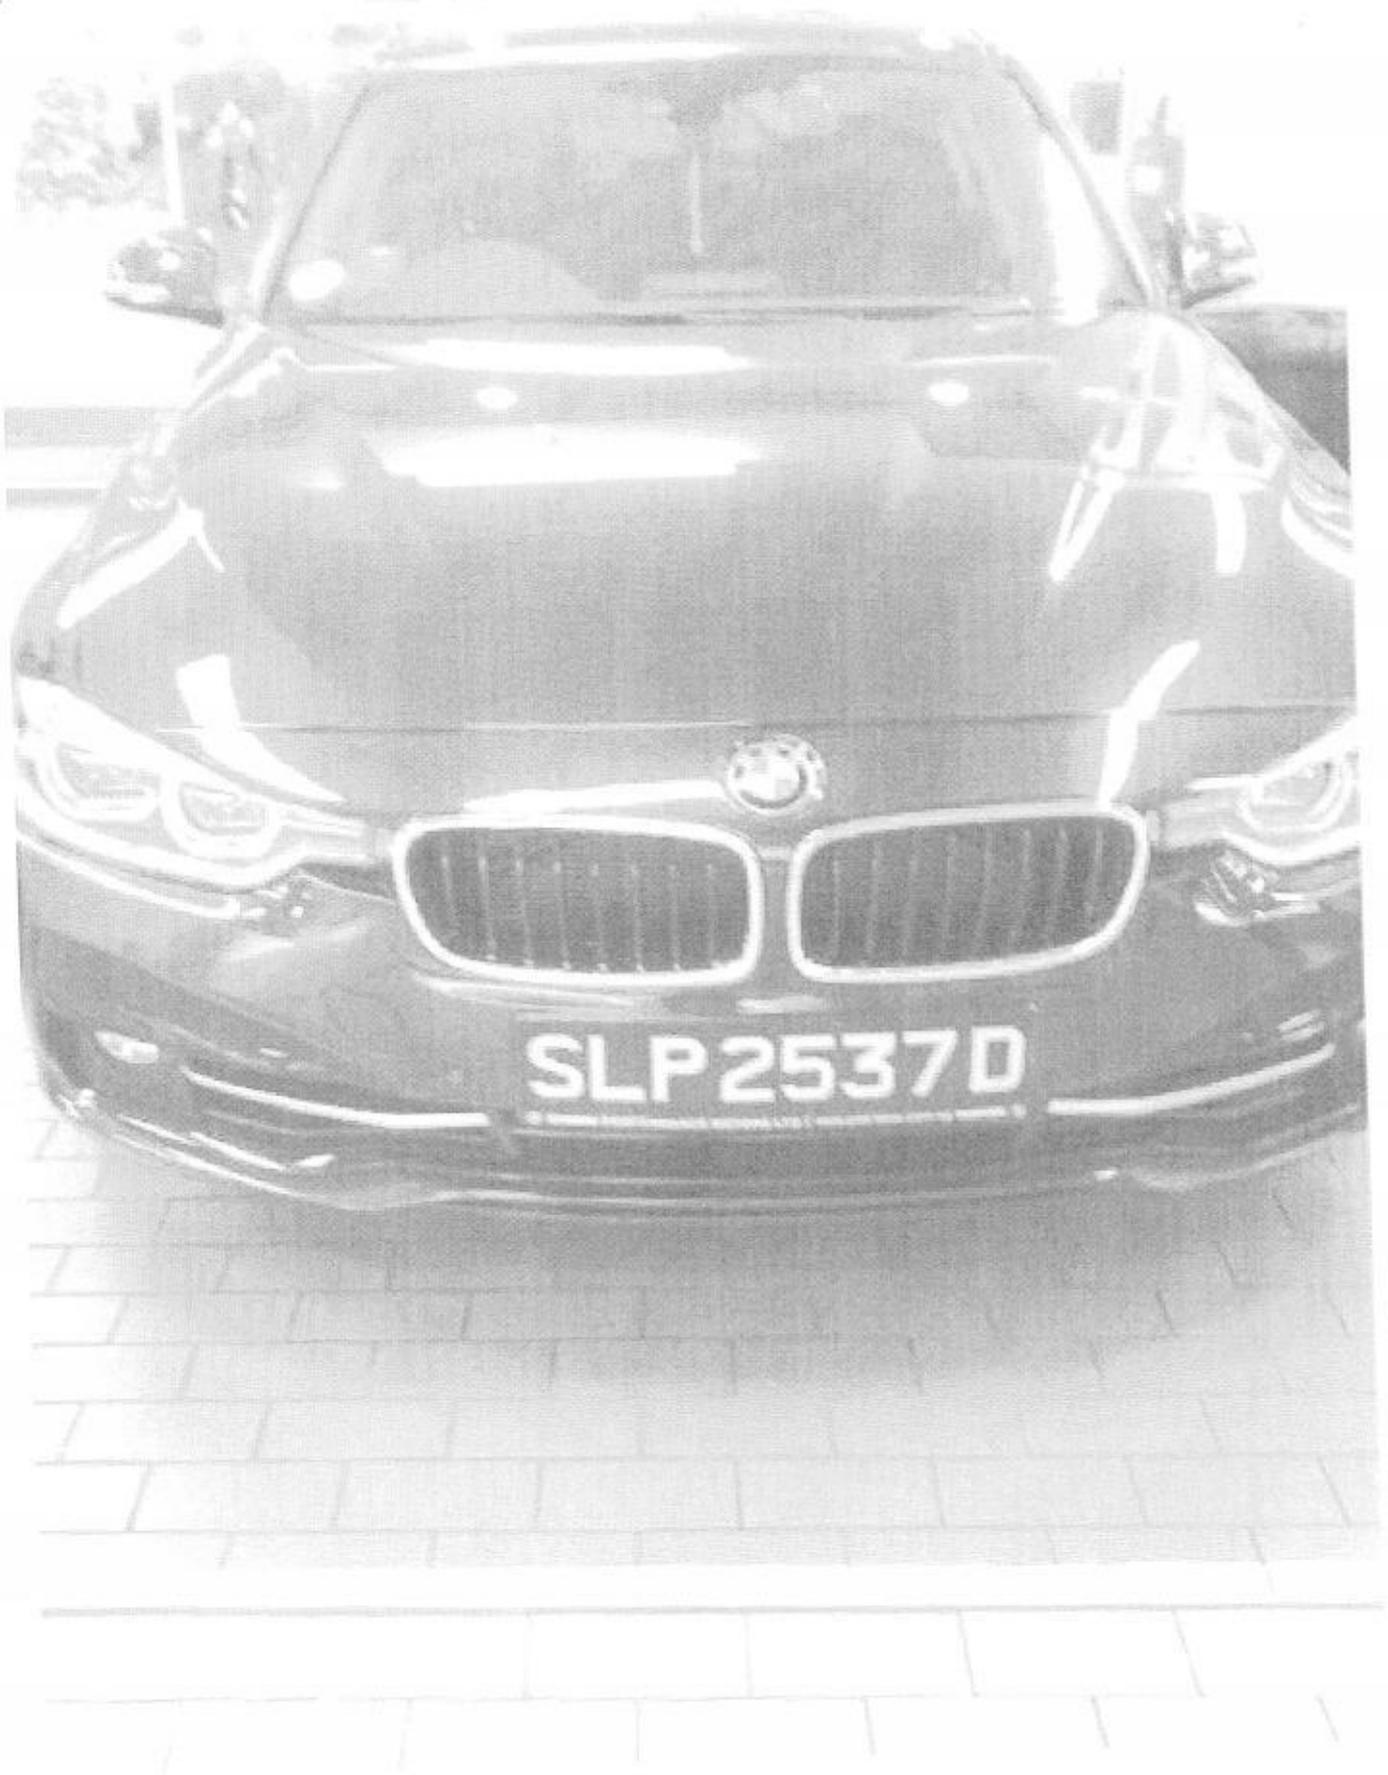
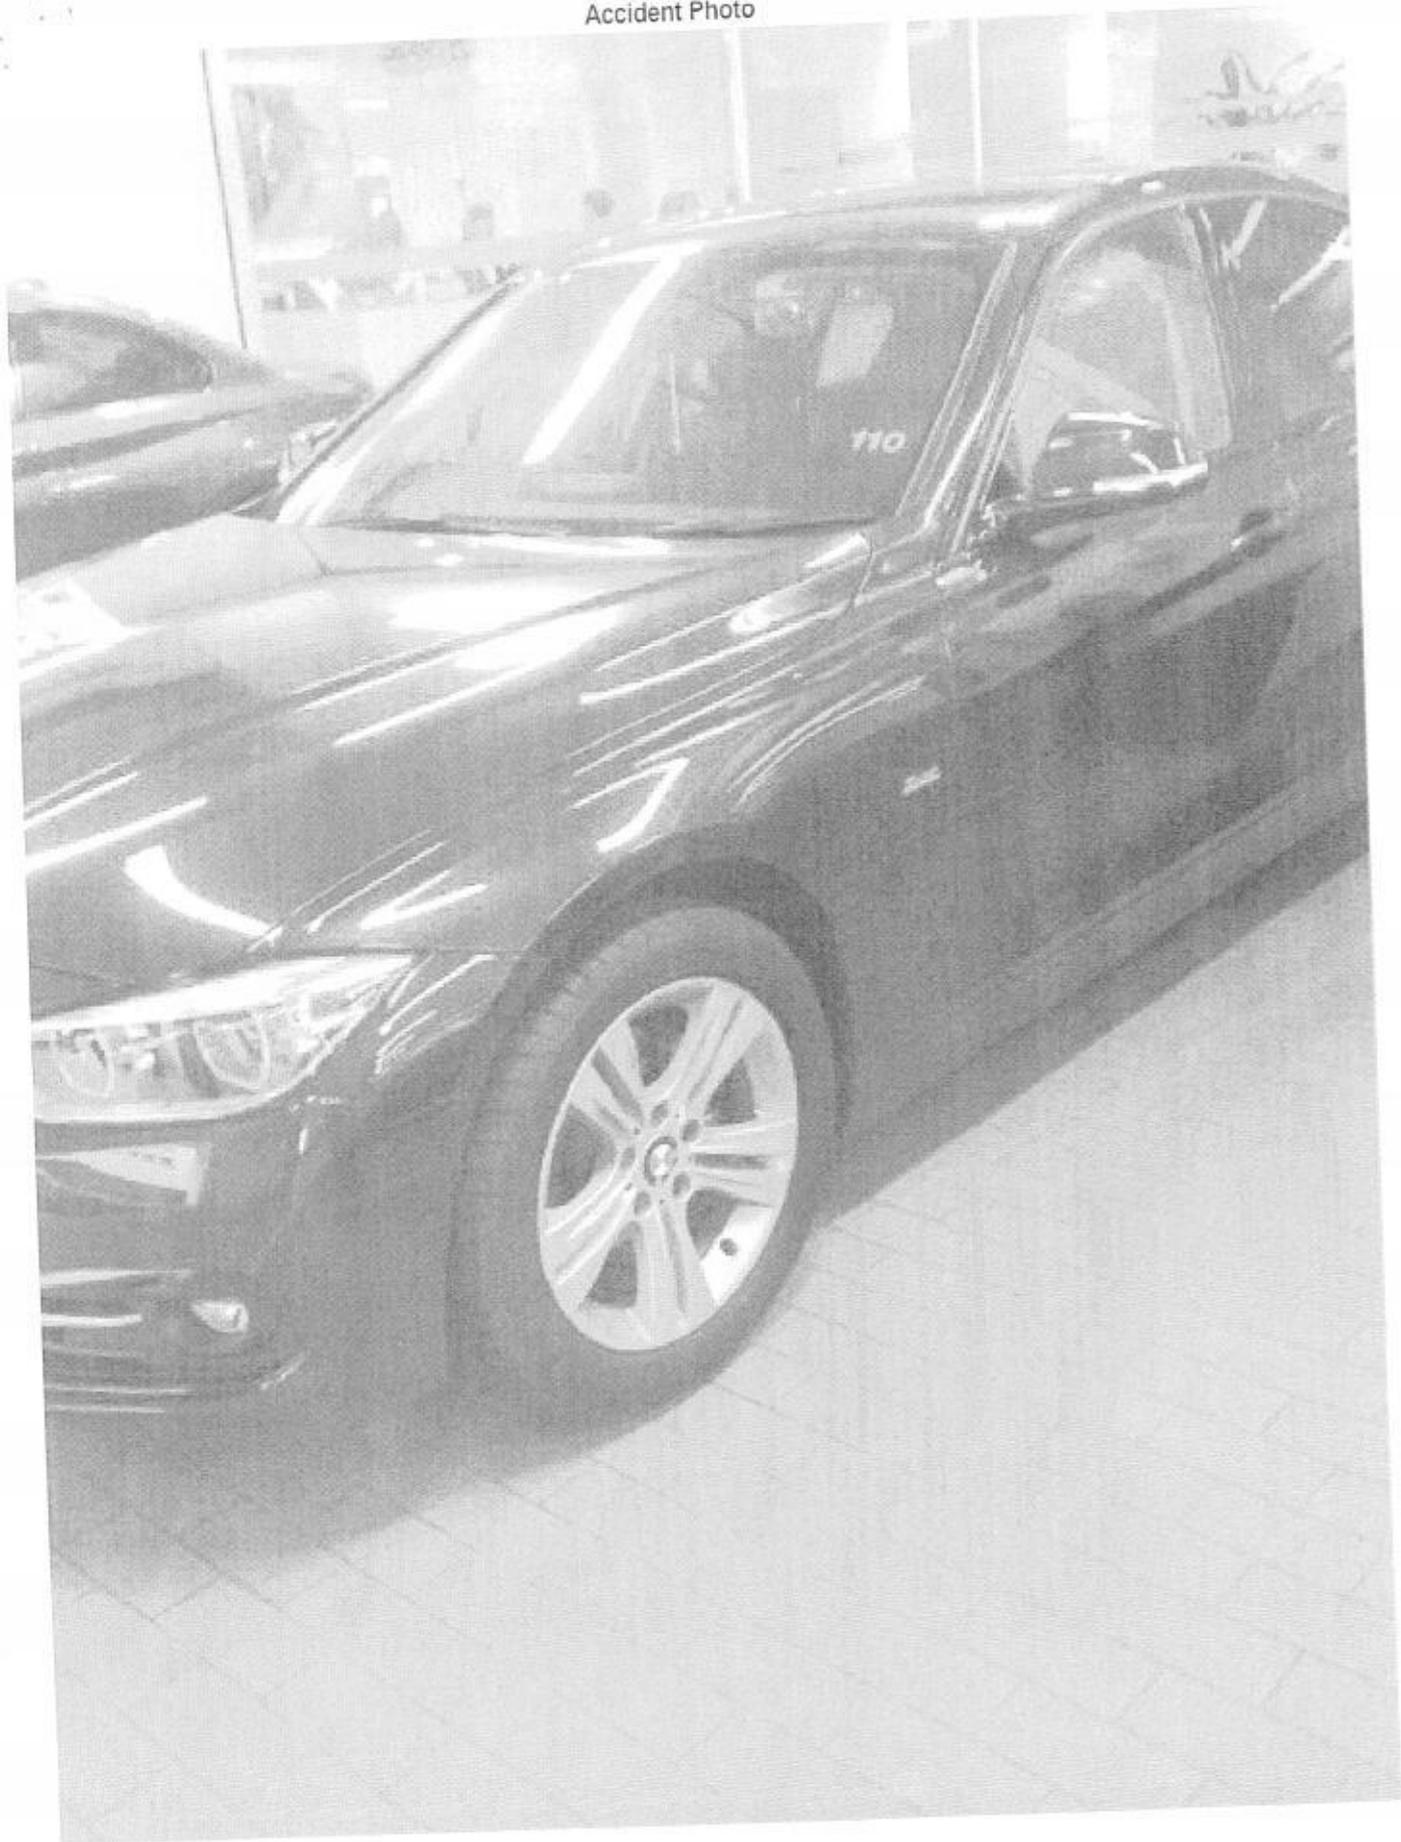
Description of Damage:
The vehicle sustained damages
at the front and rear portion, o/s body
and rooftop.

Comments/ Present Status:
Damages Consistent.
Estimate amount not revised due to cash job repair
Repair day : 10 days

THE VEHICLE SUSTAINED DAMAGES AT THE O/S BODY, FRONT, REAR AND ROOFTOP PORTION. DAMAGES SEE DETAILS.

To repair on front bonnet, front right door, rear right door, rear right fender, rear tailgate, roof top & replace on front & rear right door moulding

PAINTING ON FRONT BONNET, FRT RIGHT DOOR, REAR RIGHT DOOR, REAR RIGHT FENDER, REAR TAIL GATE, ROOF TOP & REAR RIGHT RIM.			6,209.00	6,209.00
POLISHING ALL CAR (BMW 1,2,3,4,X1,Z,I3 SERIES)			280.00	280.00
THE QUOTE IS NOT INSURANCE PURPOSE THIS REPAIR TAKES 10 WORKING DAYS. (NPA)			-	-
TO CHECK ELECTRICAL WIRING SYSTEMS FOR PROPER FUNCTION.			177.00	177.00
			10,916.00	10,916.00
GRAND TOTAL			12,123.85	11,909.50
RECOMMENDED COST OF REPAIRS				11,909.50

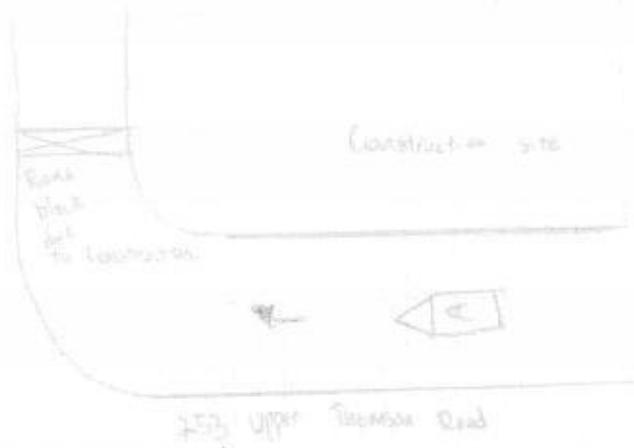
SKETCH PLAN

Suddenly, I heard a loud "Bang" sound coming from my car rooftop. After I parked my car at a parking lot, I made a check-up on the exterior part of my car and discovered there were cement stains on it. I went to the construction site nearby to complain about the incident.
