Point of Impact / General Description of Damages

Estimated repair cost for vehicle no: SKR6873H VOLKSWAGEN JETTA 1.4 A '15

VEHICLE DAMAGE INSPECTION REPORT

Our File No: CC3/MSG17023958/AQBN2

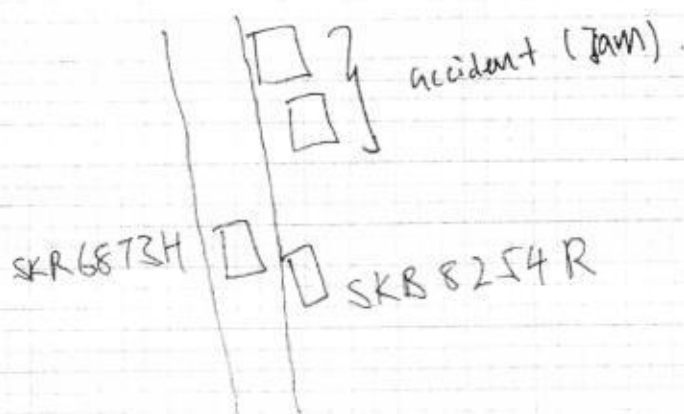
Sketch Plan #2

SKETCH PLAN

DESCRIBE CIRCUMSTANCES OF THE ACCIDENT

On 13/12/17 @ about 19:50 HRE.

There was an accident ahead and there was a heavy Jam, suddenly SKB 8254R change lane and hit onto my rear. I wish to state that the accident happen on SKB 8254R lane, thus he needs to change lane in order to move.
