TOKIO MARINE INSURANCE SINGAPORE LTD Ref : CS/TMI17024134/K1qb

1. Policy Particulars :- THIRD PARTY CLAIM

VEHICLE DAMAGE INSPECTION REPORT

Our File No: CS/TMI17024134/K1QBS2

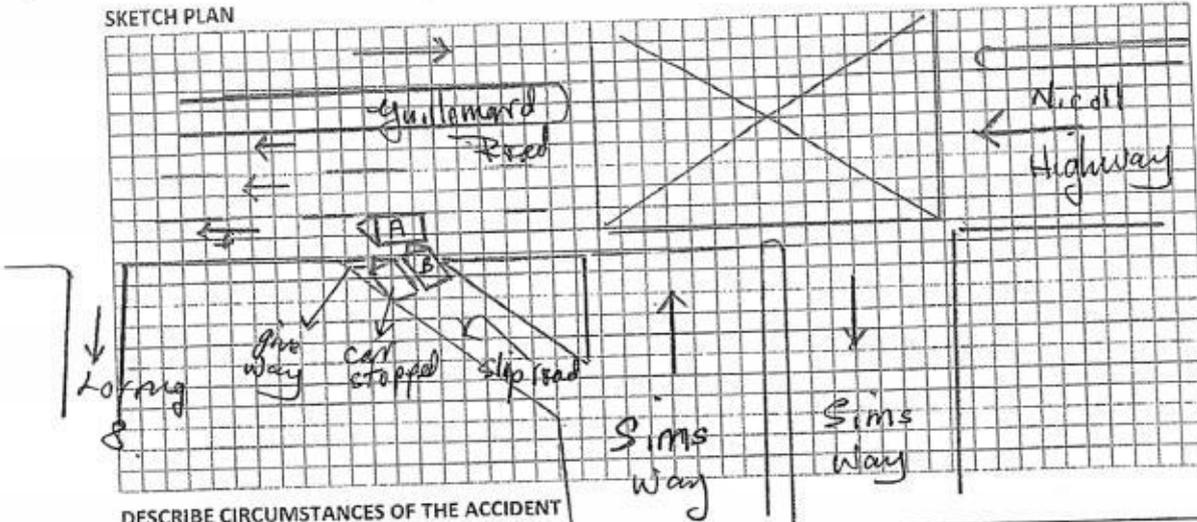
SKETCH PLAN

A: SHA 70124
 B: SJH 86637

While I was proceeding towards Lorong 8, Geylang, my taxi was suddenly hit into by car B(SJH 8663Z), a Mazda, amid exiting the slip road of Sims Way into Guillemard Road.

The impact inflicted damage to the left rear portion of my taxi while the front of car B sustained dents,
