**INITIAL INSPECTION REPORT OF VEHICLE NO. SKP 5263K**

The vehicle sustained damages at the o/s body. The undercarriage affected due to collision.

## ADJUSTMENT ON REPAIR COST FOR VEHICLE NO. SKP 5263K

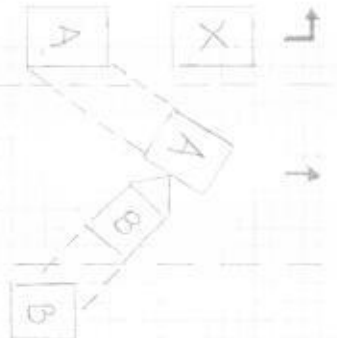
SKETCH PLAN

Approach Road toward Left lane

A - SKP5263K  
B - SHB4346X

On 4.12.17 at about 6.55 hr. I was driving (SKP5263K) from Airport Road toward left lane. I was at the most extreme left lane, I signal & saw the middle lane to be clear. When I safely moved to the middle lane, completely a taxi (SHB4346X) was there at my rear side of my vehicle. The impact caused me to swerve and was given 3 days MC
