NTUC INCOME INSURANCE CO-OPERATIVE LTD Ref: NS/INC17024182/Stb				
73 BRAS BASAH ROAD #05-01 NTUC TRADE UNION HOUSESINGAPORE 189556			Date: 21-12-2017	 
Code: INC4

1. Policy Particulars :- THIRD PARTY CLAIM				
Insured Veh.	SGL 7859Y	Veh. Inspected	SHB 920P	
Policy No.	5092860159	Coverage (\$)	0.00	
Claim No.		Excess (\$)	0.00	
Assign From		Assign Date	19/12/2017

4. Description of Damages				
THE VEHICLE SUSTAINED DAMAGES AT THE N/S BODY. DAMAGES SEE DETAILS.				
5. General Information				
Accident Date	16/12/2017	Inspection Date	19/12/2017	
Survey held at	SMRT AUTOMOTIVE SERVICES PTE LTD 60 WOODLANDS INDUSTRIAL PARK E4 SINGAPORE 757705			
5a. Remarks				
A)THE INSPECTION WAS CONDUCTED ON A"WITHOUT PREJUDICE" BASIS. B)IN ACCORDANCE TO YOUR INSTRUCTIONS, WE HAVE NOT AUTHORISED REPAIRS.				
5b. Estimate Days of Repair				
ESTIMATED NORMAL PERIOD FOR REPAIR:		5 Working Days

ADJUSTMENT ON REPAIR COST FOR VEHICLE NO. SHB 920P

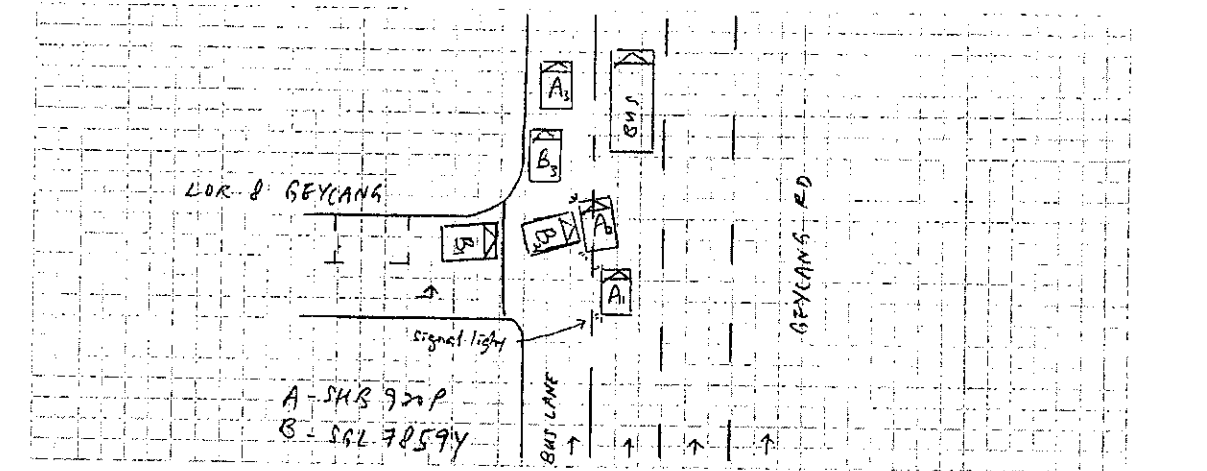
SKETCH PLAN

On 16 December 2017, 5.17pm (17.17.03), I (Party A) was driving along Geylang Road. There was a bus lane which a SBS Transit bus, number 80, was moving out and I slowed down to give way to. Afterwards, I was behind the bus and I signalled my intention towards the fourth lane, but party B did not see it. The car, SGL 7859 Y (Party B), in the junction of Geylang Lorong 8, was seen in the video that it was not moving at all as I started turning towards the fourth lane. At that moment, the car (party B) suddenly emerge from the side road of Geylang Lorong 8 with a wide gap, turning towards the third lane and hit on my left side doors, causing scratches and dents.
